REPETITIVE LOSS AREA ANALYSIS

City of Wilson, North Carolina
Planning & Development Services

Prepared by:
Amec Foster Wheeler
Environment & Infrastructure, Inc.

October 2015

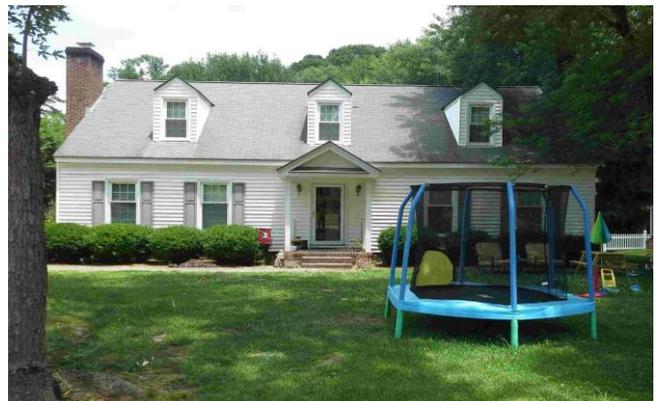
Property Locator / Repetitive Loss#: 3713-23-4211.000
Inspection Date: 6/11/2015 **Inspector:** Scott Gentry
No. of Stories: 1 **Basement:**
Occupied: Yes **Neighborhood:** Single Family Residential
Fill: 0-1 Feet **Elevated:** 2-3 Feet
Observations: Has shed. Has hvac, elevated on concrete pad. No gutter. Street is curb and gutter.
Flooding: Unknown
Flooding Notes:
Land Use: Single-family residential
Land Use Notes:
Adequate Vents Present: Yes
Spoke with: Owner Unavailable
Structure Type: Wood Frame
Structure Type Notes:
Condition of Structure: Good (optional minor repairs)
Foundation Type: Crawlspace floor at or above grade on at least 1 side
Foundation Type Notes:
Condition of Foundation: Good (optional minor repairs)

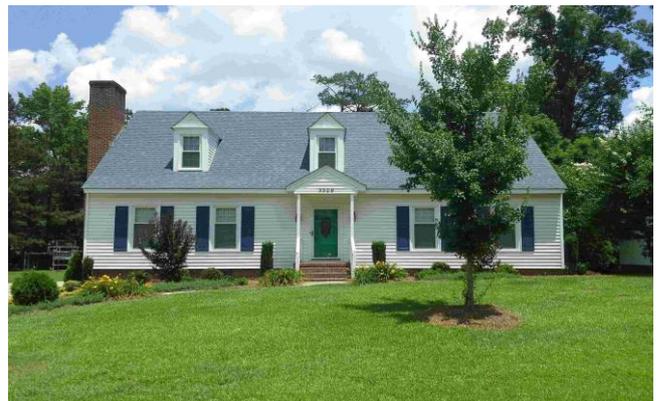
Property Locator / Repetitive Loss#: 3713-32-3867.000
Inspection Date: 6/11/2015 **Inspector:** Scott Gentry
No. of Stories: 2 **Basement:** No
Occupied: **Neighborhood:** Single Family Residential
Fill: None **Elevated:** 1-2 Feet
Observations: No gutter. No hvac seen from street. Street is curb and gutted.
Flooding: Unknown
Flooding Notes:
Land Use: Single-family residential
Land Use Notes:
Adequate Vents Present: Yes
Spoke with: Owner Unavailable
Structure Type: Masonry
Structure Type Notes:
Condition of Structure: Good (optional minor repairs)
Foundation Type: Crawlspace floor at or above grade on at least 1 side
Foundation Type Notes:
Condition of Foundation: Good (optional minor repairs)

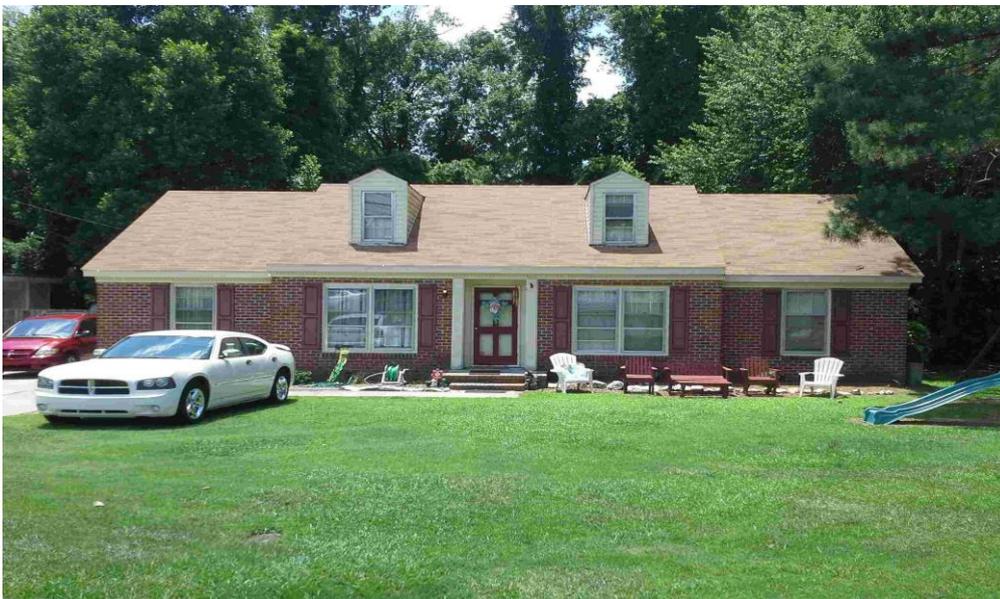
Property Locator / Repetitive Loss#: 3713-32-5629.000
Inspection Date: 6/11/2015 **Inspector:** Scott Gentry
No. of Stories: 1 **Basement:** Unknown
Occupied: Yes **Neighborhood:** Single Family Residential
Fill: Below Street **Elevated:** 0-1 Feet
Grads
Observations: Has shed which is below grade of the house. Hvac seen at side of house. Gutters on side of house, not on the front.
Flooding: Unknown
Flooding Notes:
Land Use: Single-family residential
Land Use Notes:
Adequate Vents Present: Unknown
Spoke with: Owner Unavailable
Structure Type: Masonry
Structure Type Notes:
Condition of Structure: Good (optional minor repairs)
Foundation Type: Unable to determine
Foundation Type Notes:
Condition of Foundation: Good (optional minor repairs)

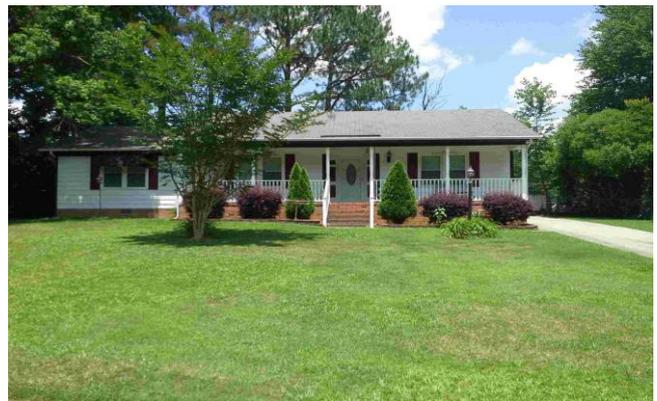
Property Locator / Repetitive Loss#: 3713-32-7665.000
Inspection Date: 6/11/2015 **Inspector:** Scott Gentry
No. of Stories: 1 **Basement:** No
Occupied: Yes **Neighborhood:** Single Family Residential
Fill: 0-1 Feet **Elevated:** 2-3 Feet
Observations: No gutter. Has shed. Hvac not seen from street.
Flooding: Unknown
Flooding Notes:
Land Use: Single-family residential
Land Use Notes:
Adequate Vents Present: Yes
Spoke with: Owner Unavailable
Structure Type: Wood Frame
Structure Type Notes:
Condition of Structure: Good (optional minor repairs)
Foundation Type: Crawlspace floor at or above grade on at least 1 side
Foundation Type Notes:
Condition of Foundation: Good (optional minor repairs)

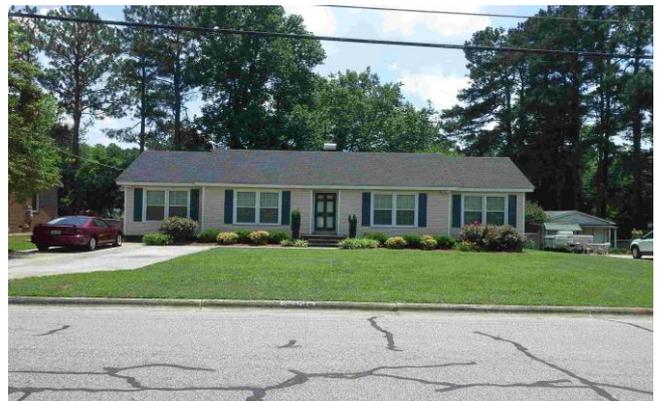
Property Locator / Repetitive Loss#: 3713-33-0090.000
Inspection Date: 6/11/2015 **Inspector:** Scott Gentry
No. of Stories: 1 **Basement:** No
Occupied: Yes **Neighborhood:** Single Family Residential
Fill: 0-1 Feet **Elevated:** 2-3 Feet
Observations: No gutter. Hvac not seen from street.
Flooding: Unknown
Flooding Notes:
Land Use: Single-family residential
Land Use Notes:
Adequate Vents Present: Yes
Spoke with: Owner Unavailable
Structure Type: Wood Frame
Structure Type Notes:
Condition of Structure: Good (optional minor repairs)
Foundation Type: Crawlspace floor at or above grade on at least 1 side
Foundation Type Notes:
Condition of Foundation: Good (optional minor repairs)

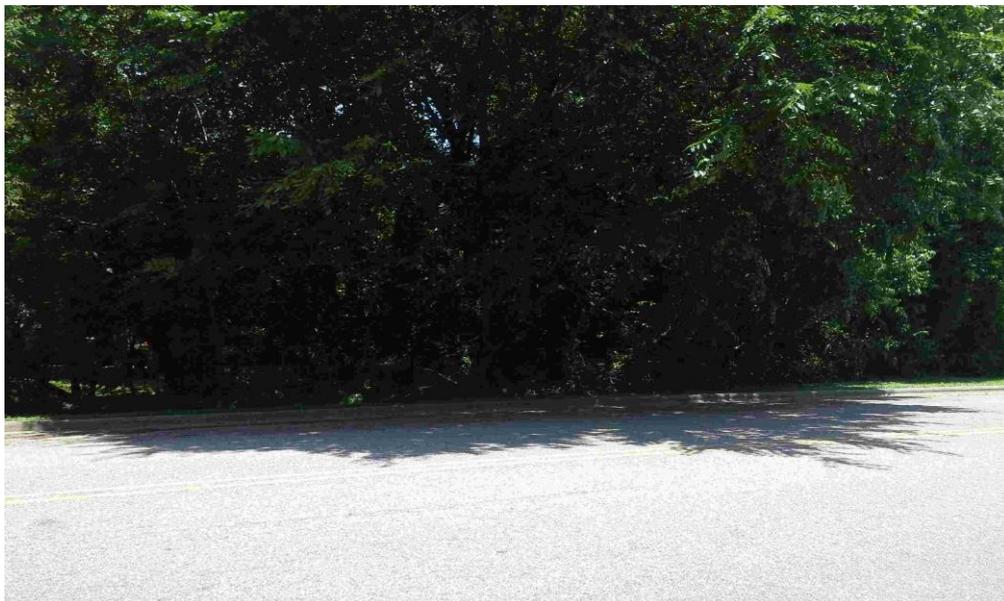
Property Locator / Repetitive Loss#: 3713-32-2698.000
Inspection Date: 6/11/2015 **Inspector:** Scott Gentry
No. of Stories: 1 **Basement:** No
Occupied: Yes **Neighborhood:** Single Family Residential
Fill: Below Street **Elevated:** 2-3 Feet
Grads
Observations: No gutter. Hvac not seen from street.
Flooding: Unknown
Flooding Notes:
Land Use: Single-family residential
Land Use Notes:
Adequate Vents Present: Yes
Spoke with: Owner Unavailable
Structure Type: Wood Frame
Structure Type Notes:
Condition of Structure: Good (optional minor repairs)
Foundation Type: Crawlspace floor at or above grade on at least 1 side
Foundation Type Notes:
Condition of Foundation: Good (optional minor repairs)

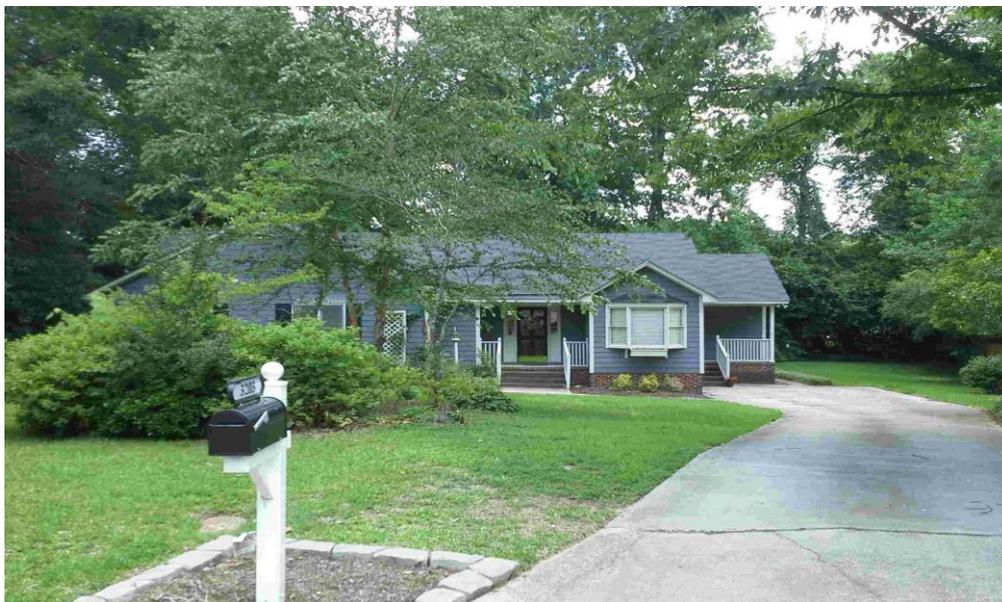
Property Locator / Repetitive Loss#: 3713-22-7964.000
Inspection Date: 6/11/2015 **Inspector:** Yuqi
No. of Stories: 1 **Basement:** No
Occupied: Yes **Neighborhood:** Single Family Residential
Fill: None **Elevated:** 2-3 Feet
Observations: Has gutters, unobserved secondary structures, has HVAC.
Flooding: Unknown
Flooding Notes:
Land Use: Single-family residential
Land Use Notes:
Adequate Vents Present: Yes
Spoke with: Owner Unavailable
Structure Type: Wood Frame
Structure Type Notes:
Condition of Structure: Good (optional minor repairs)
Foundation Type: Crawlspace floor at or above grade on at least 1 side
Foundation Type Notes:
Condition of Foundation: Good (optional minor repairs)

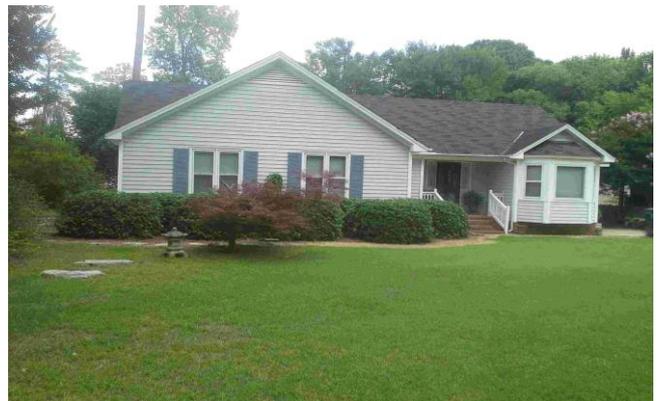
Property Locator / Repetitive Loss#: 3713-23-5023.000
Inspection Date: 6/11/2015 **Inspector:** Yuqi
No. of Stories: 2 **Basement:** No
Occupied: Yes **Neighborhood:** Single Family Residential
Fill: None **Elevated:** 3-4 Feet
Observations: No gutters, has HVAC, cannot see secondary structures.
Flooding: Unknown
Flooding Notes:
Land Use: Single-family residential
Land Use Notes:
Adequate Vents Present: Yes
Spoke with: Owner Unavailable
Structure Type: Wood Frame
Structure Type Notes:
Condition of Structure: Good (optional minor repairs)
Foundation Type: Crawlspace floor at or above grade on at least 1 side
Foundation Type Notes:
Condition of Foundation: Good (optional minor repairs)

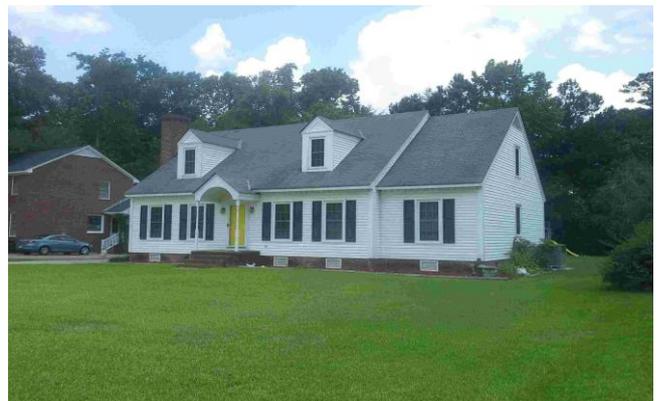
Property Locator / Repetitive Loss#: 3713-32-1730.000
Inspection Date: 6/11/2015 **Inspector:** Yuqi
No. of Stories: 1 **Basement:**
Occupied: Yes **Neighborhood:** Single Family Residential
Fill: 0-1 Feet **Elevated:** 3-4 Feet
Observations: No gutters, has secondary structure as detached storage room, unobserved HVAC
Flooding: No
Flooding Notes:
Land Use: Single-family residential
Land Use Notes:
Adequate Vents Present: Yes
Spoke with: Owner Unavailable
Structure Type: Masonry
Structure Type Notes:
Condition of Structure: Good (optional minor repairs)
Foundation Type: Crawlspace floor at or above grade on at least 1 side
Foundation Type Notes:
Condition of Foundation: Good (optional minor repairs)

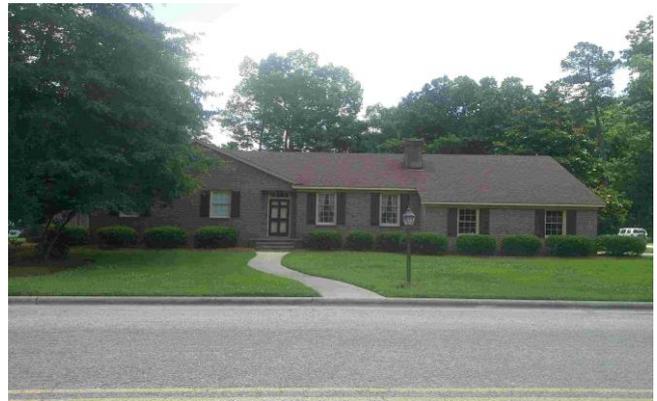
Property Locator / Repetitive Loss#: 3713-43-1510.000
Inspection Date: 6/11/2015 **Inspector:** Yuqi
No. of Stories: 1 **Basement:**
Occupied: Yes **Neighborhood:** Single Family Residential
Fill: 0-1 Feet **Elevated:** 3-4 Feet
Observations: No gutters, has secondary structure as storage room, has HVAC. Adjacent to a creek.
Flooding: Yes
Flooding Notes: The owner said this house was flooded, the picnic table was floating, the water got high up to the fence, and the air conditioner was flooded. It floods two to three times per year. The street was flooded.
Land Use: Single-family residential
Land Use Notes:
Adequate Vents Present: Yes
Spoke with: Owner/Occupant
Structure Type: Masonry
Structure Type Notes:
Condition of Structure: Good (optional minor repairs)
Foundation Type: Crawlspace floor at or above grade on at least 1 side
Foundation Type Notes:
Condition of Foundation: Good (optional minor repairs)

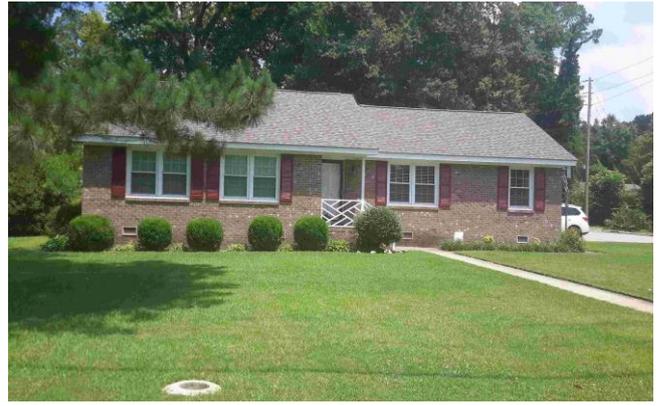
Property Locator / Repetitive Loss#: 3713-22-9738.000
Inspection Date: 6/11/2015 **Inspector:** Alex Magruder
No. of Stories: 2 **Basement:** No
Occupied: Yes **Neighborhood:** Single Family Residential
Fill: 0-1 Feet **Elevated:** 2-3 Feet
Observations: No gutters. Secondary structure. Unknown hvac.
Flooding: Unknown
Flooding Notes:
Land Use: Single-family residential
Land Use Notes:
Adequate Vents Present: Yes
Spoke with: Owner Unavailable
Structure Type: Wood Frame
Structure Type Notes:
Condition of Structure: Good (optional minor repairs)
Foundation Type: Crawlspace floor at or above grade on at least 1 side
Foundation Type Notes:
Condition of Foundation: Good (optional minor repairs)

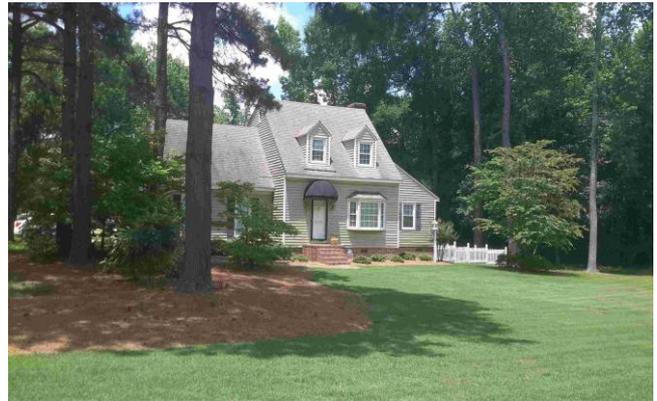
Property Locator / Repetitive Loss#: 3713-23-4182.000
Inspection Date: 6/11/2015 **Inspector:** Alex Magruder
No. of Stories: 2 **Basement:** No
Occupied: Yes **Neighborhood:** Single Family Residential
Fill: 0-1 Feet **Elevated:** 2-3 Feet
Observations: No gutters. Hvac unit on ground. Shed in backyard.
Flooding: Unknown
Flooding Notes:
Land Use: Single-family residential
Land Use Notes:
Adequate Vents Present: Yes
Spoke with: Owner Unavailable
Structure Type: Masonry
Structure Type Notes:
Condition of Structure: Good (optional minor repairs)
Foundation Type: Crawlspace floor at or above grade on at least 1 side
Foundation Type Notes:
Condition of Foundation: Good (optional minor repairs)

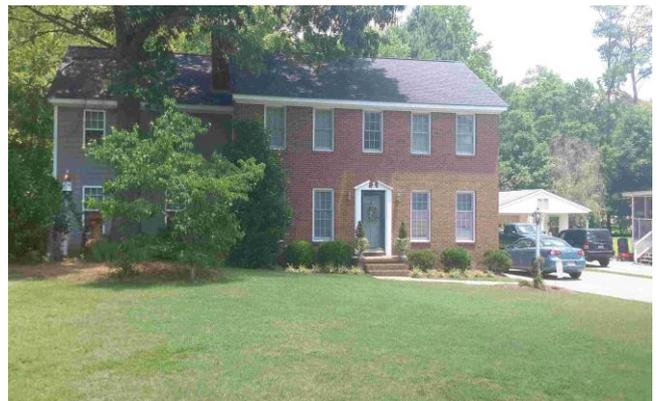
Property Locator / Repetitive Loss#: 3713-23-7000.000
Inspection Date: 6/11/2015 **Inspector:** Alex Magruder
No. of Stories: 1 **Basement:** No
Occupied: Yes **Neighborhood:** Single Family Residential
Fill: 2-3 Feet **Elevated:** 2-3 Feet
Observations: No gutters. Secondary structure. HVAC unit unknown.
Flooding: Unknown
Flooding Notes:
Land Use: Single-family residential
Land Use Notes:
Adequate Vents Present: Yes
Spoke with: Owner Unavailable
Structure Type: Wood Frame
Structure Type Notes:
Condition of Structure: Good (optional minor repairs)
Foundation Type: Crawlspace floor at or above grade on at least 1 side
Foundation Type Notes:
Condition of Foundation: Good (optional minor repairs)

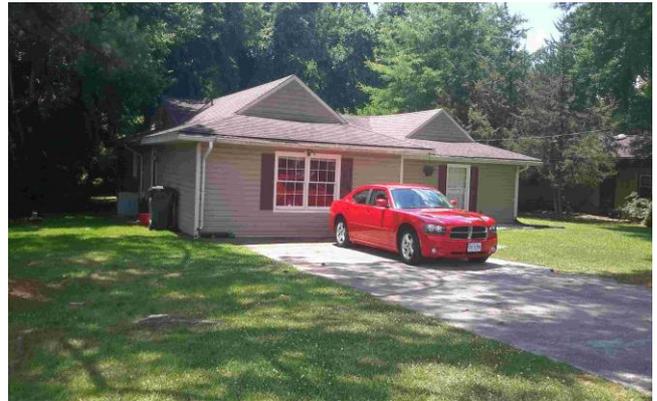
Property Locator / Repetitive Loss#: 3713-32-4754.000
Inspection Date: 6/11/2015 **Inspector:** Yuqi
No. of Stories: 2 **Basement:** Unknown
Occupied: Yes **Neighborhood:** Single Family Residential
Fill: Below Street **Elevated:** 3-4 Feet
Grads
Observations: Has HVAC, no gutters, has secondary structures detached garage and pool.
Flooding: Unknown
Flooding Notes:
Land Use: Single-family residential
Land Use Notes:
Adequate Vents Present: Yes
Spoke with: Owner Unavailable
Structure Type: Masonry
Structure Type Notes: Blend with wood and bricks, most are bricks.
Condition of Structure: Good (optional minor repairs)
Foundation Type: Crawlspace floor at or above grade on at least 1 side
Foundation Type Notes:
Condition of Foundation: Good (optional minor repairs)

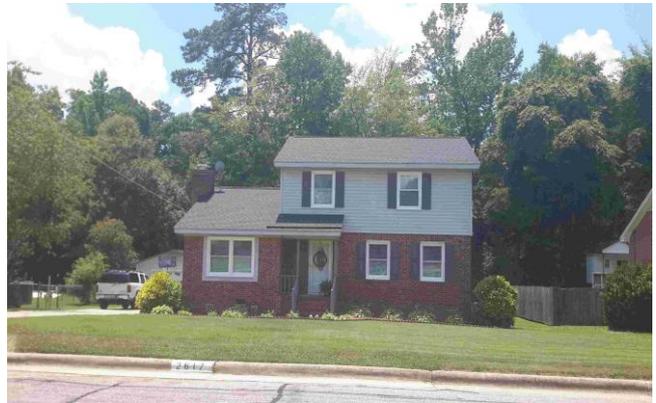
Property Locator / Repetitive Loss#: 3713-32-6331.000
Inspection Date: 6/11/2015 **Inspector:** Yuqi
No. of Stories: 1 **Basement:** No
Occupied: Yes **Neighborhood:** Single Family Residential
Fill: 0-1 Feet **Elevated:** 2-3 Feet
Observations: Has gutters, has secondary structure as detached garage, and has HVAC.
Flooding: Unknown
Flooding Notes:
Land Use: Single-family residential
Land Use Notes:
Adequate Vents Present: Yes
Spoke with: Owner Unavailable
Structure Type: Wood Frame
Structure Type Notes:
Condition of Structure: Good (optional minor repairs)
Foundation Type: Crawlspace floor at or above grade on at least 1 side
Foundation Type Notes:
Condition of Foundation: Good (optional minor repairs)

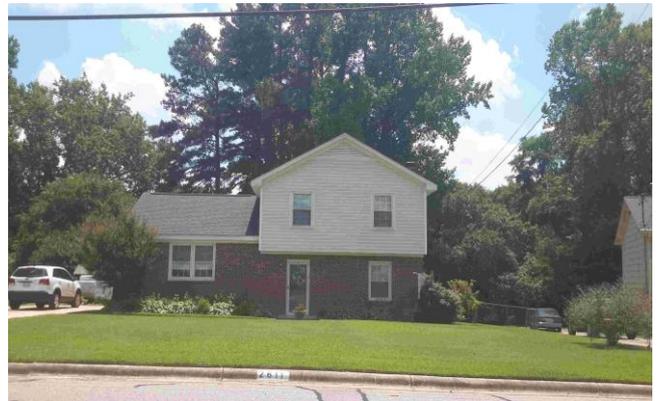
Property Locator / Repetitive Loss#: 3713-32-7512.000
Inspection Date: 6/11/2015 **Inspector:** Yuqi
No. of Stories: 1 **Basement:** No
Occupied: Yes **Neighborhood:** Single Family Residential
Fill: 2-3 Feet **Elevated:** 3-4 Feet
Observations: No gutters, has secondary structure as storage room, unobserved HVAC.
Flooding: Unknown
Flooding Notes:
Land Use: Single-family residential
Land Use Notes:
Adequate Vents Present: Yes
Spoke with: Owner Unavailable
Structure Type: Masonry
Structure Type Notes:
Condition of Structure: Good (optional minor repairs)
Foundation Type: Crawlspace floor at or above grade on at least 1 side
Foundation Type Notes:
Condition of Foundation: Good (optional minor repairs)

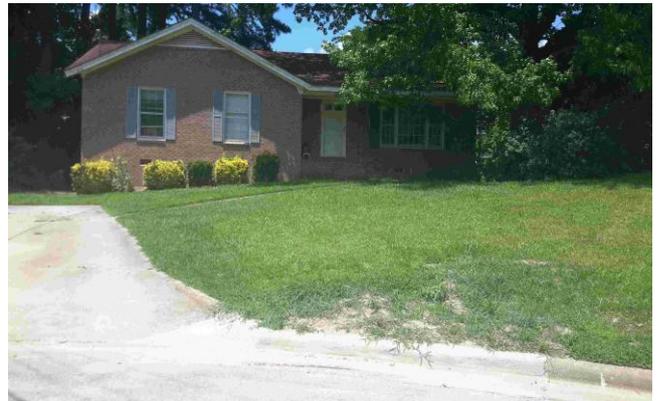
Property Locator / Repetitive Loss#: 3713-32-8360.000
Inspection Date: 6/11/2015 **Inspector:** Yuqi
No. of Stories: 1 **Basement:** No
Occupied: Yes **Neighborhood:** Single Family Residential
Fill: 0-1 Feet **Elevated:** 3-4 Feet
Observations: No gutters, has secondary structure as detached garage, unobserved HVAC
Flooding: Unknown
Flooding Notes:
Land Use: Single-family residential
Land Use Notes:
Adequate Vents Present: Yes
Spoke with: Owner Unavailable
Structure Type: Masonry
Structure Type Notes: Blend with wood and bricks.
Condition of Structure: Good (optional minor repairs)
Foundation Type: Crawlspace floor at or above grade on at least 1 side
Foundation Type Notes:
Condition of Foundation: Good (optional minor repairs)

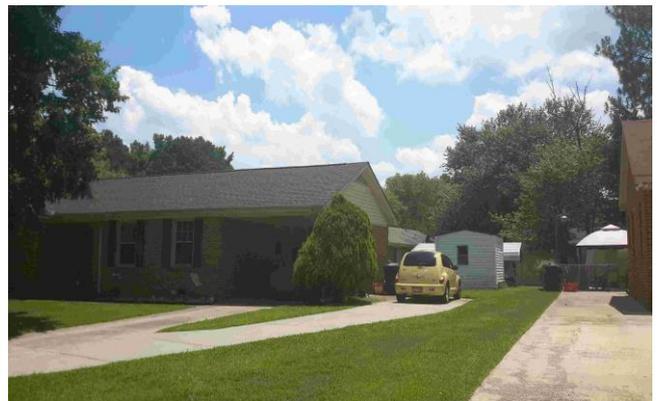
Property Locator / Repetitive Loss#: 3713-32-1776.000
Inspection Date: 6/11/2015 **Inspector:** Alex Magruder
No. of Stories: 2 **Basement:** No
Occupied: Yes **Neighborhood:** Single Family Residential
Fill: 0-1 Feet **Elevated:** 2-3 Feet
Observations: Has guttering. Hvac unit is on ground. Secondary structure. Creek to the left of property
Flooding: Unknown
Flooding Notes:
Land Use: Single-family residential
Land Use Notes:
Adequate Vents Present: Yes
Spoke with: Owner Unavailable
Structure Type: Wood Frame
Structure Type Notes:
Condition of Structure: Good (optional minor repairs)
Foundation Type: Crawlspace floor at or above grade on at least 1 side
Foundation Type Notes:
Condition of Foundation: Good (optional minor repairs)

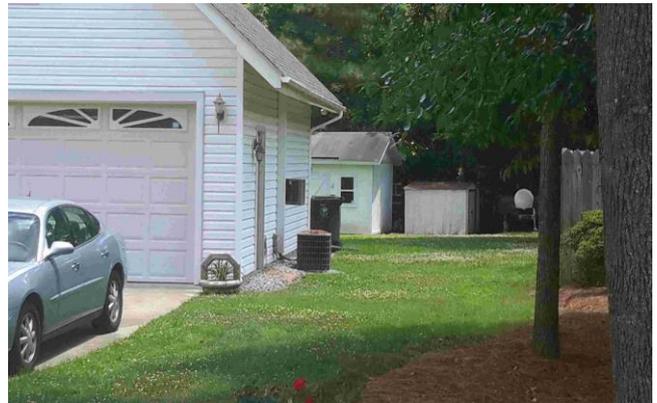
Property Locator / Repetitive Loss#: 3713-32-3640.000
Inspection Date: 6/11/2015 **Inspector:** Alex Magruder
No. of Stories: 1 **Basement:** Unknown
Occupied: **Neighborhood:** Single Family Residential
Fill: Below Street **Elevated:** 3-4 Feet
Grads
Observations: No gutters. Hvac unit on ground.
Flooding: Unknown
Flooding Notes:
Land Use: Single-family residential
Land Use Notes:
Adequate Vents Present: Yes
Spoke with: Owner Unavailable
Structure Type: Wood Frame
Structure Type Notes:
Condition of Structure: Good (optional minor repairs)
Foundation Type: Crawlspace floor at or above grade on at least 1 side
Foundation Type Notes:
Condition of Foundation: Good (optional minor repairs)

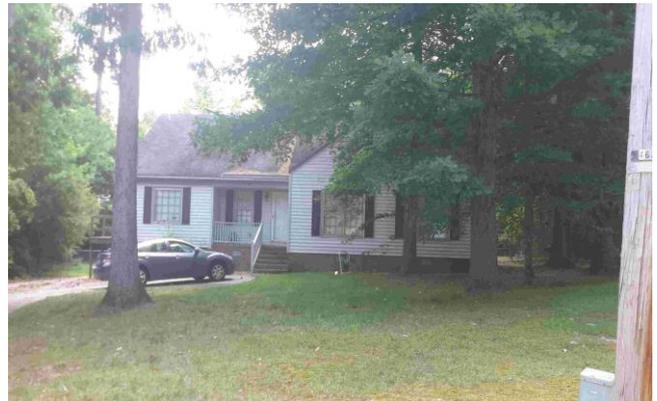
Property Locator / Repetitive Loss#: 3713-43-1519.000
Inspection Date: 6/11/2015 **Inspector:** Alex Magruder
No. of Stories: 2 **Basement:** No
Occupied: Yes **Neighborhood:** Single Family Residential
Fill: 0-1 Feet **Elevated:** 0-1 Feet
Observations: No guttering. Secondary structure. Hvac unit unknown.
Flooding: Unknown
Flooding Notes:
Land Use: Single-family residential
Land Use Notes:
Adequate Vents Present: Yes
Spoke with: Owner Unavailable
Structure Type: Masonry
Structure Type Notes:
Condition of Structure: Good (optional minor repairs)
Foundation Type: Crawlspace floor at or above grade on at least 1 side
Foundation Type Notes:
Condition of Foundation: Good (optional minor repairs)

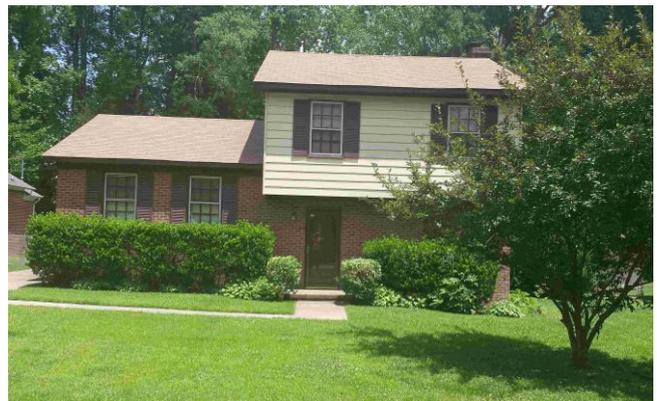
Property Locator / Repetitive Loss#: 3713-43-1605.000
Inspection Date: 6/11/2015 **Inspector:** Alex Magruder
No. of Stories: 1 **Basement:** No
Occupied: Yes **Neighborhood:** Single Family Residential
Fill: 0-1 Feet **Elevated:** 3-4 Feet
Observations: Has guttering. Hvac unit on ground.
Flooding: Unknown
Flooding Notes:
Land Use: Single-family residential
Land Use Notes:
Adequate Vents Present: Yes
Spoke with: Owner Unavailable
Structure Type: Masonry
Structure Type Notes:
Condition of Structure: Good (optional minor repairs)
Foundation Type: Crawlspace floor at or above grade on at least 1 side
Foundation Type Notes:
Condition of Foundation: Good (optional minor repairs)

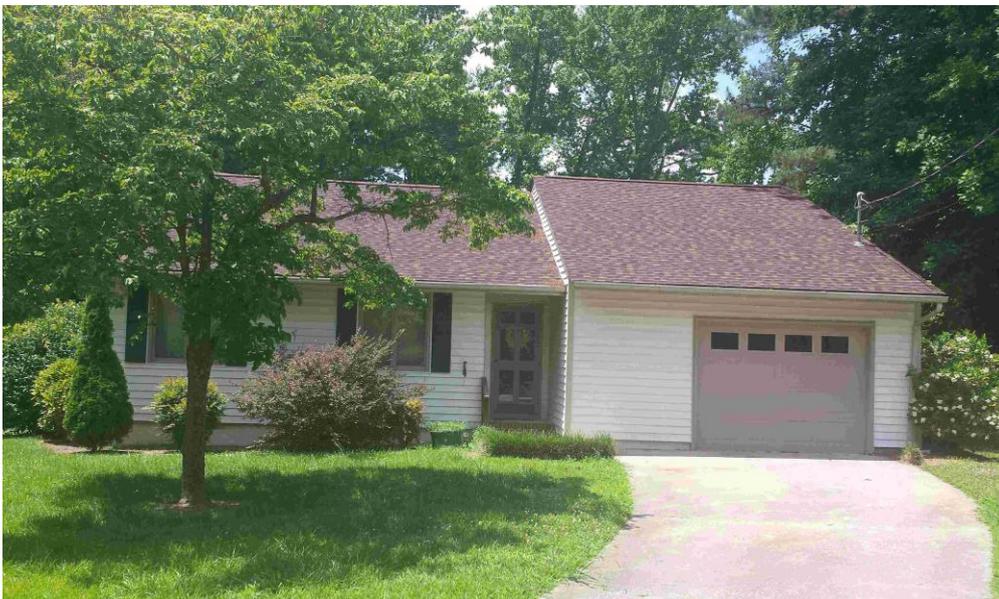
Property Locator / Repetitive Loss#: 3713-32-5693.000
Inspection Date: 6/11/2015 **Inspector:** Alex Magruder
No. of Stories: 1 **Basement:** Yes
Occupied: Yes **Neighborhood:** Single Family Residential
Fill: Below Street **Elevated:**
Grads
Observations: Has guttering. Unknown hvac.
Flooding: Unknown
Flooding Notes:
Land Use: Single-family residential
Land Use Notes:
Adequate Vents Present: No
Spoke with: Owner Unavailable
Structure Type: Masonry
Structure Type Notes:
Condition of Structure: Good (optional minor repairs)
Foundation Type: Basement sub-grade with windows
Foundation Type Notes:
Condition of Foundation: Good (optional minor repairs)

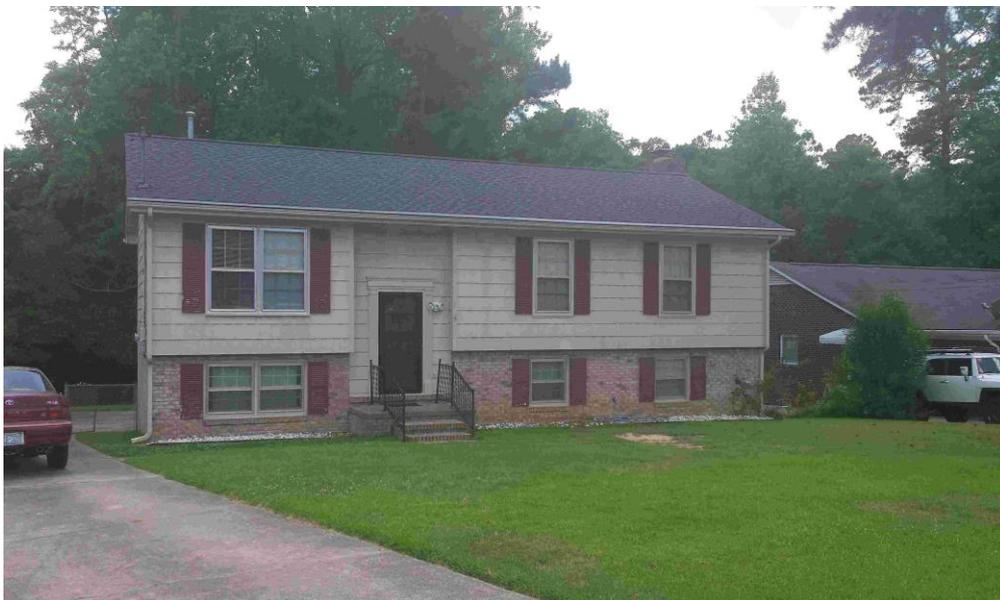
Property Locator / Repetitive Loss#: 3713-32-7249.000
Inspection Date: 6/11/2015 **Inspector:** Alex Magruder
No. of Stories: 1 **Basement:** No
Occupied: Yes **Neighborhood:** Single Family Residential
Fill: 0-1 Feet **Elevated:** 2-3 Feet
Observations: No guttering. Hvac unit unknown. Secondary structure. Fence blocking view.
Flooding: Unknown
Flooding Notes:
Land Use: Single-family residential
Land Use Notes:
Adequate Vents Present: Yes
Spoke with: Neighbor
Structure Type: Wood Frame
Structure Type Notes:
Condition of Structure: Good (optional minor repairs)
Foundation Type: Crawlspace floor at or above grade on at least 1 side
Foundation Type Notes:
Condition of Foundation: Good (optional minor repairs)

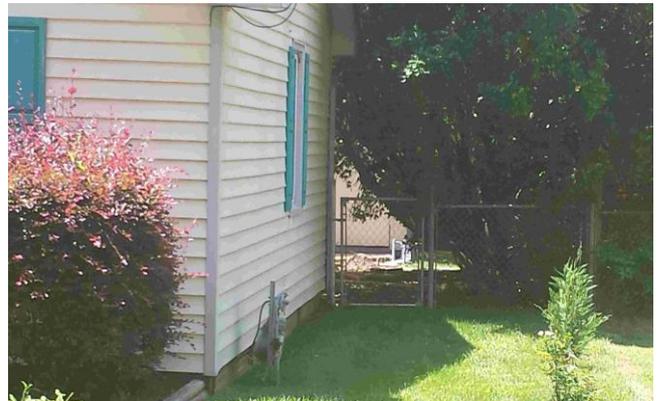
Property Locator / Repetitive Loss#: 3713-32-8644.000
Inspection Date: 6/11/2015 **Inspector:** Alex Magruder
No. of Stories: 1 **Basement:** No
Occupied: Yes **Neighborhood:** Single Family Residential
Fill: 0-1 Feet **Elevated:** 3-4 Feet
Observations: No guttering. Hvac unknown. Secondary structure.
Flooding: Unknown
Flooding Notes:
Land Use: Single-family residential
Land Use Notes:
Adequate Vents Present: Yes
Spoke with: Owner Unavailable
Structure Type: Masonry
Structure Type Notes:
Condition of Structure: Good (optional minor repairs)
Foundation Type: Crawlspace floor at or above grade on at least 1 side
Foundation Type Notes:
Condition of Foundation: Good (optional minor repairs)

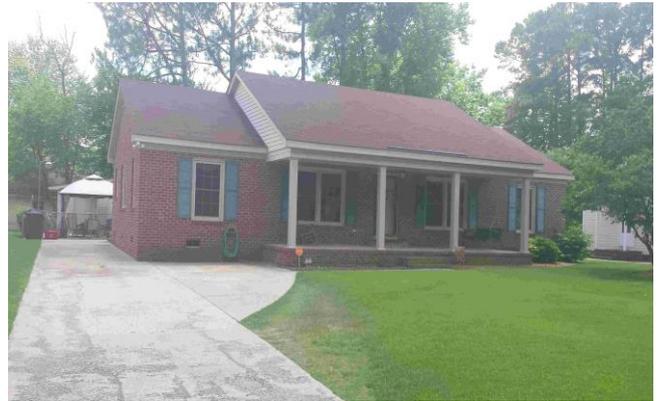
Property Locator / Repetitive Loss#: 3713-32-9403.000
Inspection Date: 6/11/2015 **Inspector:** Alex Magruder
No. of Stories: 1 **Basement:** No
Occupied: No **Neighborhood:** Single Family Residential
Fill: 2-3 Feet **Elevated:** 0-1 Feet
Observations: No guttering. Secondary structure. Hvac unit unknown.
Flooding: Unknown
Flooding Notes:
Land Use: Single-family residential
Land Use Notes:
Adequate Vents Present: Yes
Spoke with: Owner Unavailable
Structure Type: Masonry
Structure Type Notes:
Condition of Structure: Good (optional minor repairs)
Foundation Type: Crawlspace floor at or above grade on at least 1 side
Foundation Type Notes:
Condition of Foundation: Good (optional minor repairs)

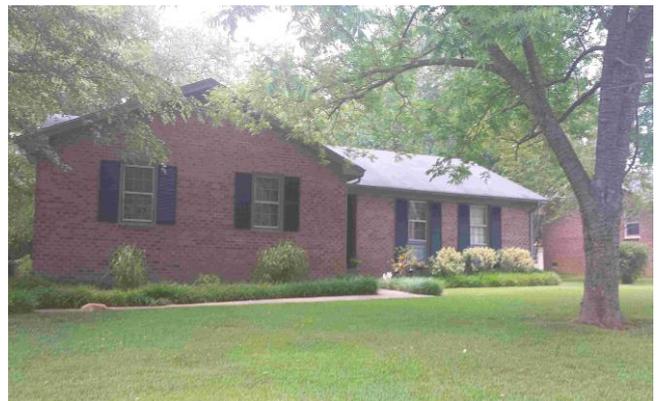
Property Locator / Repetitive Loss#: 3713-32-9512.000
Inspection Date: 6/11/2015 **Inspector:** Alex Magruder
No. of Stories: 1 **Basement:** No
Occupied: Yes **Neighborhood:** Single Family Residential
Fill: 2-3 Feet **Elevated:** 2-3 Feet
Observations: No guttering. Unknown hvac. Secondary structure.
Flooding: Unknown
Flooding Notes:
Land Use: Single-family residential
Land Use Notes:
Adequate Vents Present: Yes
Spoke with: Owner Unavailable
Structure Type: Masonry
Structure Type Notes:
Condition of Structure: Good (optional minor repairs)
Foundation Type: Crawlspace floor at or above grade on at least 1 side
Foundation Type Notes:
Condition of Foundation: Good (optional minor repairs)

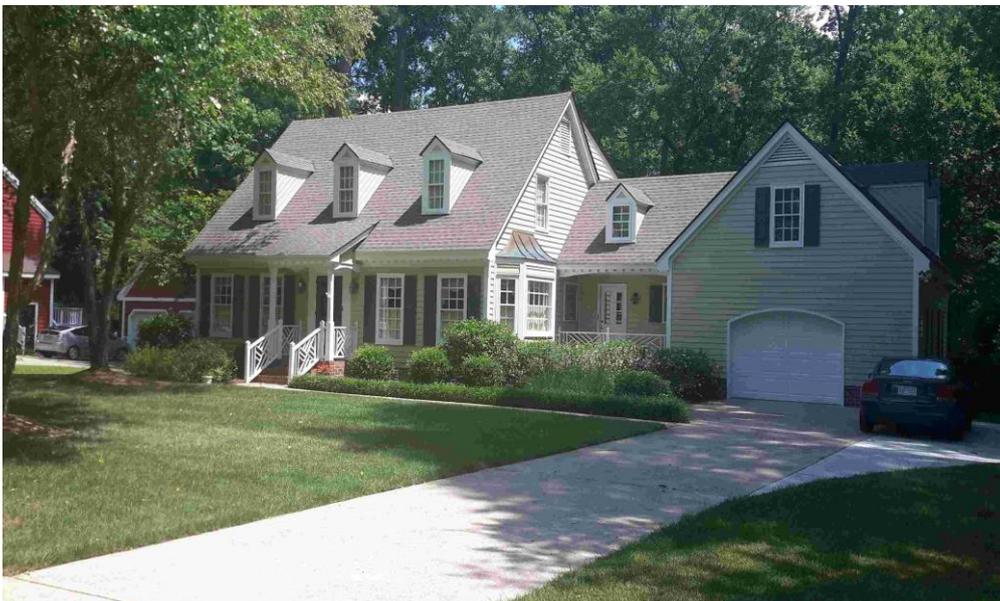
Property Locator / Repetitive Loss#: 3713-10-4523.000
Inspection Date: 6/11/2015 **Inspector:** Alex Magruder
No. of Stories: 2 **Basement:** No
Occupied: Yes **Neighborhood:** Single Family Residential
Fill: Below Street **Elevated:** 2-3 Feet
Grads
Observations: No gutters. Secondary structure. Hvac unit raised 1 foot. Drain to right of property.
Flooding: Unknown
Flooding Notes:
Land Use: Single-family residential
Land Use Notes:
Adequate Vents Present: Yes
Spoke with: Owner Unavailable
Structure Type: Masonry
Structure Type Notes:
Condition of Structure: Good (optional minor repairs)
Foundation Type: Crawlspace floor at or above grade on at least 1 side
Foundation Type Notes:
Condition of Foundation: Good (optional minor repairs)

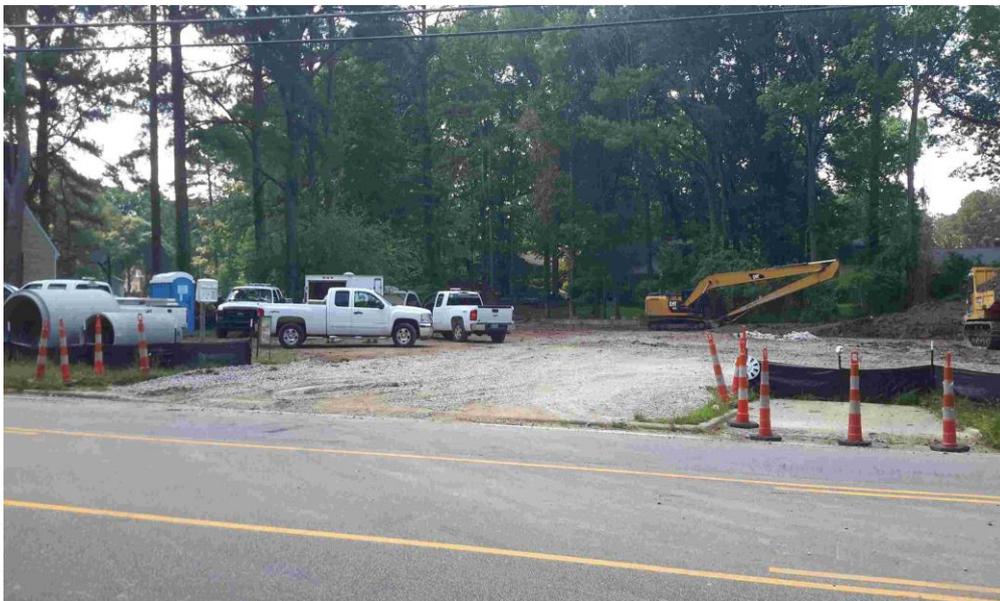
Property Locator / Repetitive Loss#: 3712-29-2156.000
Inspection Date: 6/11/2015 **Inspector:** Alex Magruder
No. of Stories: 2 **Basement:** No
Occupied: Yes **Neighborhood:** Single Family Residential
Fill: 2-3 Feet **Elevated:** 3-4 Feet
Observations: No gutters. Hvac unit on ground. Secondary structure. Construction adjacent and behind property.
Flooding: Unknown
Flooding Notes:
Land Use: Single-family residential
Land Use Notes:
Adequate Vents Present: Yes
Spoke with: Owner Unavailable
Structure Type: Wood Frame
Structure Type Notes:
Condition of Structure: Good (optional minor repairs)
Foundation Type: Crawlspace floor at or above grade on at least 1 side
Foundation Type Notes:
Condition of Foundation: Good (optional minor repairs)

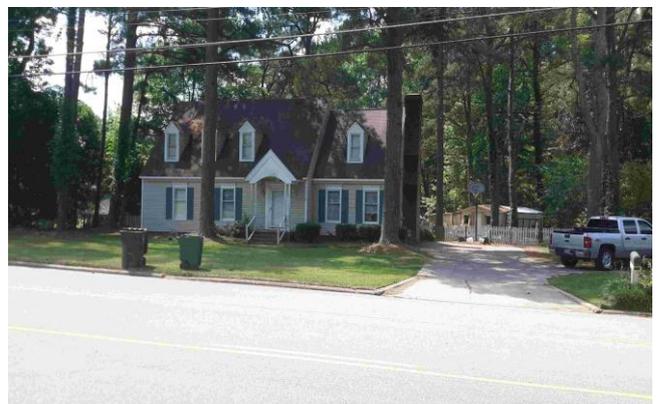
Property Locator / Repetitive Loss#: 3712-58-3588.000
Inspection Date: 6/11/2015 **Inspector:** Scott Gentry
No. of Stories: 1 **Basement:** No
Occupied: Yes **Neighborhood:** Single Family Residential
Fill: 0-1 Feet **Elevated:** 1-2 Feet
Observations: No gutter. Hvac not seen from street. Has shed.
Flooding: Unknown
Flooding Notes:
Land Use: Single-family residential
Land Use Notes:
Adequate Vents Present: Yes
Spoke with: Owner Unavailable
Structure Type: Masonry
Structure Type Notes:
Condition of Structure: Good (optional minor repairs)
Foundation Type: Crawlspace floor at or above grade on at least 1 side
Foundation Type Notes:
Condition of Foundation: Good (optional minor repairs)

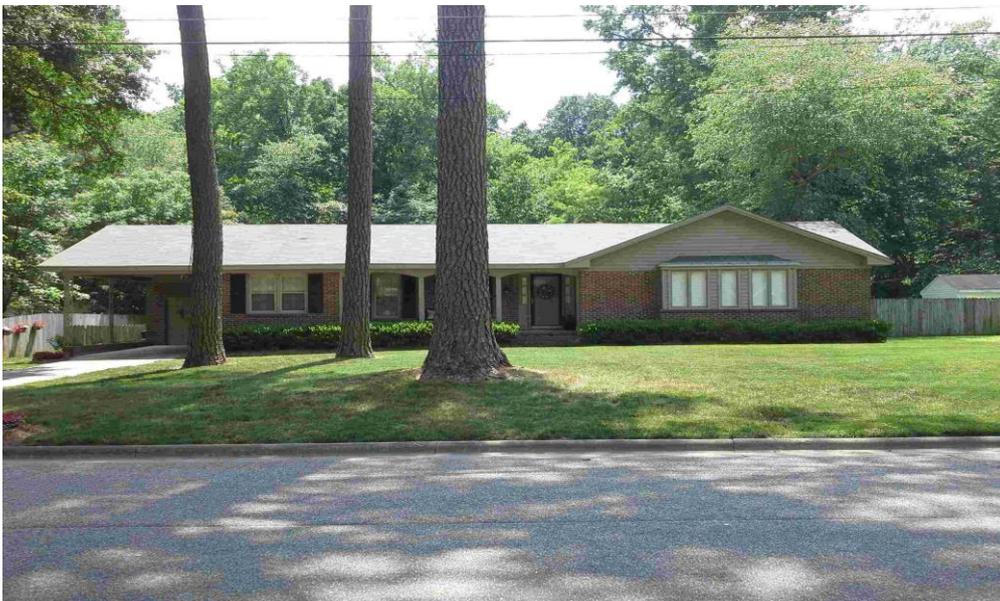
Property Locator / Repetitive Loss#: 3712-59-3041.000
Inspection Date: 6/11/2015 **Inspector:** Yuqi
No. of Stories: 1 **Basement:** No
Occupied: Yes **Neighborhood:** Single Family Residential
Fill: 2-3 Feet **Elevated:** 2-3 Feet
Observations: No gutters, unobserved secondary structure, unobserved HVAC.
Flooding: Unknown
Flooding Notes:
Land Use: Single-family residential
Land Use Notes:
Adequate Vents Present: Yes
Spoke with: Owner Unavailable
Structure Type: Masonry
Structure Type Notes:
Condition of Structure: Good (optional minor repairs)
Foundation Type: Crawlspace floor at or above grade on at least 1 side
Foundation Type Notes:
Condition of Foundation: Good (optional minor repairs)

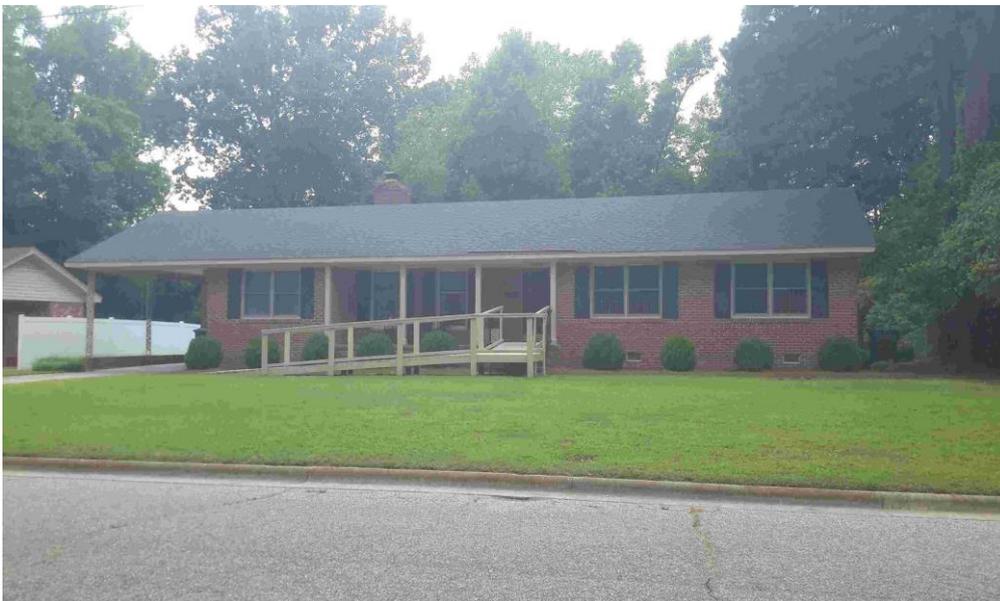
Property Locator / Repetitive Loss#: 3712-59-3218.000
Inspection Date: 6/11/2015 **Inspector:** Yuqi
No. of Stories: 1 **Basement:** No
Occupied: Yes **Neighborhood:** Single Family Residential
Fill: 0-1 Feet **Elevated:** 3-4 Feet
Observations: Has secondary structure, has gutters, unobserved HVAC.
Flooding: Unknown
Flooding Notes:
Land Use: Single-family residential
Land Use Notes:
Adequate Vents Present: Yes
Spoke with: Owner Unavailable
Structure Type: Masonry
Structure Type Notes:
Condition of Structure: Good (optional minor repairs)
Foundation Type: Crawlspace floor at or above grade on at least 1 side
Foundation Type Notes:
Condition of Foundation: Good (optional minor repairs)

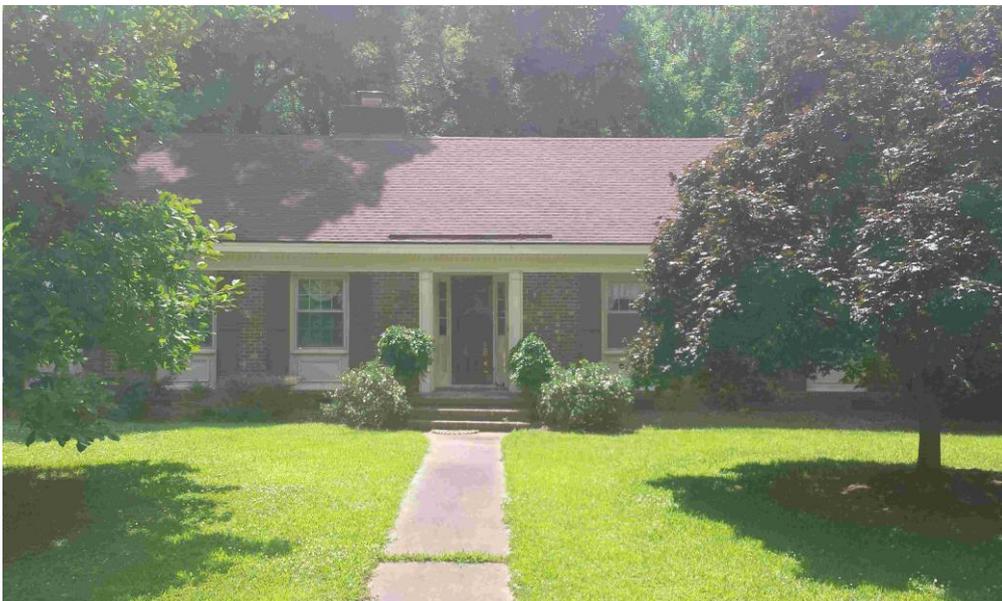
Property Locator / Repetitive Loss#: 3712-58-3871.000
Inspection Date: 6/11/2015 **Inspector:** Alex Magruder
No. of Stories: 1 **Basement:** No
Occupied: Yes **Neighborhood:** Single Family Residential
Fill: 0-1 Feet **Elevated:** 1-2 Feet
Observations: No guttering. Hvac unit unknown. Secondary structure. Fence blocking view.
Flooding: Unknown
Flooding Notes:
Land Use: Single-family residential
Land Use Notes:
Adequate Vents Present: Yes
Spoke with: Owner Unavailable
Structure Type: Masonry
Structure Type Notes:
Condition of Structure: Good (optional minor repairs)
Foundation Type: Crawlspace floor at or above grade on at least 1 side
Foundation Type Notes:
Condition of Foundation: Good (optional minor repairs)

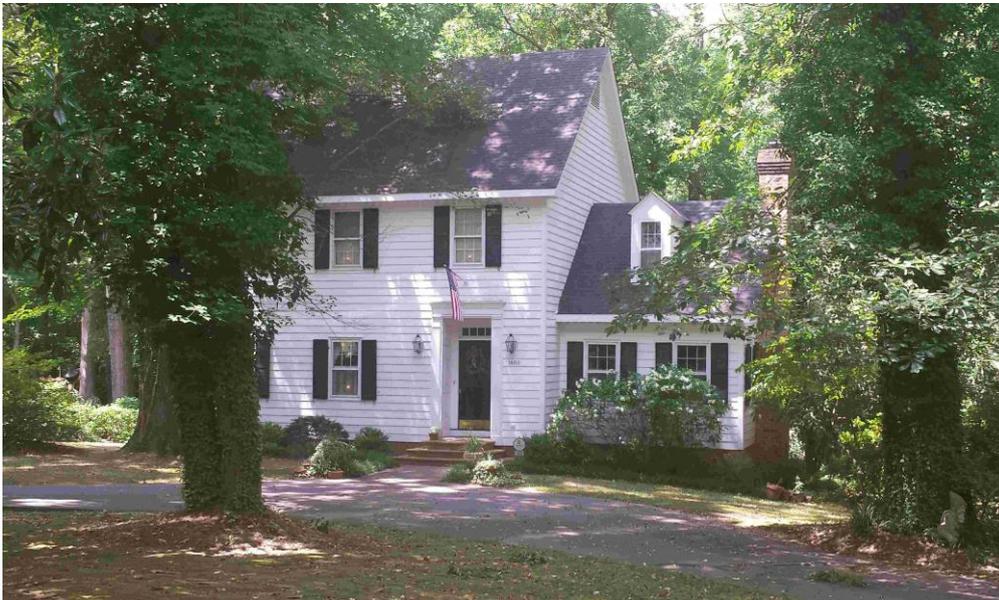
Property Locator / Repetitive Loss#: 3712-36-3565.000
Inspection Date: 6/11/2015 **Inspector:** Alex Magruder
No. of Stories: 2 **Basement:** No
Occupied: Yes **Neighborhood:** Single Family Residential
Fill: 2-3 Feet **Elevated:** 3-4 Feet
Observations: Has gutters. Unknown hvac. Secondary structure.
Flooding: Unknown
Flooding Notes:
Land Use: Single-family residential
Land Use Notes:
Adequate Vents Present: Yes
Spoke with: Owner Unavailable
Structure Type: Masonry
Structure Type Notes:
Condition of Structure: Good (optional minor repairs)
Foundation Type: Crawlspace floor at or above grade on at least 1 side
Foundation Type Notes:
Condition of Foundation: Good (optional minor repairs)

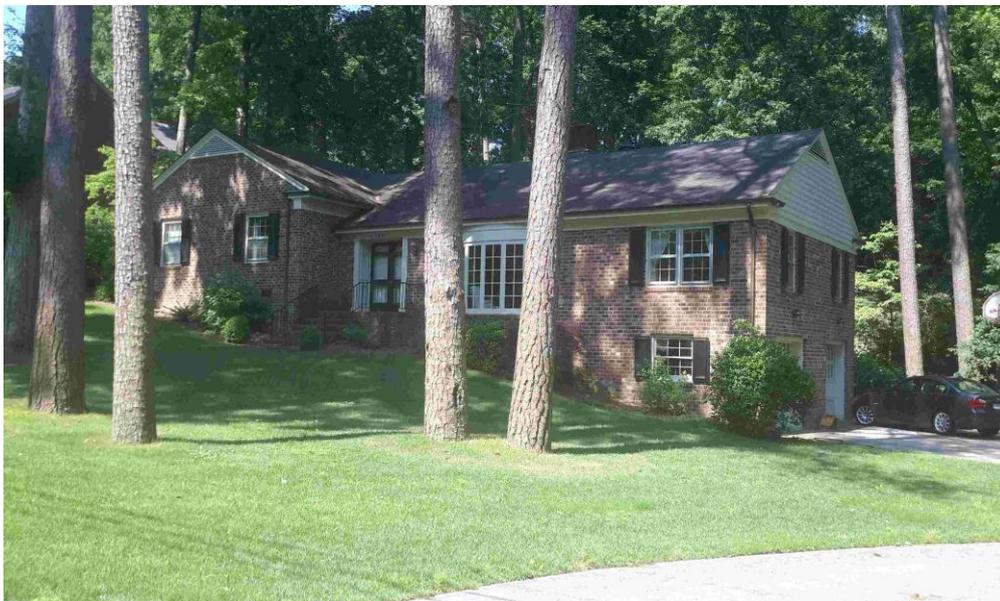
Property Locator / Repetitive Loss#: 3712-16-0799.000
Inspection Date: 6/11/2015 **Inspector:** Alex Magruder
No. of Stories: 1 **Basement:** No
Occupied: Yes **Neighborhood:** Single Family Residential
Fill: 0-1 Feet **Elevated:** 1-2 Feet
Observations: Has gutters. Has Hvac. Has secondary detached garage. Has channel adjacent. Large amount of water coming from main street.
Flooding: Unknown
Flooding Notes:
Land Use: Single-family residential
Land Use Notes:
Adequate Vents Present: Yes
Spoke with: Neighbor
Structure Type: Masonry
Structure Type Notes:
Condition of Structure: Good (optional minor repairs)
Foundation Type: Crawlspace floor at or above grade on at least 1 side
Foundation Type Notes:
Condition of Foundation: Good (optional minor repairs)

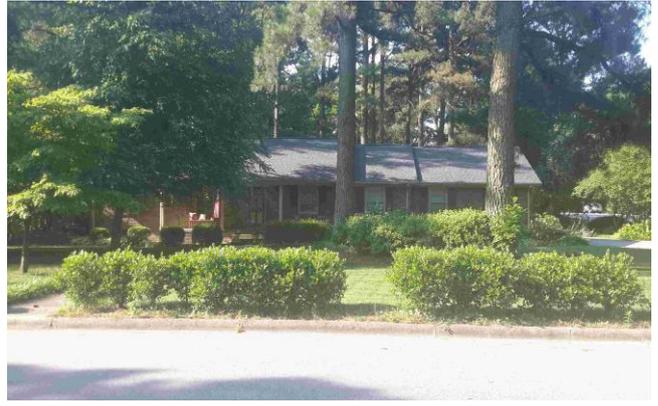
Property Locator / Repetitive Loss#: 3712-16-5726.000
Inspection Date: 6/11/2015 **Inspector:** Alex Magruder
No. of Stories: 1 **Basement:** No
Occupied: Yes **Neighborhood:** Single Family Residential
Fill: 0-1 Feet **Elevated:** 2-3 Feet
Observations: Has gutters. Has hvac on ground. Has secondary structure.
Flooding: Unknown
Flooding Notes:
Land Use: Single-family residential
Land Use Notes:
Adequate Vents Present: Yes
Spoke with: Neighbor
Structure Type: Masonry
Structure Type Notes:
Condition of Structure: Good (optional minor repairs)
Foundation Type: Crawlspace floor at or above grade on at least 1 side
Foundation Type Notes:
Condition of Foundation: Good (optional minor repairs)

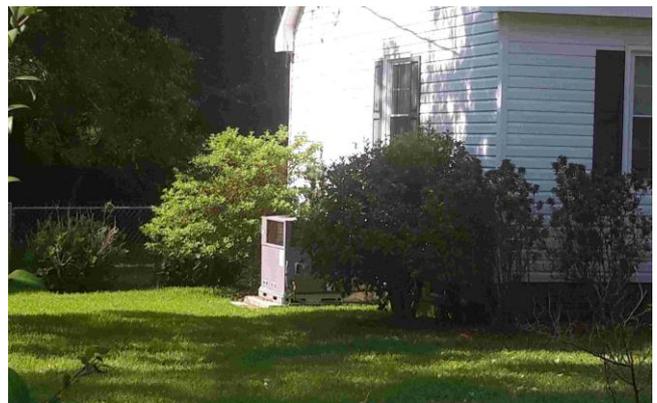
Property Locator / Repetitive Loss#: 3712-27-7201.000
Inspection Date: 6/11/2015 **Inspector:** Alex Magruder
No. of Stories: 2 **Basement:** Unknown
Occupied: Yes **Neighborhood:** Single Family Residential
Fill: Below Street **Elevated:** At Grade
Grads
Observations: Has gutters. Vegetation blocking view.
Flooding: Unknown
Flooding Notes:
Land Use: Single-family residential
Land Use Notes:
Adequate Vents Present: Unknown
Spoke with: Owner Unavailable
Structure Type: Wood Frame
Structure Type Notes:
Condition of Structure: Good (optional minor repairs)
Foundation Type: Unable to determine
Foundation Type Notes:
Condition of Foundation: Good (optional minor repairs)

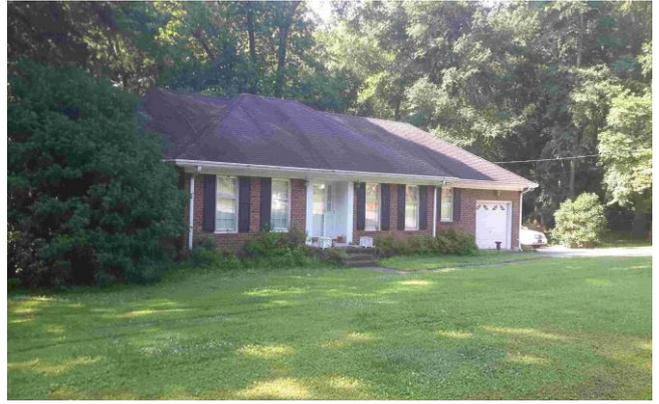
Property Locator / Repetitive Loss#: 3712-37-0158.000
Inspection Date: 6/11/2015 **Inspector:** Alex Magruder
No. of Stories: 2 **Basement:** No
Occupied: Yes **Neighborhood:** Single Family Residential
Fill: Below Street **Elevated:** 0-1 Feet
Grads
Observations: No gutters. Unknown hvac. Creek visible behind building.
Flooding: Unknown
Flooding Notes:
Land Use: Single-family residential
Land Use Notes:
Adequate Vents Present: Yes
Spoke with: Owner Unavailable
Structure Type: Wood Frame
Structure Type Notes:
Condition of Structure: Good (optional minor repairs)
Foundation Type: Crawlspace floor at or above grade on at least 1 side
Foundation Type Notes:
Condition of Foundation: Good (optional minor repairs)

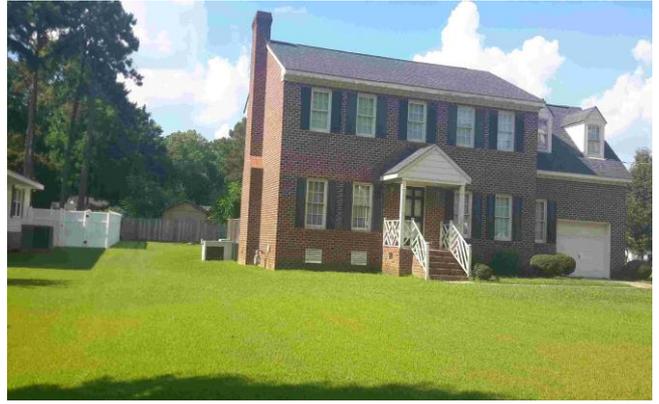
Property Locator / Repetitive Loss#: 3712-34-4024.000
Inspection Date: 6/11/2015 **Inspector:** Alex Magruder
No. of Stories: 1 **Basement:** No
Occupied: Yes **Neighborhood:** Single Family Residential
Fill: 0-1 Feet **Elevated:** 1-2 Feet
Observations: No guttering. Hvac unit unknown.
Flooding: Unknown
Flooding Notes:
Land Use: Single-family residential
Land Use Notes:
Adequate Vents Present: Yes
Spoke with: Owner Unavailable
Structure Type: Masonry
Structure Type Notes:
Condition of Structure: Good (optional minor repairs)
Foundation Type: Crawlspace floor at or above grade on at least 1 side
Foundation Type Notes:
Condition of Foundation: Good (optional minor repairs)

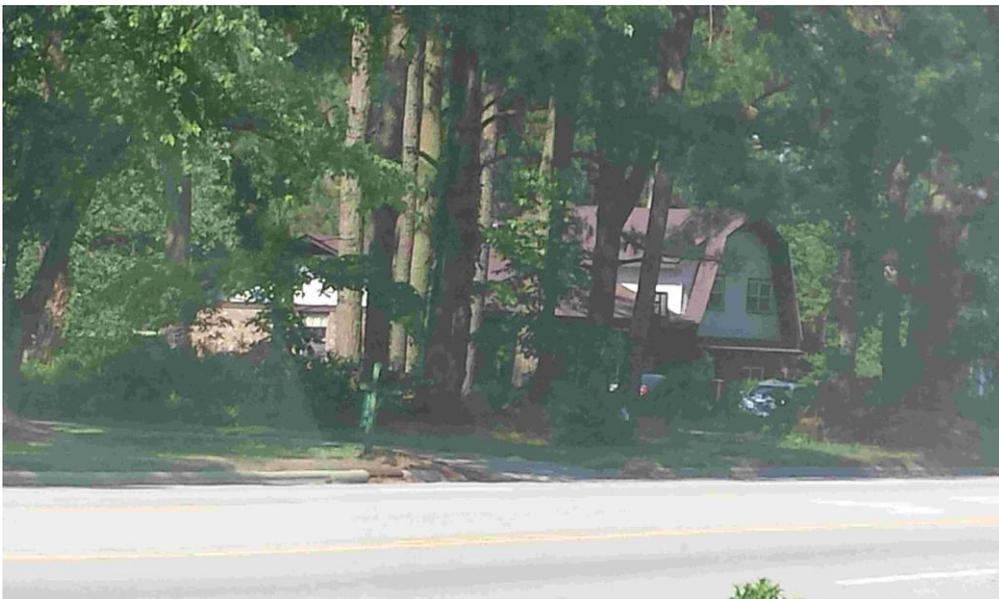
Property Locator / Repetitive Loss#: 3712-34-7023.000
Inspection Date: 6/11/2015 **Inspector:** Alex Magruder
No. of Stories: 1 **Basement:**
Occupied: Yes **Neighborhood:** Single Family Residential
Fill: Below Street **Elevated:** 2-3 Feet
Grads
Observations: No guttering. Hvac unit raised 1 ft. Secondary structure. Drain in front yard.
Flooding: Unknown
Flooding Notes:
Land Use: Single-family residential
Land Use Notes:
Adequate Vents Present: Yes
Spoke with: Owner Unavailable
Structure Type: Masonry
Structure Type Notes:
Condition of Structure: Good (optional minor repairs)
Foundation Type: Crawlspace floor at or above grade on at least 1 side
Foundation Type Notes:
Condition of Foundation: Good (optional minor repairs)
