REPETITIVE LOSS AREA ANALYSIS

City of Wilson, North Carolina
Planning & Development Services

Prepared by:
Amec Foster Wheeler
Environment & Infrastructure, Inc.

October 2015

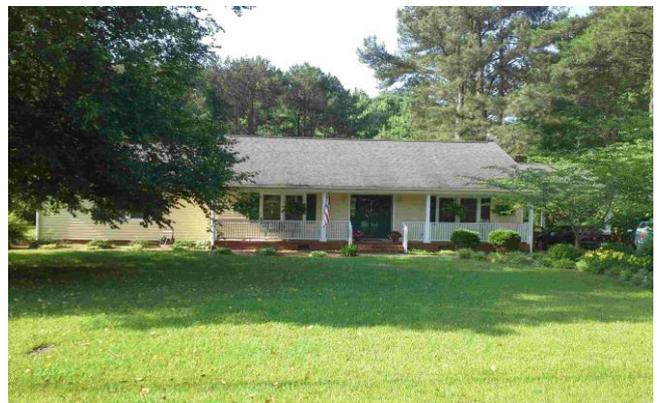
Property Locator / Repetitive Loss#: 3712-16-7799.000
Inspection Date: 6/11/2015 **Inspector:** Scott Gentry
No. of Stories: 1 **Basement:** No
Occupied: Yes **Neighborhood:** Single Family Residential
Fill: 0-1 Feet **Elevated:** 2-3 Feet
Observations: Has shed. Hvac not seen from road. Has gutters.
Flooding: Unknown
Flooding Notes:
Land Use: Single-family residential
Land Use Notes:
Adequate Vents Present: Yes
Spoke with: Neighbor
Structure Type: Masonry
Structure Type Notes:
Condition of Structure: Good (optional minor repairs)
Foundation Type: Crawlspace floor at or above grade on at least 1 side
Foundation Type Notes:
Condition of Foundation: Good (optional minor repairs)

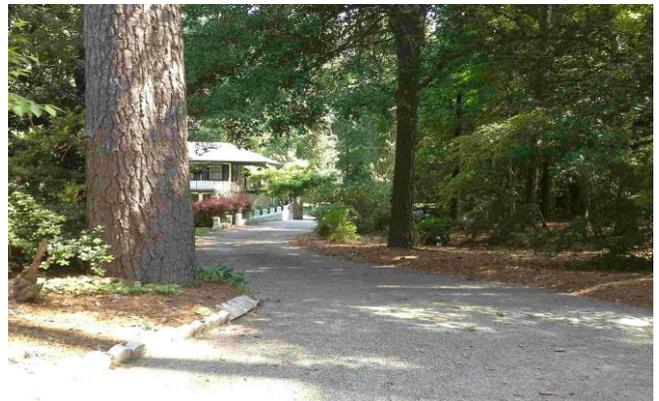
Property Locator / Repetitive Loss#: 3712-34-5023.000
Inspection Date: 6/11/2015 **Inspector:** Scott Gentry
No. of Stories: **Basement:** No
Occupied: Yes **Neighborhood:** Single Family Residential
Fill: 0-1 Feet **Elevated:** 1-2 Feet
Observations: Has gutters.
Flooding: Unknown
Flooding Notes:
Land Use: Single-family residential
Land Use Notes:
Adequate Vents Present: Yes
Spoke with: Owner Unavailable
Structure Type: Masonry
Structure Type Notes:
Condition of Structure: Good (optional minor repairs)
Foundation Type: Crawlspace floor at or above grade on at least 1 side
Foundation Type Notes:
Condition of Foundation: Unable To Determine

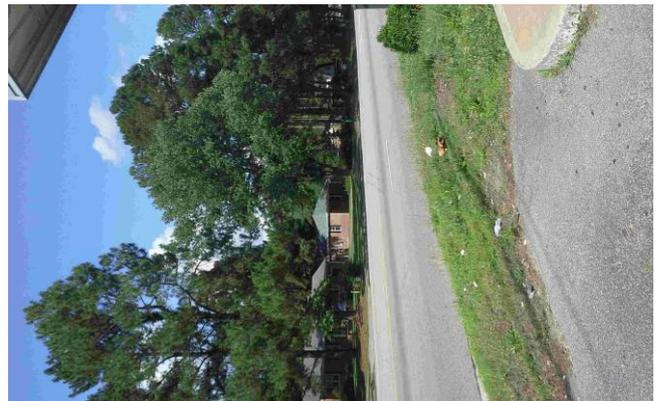
Property Locator / Repetitive Loss#: 3712-36-3675.000
Inspection Date: 6/11/2015 **Inspector:** Yuqi
No. of Stories: 2 **Basement:** Unknown
Occupied: Yes **Neighborhood:** Single Family Residential
Fill: 2-3 Feet **Elevated:** 2-3 Feet
Observations: Has gutters, has HVAC, unobserved secondary structure. For the fill, it's greater than 4 feet.
Flooding: Unknown
Flooding Notes:
Land Use: Single-family residential
Land Use Notes:
Adequate Vents Present: Yes
Spoke with: Owner Unavailable
Structure Type: Masonry
Structure Type Notes:
Condition of Structure: Good (optional minor repairs)
Foundation Type: Crawlspace floor at or above grade on at least 1 side
Foundation Type Notes:
Condition of Foundation: Good (optional minor repairs)
