REPETITIVE LOSS AREA ANALYSIS

City of Wilson, North Carolina
Planning & Development Services

Prepared by:
Amec Foster Wheeler
Environment & Infrastructure, Inc.

October 2015

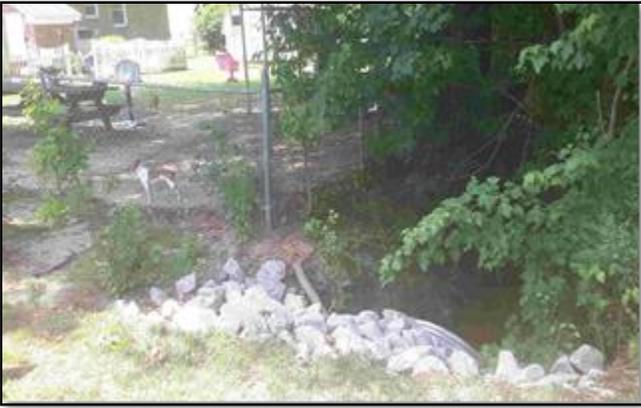
Repetitive Loss Area 1 – Little Hominy Swamp Tributary

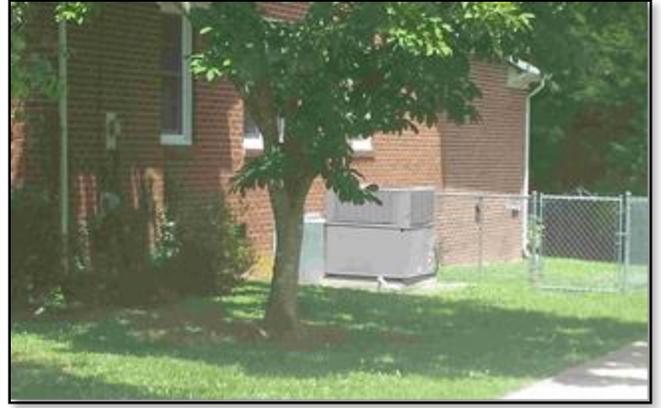
Repetitive Loss Area 3 – HVAC unit on ground

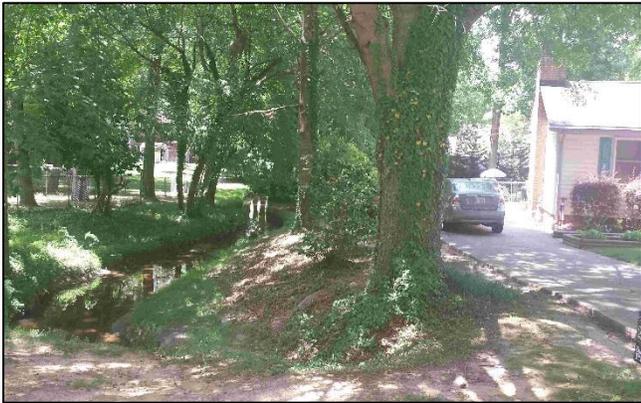
Repetitive Loss Area 3 – Little Hominy Swamp

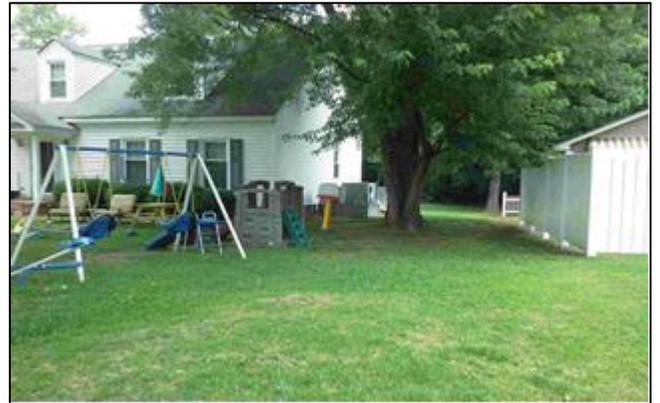
Repetitive Loss Area 2 – Elevated HVAC Unit

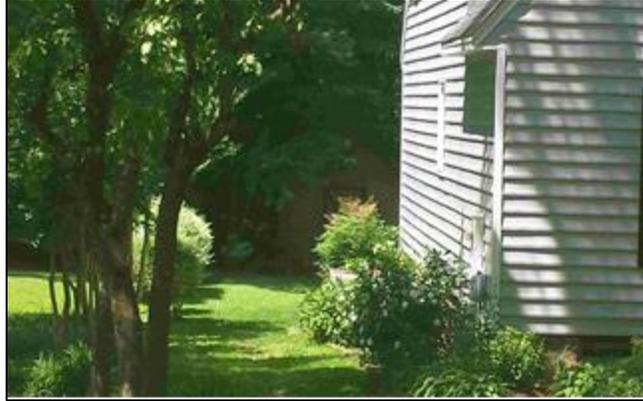
Repetitive Loss Area 6 – HVAC unit on ground

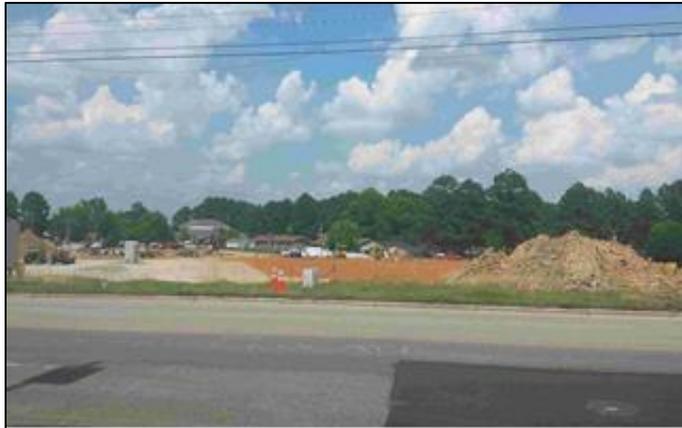
Repetitive Loss Area 7 – Vacant lot under construction

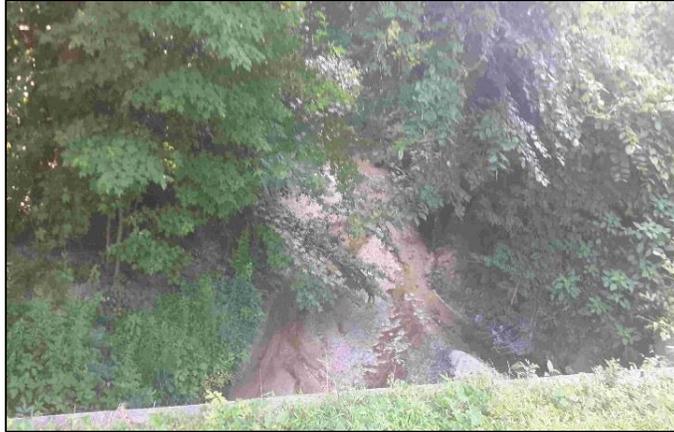
Repetitive Loss Area 8 – Channel adjacent to home

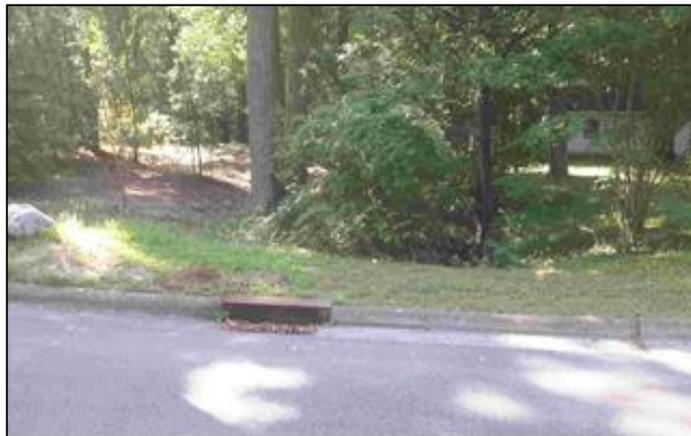
Repetitive Loss Area 8 – Channel and street drain adjacent to home

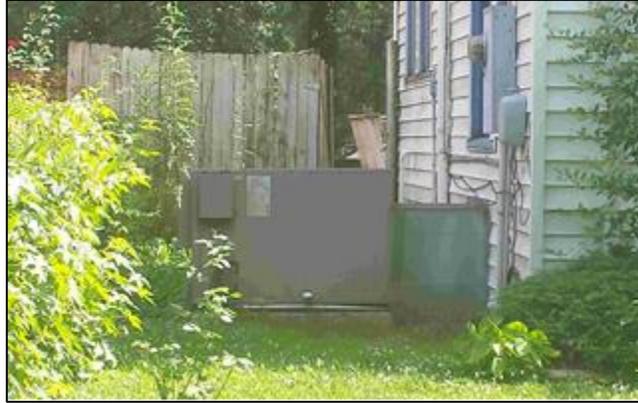
Repetitive Loss Area 10 – HVAC unit on ground

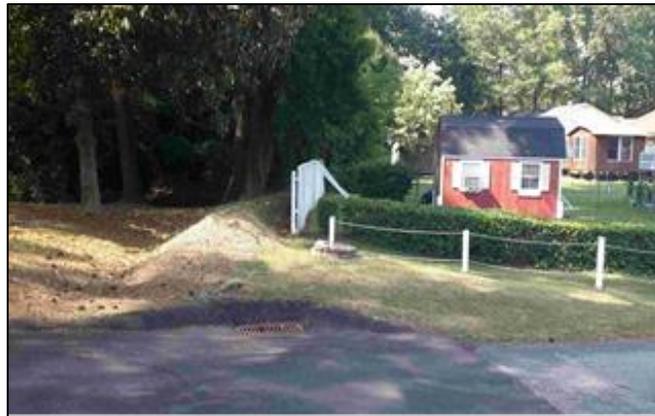
Repetitive Loss Area 12 – Raised berm adjacent to property

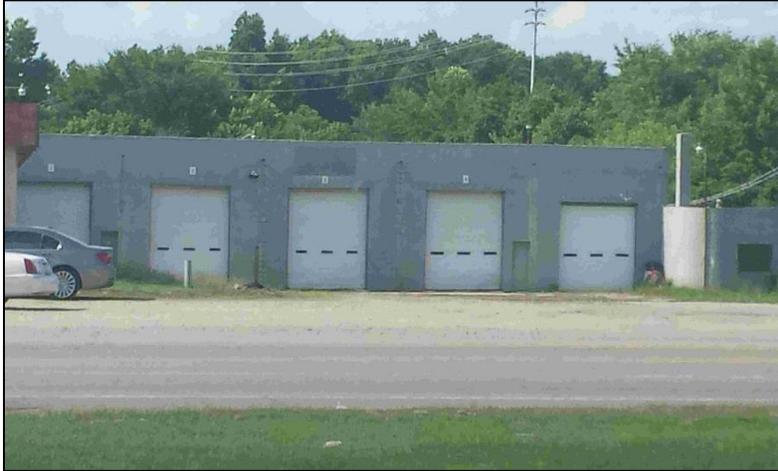
Repetitive Loss Area 13 – Commercial building on property

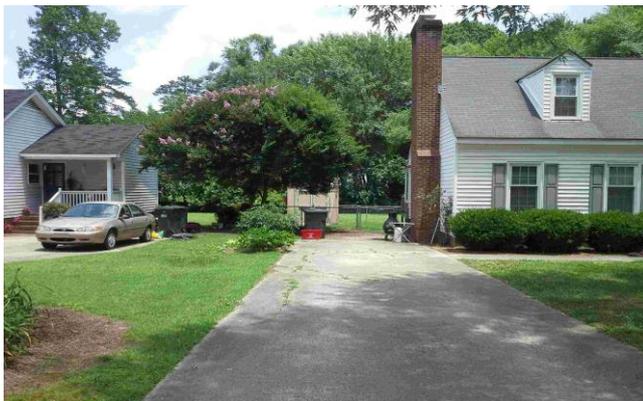
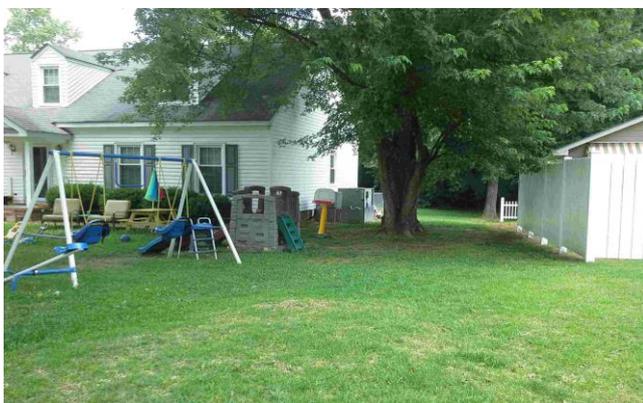
Property Locator / Repetitive Loss#: 3713-22-8941.000
Inspection Date: 6/11/2015 **Inspector:** Scott Gentry
No. of Stories: 2 **Basement:** No
Occupied: Yes **Neighborhood:** Single Family Residential
Fill: 0-1 Feet **Elevated:** 1-2 Feet
Observations: Has shed. No gutter. Hvac is elevated.
Flooding: Unknown
Flooding Notes:
Land Use: Single-family residential
Land Use Notes:
Adequate Vents Present: Yes
Spoke with: Owner Unavailable
Structure Type: Wood Frame
Structure Type Notes:
Condition of Structure: Good (optional minor repairs)
Foundation Type: Crawlspace floor at or above grade on at least 1 side
Foundation Type Notes:
Condition of Foundation: Good (optional minor repairs)

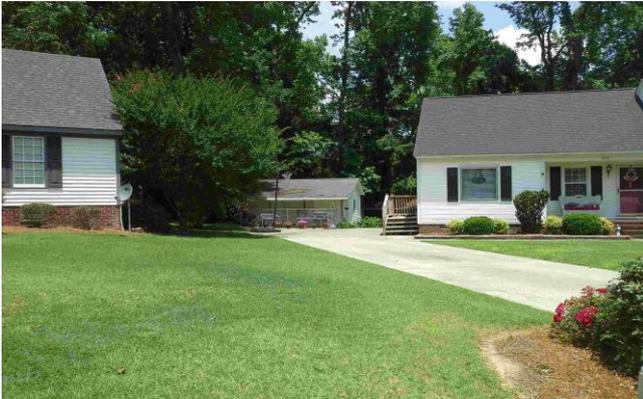
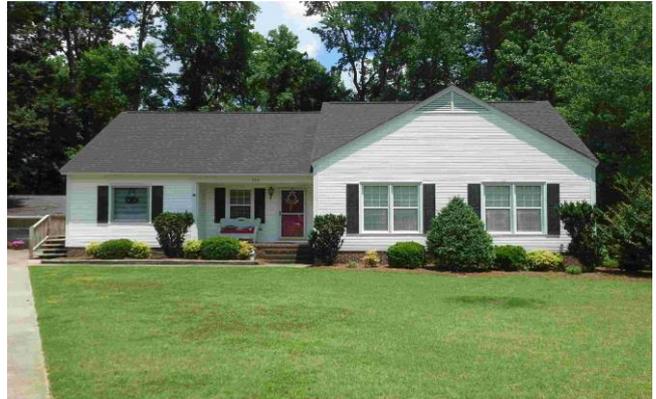
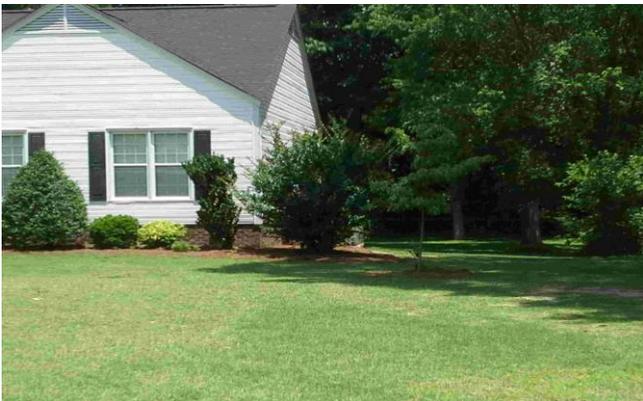
Property Locator / Repetitive Loss#: 3713-23-4211.000
Inspection Date: 6/11/2015 **Inspector:** Scott Gentry
No. of Stories: 1 **Basement:**
Occupied: Yes **Neighborhood:** Single Family Residential
Fill: 0-1 Feet **Elevated:** 2-3 Feet
Observations: Has shed. Has hvac, elevated on concrete pad. No gutter. Street is curb and gutter.
Flooding: Unknown
Flooding Notes:
Land Use: Single-family residential
Land Use Notes:
Adequate Vents Present: Yes
Spoke with: Owner Unavailable
Structure Type: Wood Frame
Structure Type Notes:
Condition of Structure: Good (optional minor repairs)
Foundation Type: Crawlspace floor at or above grade on at least 1 side
Foundation Type Notes:
Condition of Foundation: Good (optional minor repairs)

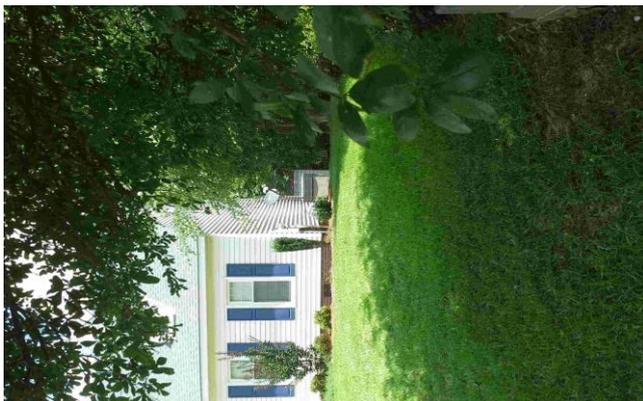
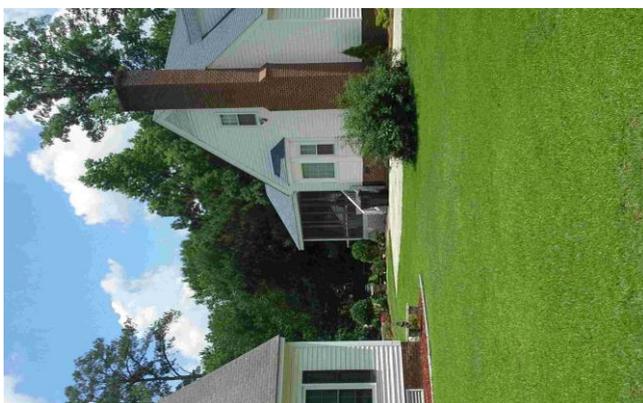
Property Locator / Repetitive Loss#: 3713-23-6034.000
Inspection Date: 6/11/2015 **Inspector:** Scott Gentry
No. of Stories: 2 **Basement:**
Occupied: Yes **Neighborhood:** Single Family Residential
Fill: 2-3 Feet **Elevated:** 2-3 Feet
Observations: Has shed. No gutter. Hvac observed on side of house.
Flooding: Unknown
Flooding Notes:
Land Use: Single-family residential
Land Use Notes:
Adequate Vents Present: Yes
Spoke with: Owner Unavailable
Structure Type: Wood Frame
Structure Type Notes:
Condition of Structure: Good (optional minor repairs)
Foundation Type: Crawlspace floor at or above grade on at least 1 side
Foundation Type Notes:
Condition of Foundation: Good (optional minor repairs)

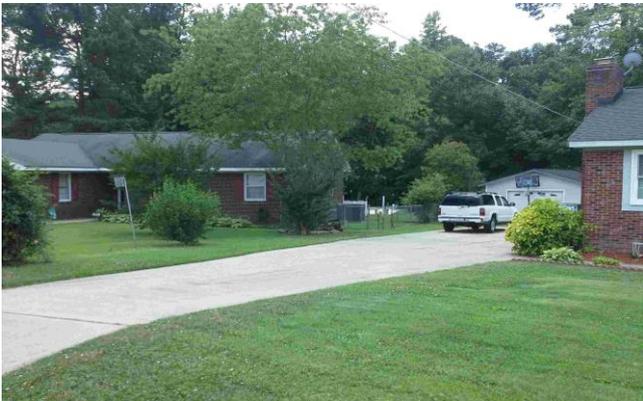
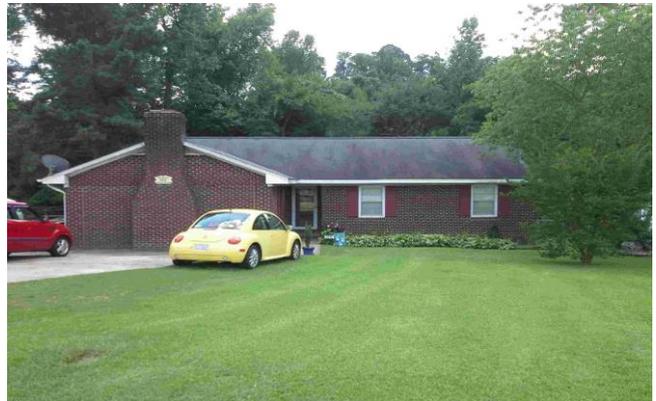
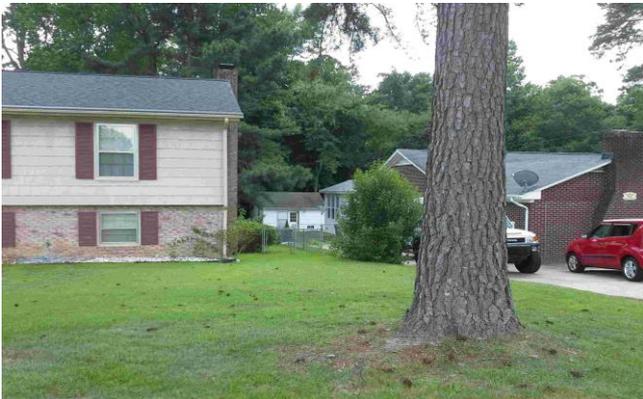
Property Locator / Repetitive Loss#: 3713-32-5629.000
Inspection Date: 6/11/2015 **Inspector:** Scott Gentry
No. of Stories: 1 **Basement:** Unknown
Occupied: Yes **Neighborhood:** Single Family Residential
Fill: Below Street **Elevated:** 0-1 Feet
Grads
Observations: Has shed which is below grade of the house. Hvac seen at side of house. Gutters on side of house, not on the front.
Flooding: Unknown
Flooding Notes:
Land Use: Single-family residential
Land Use Notes:
Adequate Vents Present: Unknown
Spoke with: Owner Unavailable
Structure Type: Masonry
Structure Type Notes:
Condition of Structure: Good (optional minor repairs)
Foundation Type: Unable to determine
Foundation Type Notes:
Condition of Foundation: Good (optional minor repairs)

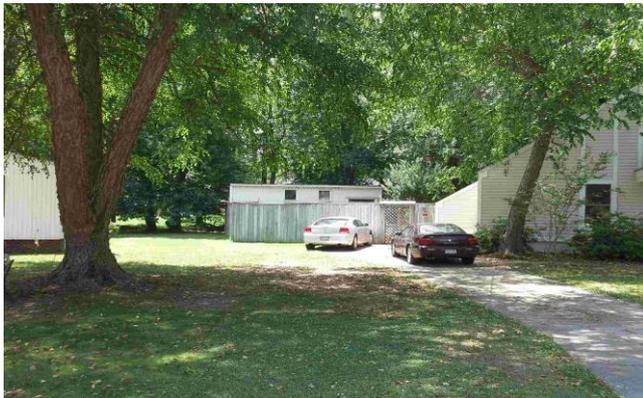
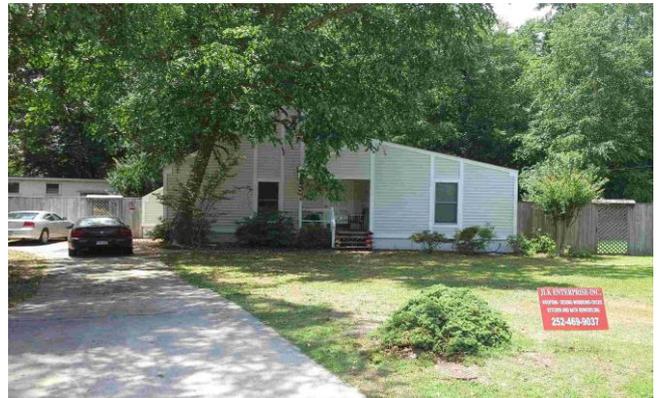
Property Locator / Repetitive Loss#: 3713-32-6410.000
Inspection Date: 6/11/2015 **Inspector:** Scott Gentry
No. of Stories: 2 **Basement:** Unknown
Occupied: Yes **Neighborhood:** Single Family Residential
Fill: 0-1 Feet **Elevated:** 2-3 Feet
Observations: Has shed/accessory structure. No gutters. No hvac seen from street.
Flooding: Unknown
Flooding Notes:
Land Use: Single-family residential
Land Use Notes:
Adequate Vents Present: Yes
Spoke with: Owner Unavailable
Structure Type: Wood Frame
Structure Type Notes:
Condition of Structure: Good (optional minor repairs)
Foundation Type: Crawlspace floor at or above grade on at least 1 side
Foundation Type Notes:
Condition of Foundation: Good (optional minor repairs)

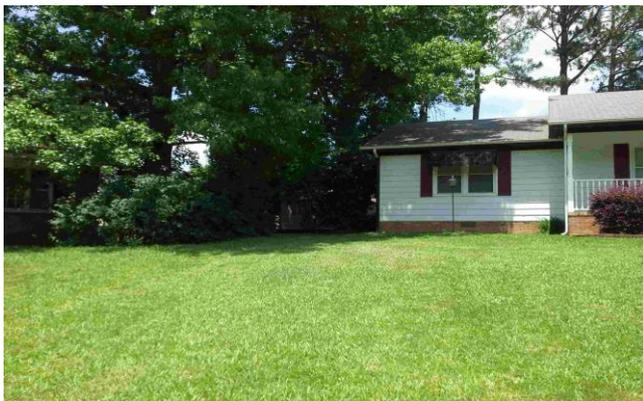
Property Locator / Repetitive Loss#: 3713-32-7590.000
Inspection Date: 6/11/2015 **Inspector:** Scott Gentry
No. of Stories: 1 **Basement:**
Occupied: Yes **Neighborhood:** Single Family Residential
Fill: 2-3 Feet **Elevated:** 3-4 Feet
Observations: Has gutters. Has shed. Observed possible hvac on side of house.
Flooding: Unknown
Flooding Notes:
Land Use: Single-family residential
Land Use Notes:
Adequate Vents Present: Yes
Spoke with: Owner Unavailable
Structure Type: Wood Frame
Structure Type Notes:
Condition of Structure: Good (optional minor repairs)
Foundation Type: Crawlspace floor at or above grade on at least 1 side
Foundation Type Notes:
Condition of Foundation: Good (optional minor repairs)

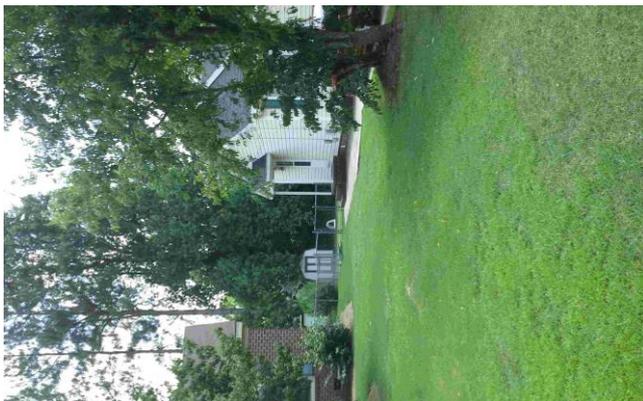
Property Locator / Repetitive Loss#: 3713-32-7665.000
Inspection Date: 6/11/2015 **Inspector:** Scott Gentry
No. of Stories: 1 **Basement:** No
Occupied: Yes **Neighborhood:** Single Family Residential
Fill: 0-1 Feet **Elevated:** 2-3 Feet
Observations: No gutter. Has shed. Hvac not seen from street.
Flooding: Unknown
Flooding Notes:
Land Use: Single-family residential
Land Use Notes:
Adequate Vents Present: Yes
Spoke with: Owner Unavailable
Structure Type: Wood Frame
Structure Type Notes:
Condition of Structure: Good (optional minor repairs)
Foundation Type: Crawlspace floor at or above grade on at least 1 side
Foundation Type Notes:
Condition of Foundation: Good (optional minor repairs)

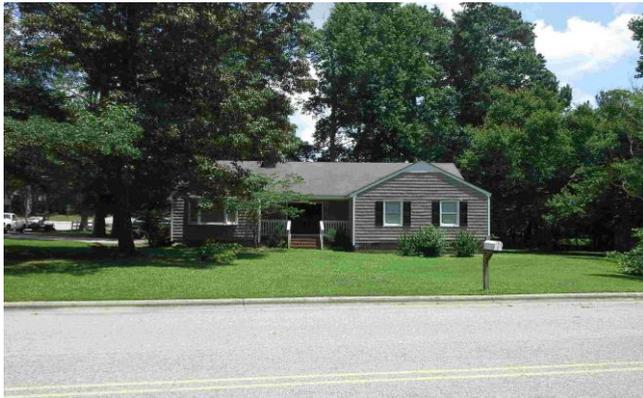
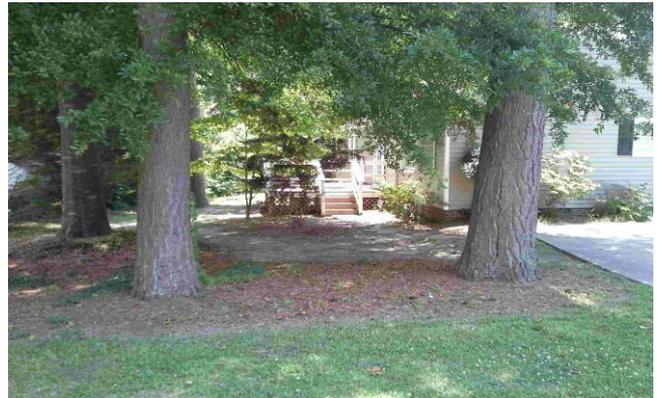
Property Locator / Repetitive Loss#: 3713-33-0090.000
Inspection Date: 6/11/2015 **Inspector:** Scott Gentry
No. of Stories: 1 **Basement:** No
Occupied: Yes **Neighborhood:** Single Family Residential
Fill: 0-1 Feet **Elevated:** 2-3 Feet
Observations: No gutter. Hvac not seen from street.
Flooding: Unknown
Flooding Notes:
Land Use: Single-family residential
Land Use Notes:
Adequate Vents Present: Yes
Spoke with: Owner Unavailable
Structure Type: Wood Frame
Structure Type Notes:
Condition of Structure: Good (optional minor repairs)
Foundation Type: Crawlspace floor at or above grade on at least 1 side
Foundation Type Notes:
Condition of Foundation: Good (optional minor repairs)

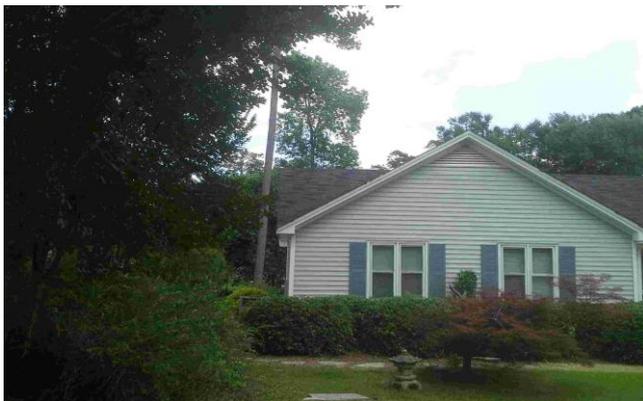
Property Locator / Repetitive Loss#: 3713-22-7964.000
Inspection Date: 6/11/2015 **Inspector:** Yuqi
No. of Stories: 1 **Basement:** No
Occupied: Yes **Neighborhood:** Single Family Residential
Fill: None **Elevated:** 2-3 Feet
Observations: Has gutters, unobserved secondary structures, has HVAC.
Flooding: Unknown
Flooding Notes:
Land Use: Single-family residential
Land Use Notes:
Adequate Vents Present: Yes
Spoke with: Owner Unavailable
Structure Type: Wood Frame
Structure Type Notes:
Condition of Structure: Good (optional minor repairs)
Foundation Type: Crawlspace floor at or above grade on at least 1 side
Foundation Type Notes:
Condition of Foundation: Good (optional minor repairs)

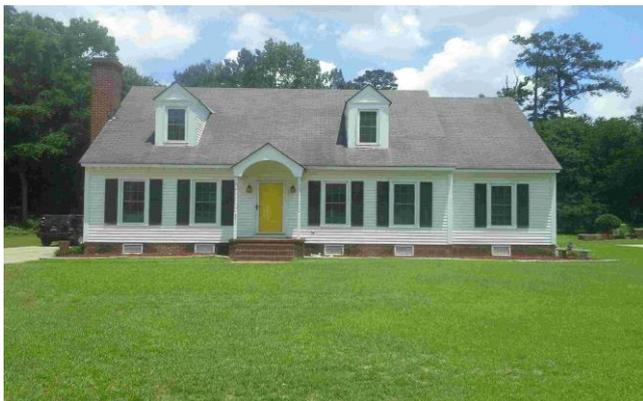
Property Locator / Repetitive Loss#: 3713-23-5023.000
Inspection Date: 6/11/2015 **Inspector:** Yuqi
No. of Stories: 2 **Basement:** No
Occupied: Yes **Neighborhood:** Single Family Residential
Fill: None **Elevated:** 3-4 Feet
Observations: No gutters, has HVAC, cannot see secondary structures.
Flooding: Unknown
Flooding Notes:
Land Use: Single-family residential
Land Use Notes:
Adequate Vents Present: Yes
Spoke with: Owner Unavailable
Structure Type: Wood Frame
Structure Type Notes:
Condition of Structure: Good (optional minor repairs)
Foundation Type: Crawlspace floor at or above grade on at least 1 side
Foundation Type Notes:
Condition of Foundation: Good (optional minor repairs)

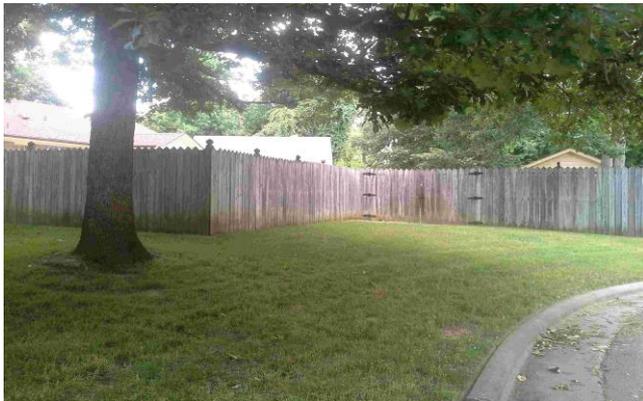
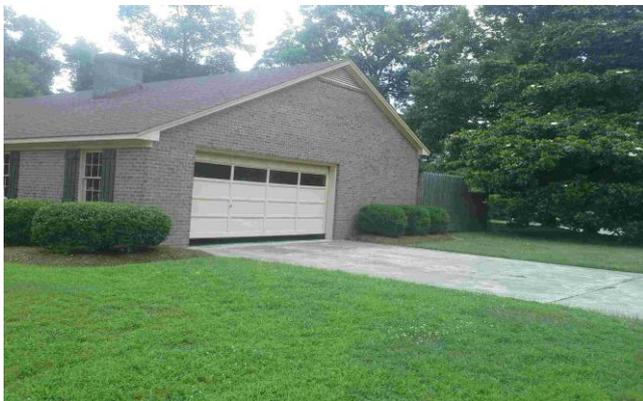
Property Locator / Repetitive Loss#: 3713-32-1730.000
Inspection Date: 6/11/2015 **Inspector:** Yuqi
No. of Stories: 1 **Basement:**
Occupied: Yes **Neighborhood:** Single Family Residential
Fill: 0-1 Feet **Elevated:** 3-4 Feet
Observations: No gutters, has secondary structure as detached storage room, unobserved HVAC
Flooding: No
Flooding Notes:
Land Use: Single-family residential
Land Use Notes:
Adequate Vents Present: Yes
Spoke with: Owner Unavailable
Structure Type: Masonry
Structure Type Notes:
Condition of Structure: Good (optional minor repairs)
Foundation Type: Crawlspace floor at or above grade on at least 1 side
Foundation Type Notes:
Condition of Foundation: Good (optional minor repairs)

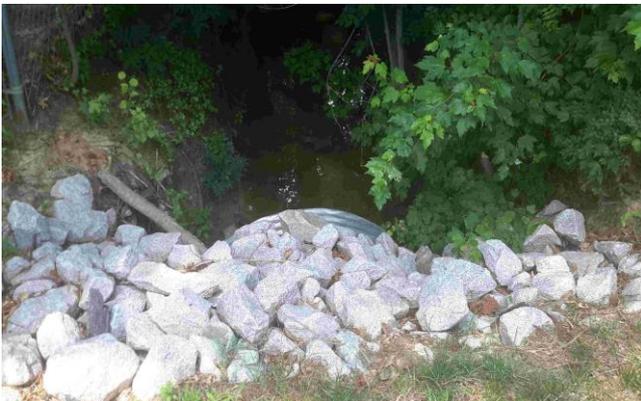
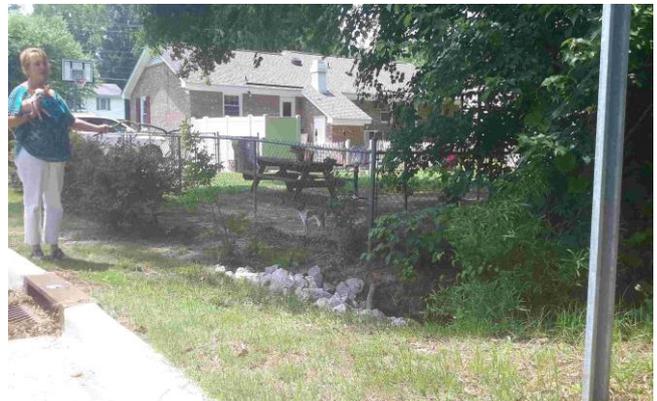
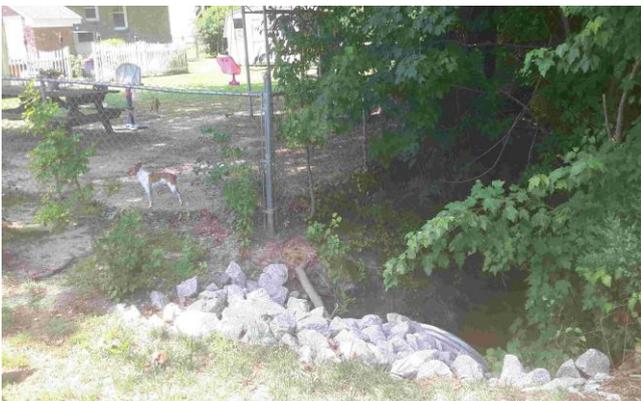
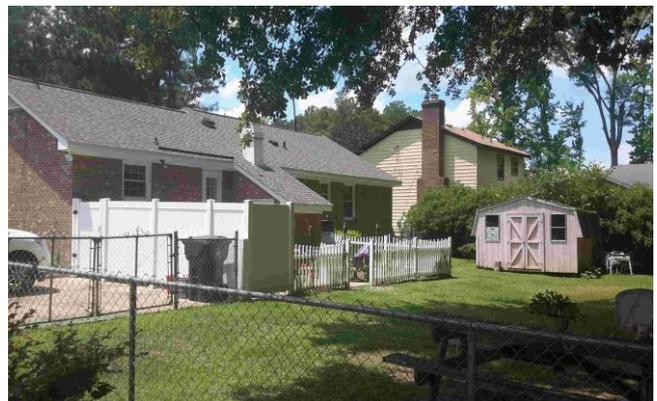
Property Locator / Repetitive Loss#: 3713-43-1510.000
Inspection Date: 6/11/2015 **Inspector:** Yuqi
No. of Stories: 1 **Basement:**
Occupied: Yes **Neighborhood:** Single Family Residential
Fill: 0-1 Feet **Elevated:** 3-4 Feet
Observations: No gutters, has secondary structure as storage room, has HVAC. Adjacent to a creek.
Flooding: Yes
Flooding Notes: The owner said this house was flooded, the picnic table was floating, the water got high up to the fence, and the air conditioner was flooded. It floods two to three times per year. The street was flooded.
Land Use: Single-family residential
Land Use Notes:
Adequate Vents Present: Yes
Spoke with: Owner/Occupant
Structure Type: Masonry
Structure Type Notes:
Condition of Structure: Good (optional minor repairs)
Foundation Type: Crawlspace floor at or above grade on at least 1 side
Foundation Type Notes:
Condition of Foundation: Good (optional minor repairs)

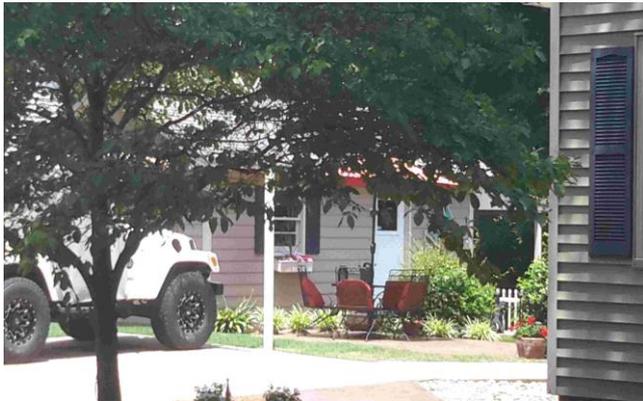
Property Locator / Repetitive Loss#: 3713-22-9738.000
Inspection Date: 6/11/2015 **Inspector:** Alex Magruder
No. of Stories: 2 **Basement:** No
Occupied: Yes **Neighborhood:** Single Family Residential
Fill: 0-1 Feet **Elevated:** 2-3 Feet
Observations: No gutters. Secondary structure. Unknown hvac.
Flooding: Unknown
Flooding Notes:
Land Use: Single-family residential
Land Use Notes:
Adequate Vents Present: Yes
Spoke with: Owner Unavailable
Structure Type: Wood Frame
Structure Type Notes:
Condition of Structure: Good (optional minor repairs)
Foundation Type: Crawlspace floor at or above grade on at least 1 side
Foundation Type Notes:
Condition of Foundation: Good (optional minor repairs)

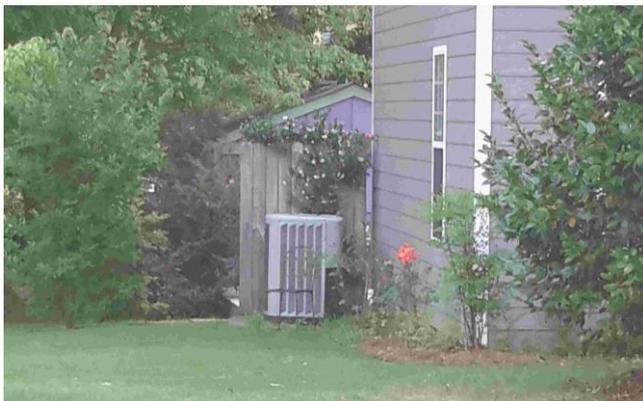
Property Locator / Repetitive Loss#: 3713-23-4182.000
Inspection Date: 6/11/2015 **Inspector:** Alex Magruder
No. of Stories: 2 **Basement:** No
Occupied: Yes **Neighborhood:** Single Family Residential
Fill: 0-1 Feet **Elevated:** 2-3 Feet
Observations: No gutters. Hvac unit on ground. Shed in backyard.
Flooding: Unknown
Flooding Notes:
Land Use: Single-family residential
Land Use Notes:
Adequate Vents Present: Yes
Spoke with: Owner Unavailable
Structure Type: Masonry
Structure Type Notes:
Condition of Structure: Good (optional minor repairs)
Foundation Type: Crawlspace floor at or above grade on at least 1 side
Foundation Type Notes:
Condition of Foundation: Good (optional minor repairs)

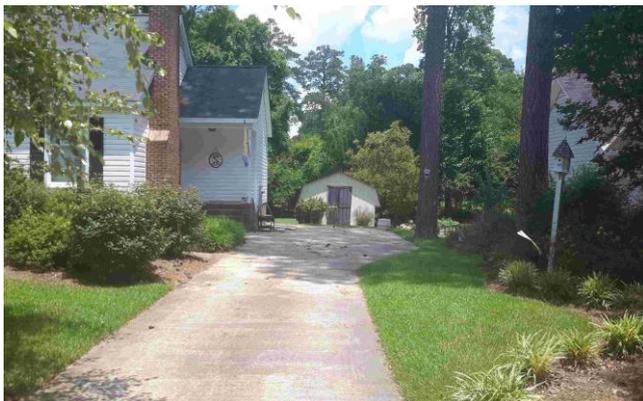
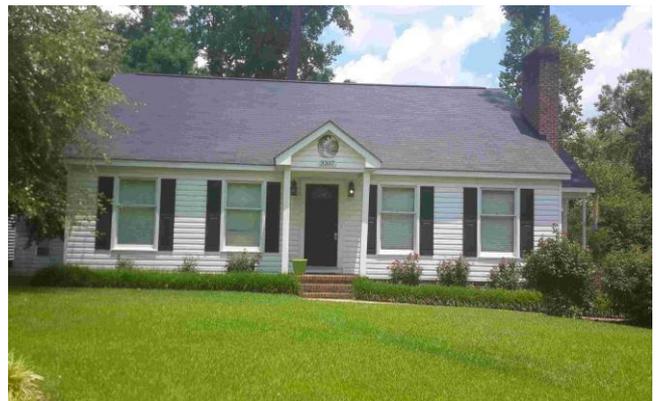
Property Locator / Repetitive Loss#: 3713-23-7000.000
Inspection Date: 6/11/2015 **Inspector:** Alex Magruder
No. of Stories: 1 **Basement:** No
Occupied: Yes **Neighborhood:** Single Family Residential
Fill: 2-3 Feet **Elevated:** 2-3 Feet
Observations: No gutters. Secondary structure. HVAC unit unknown.
Flooding: Unknown
Flooding Notes:
Land Use: Single-family residential
Land Use Notes:
Adequate Vents Present: Yes
Spoke with: Owner Unavailable
Structure Type: Wood Frame
Structure Type Notes:
Condition of Structure: Good (optional minor repairs)
Foundation Type: Crawlspace floor at or above grade on at least 1 side
Foundation Type Notes:
Condition of Foundation: Good (optional minor repairs)

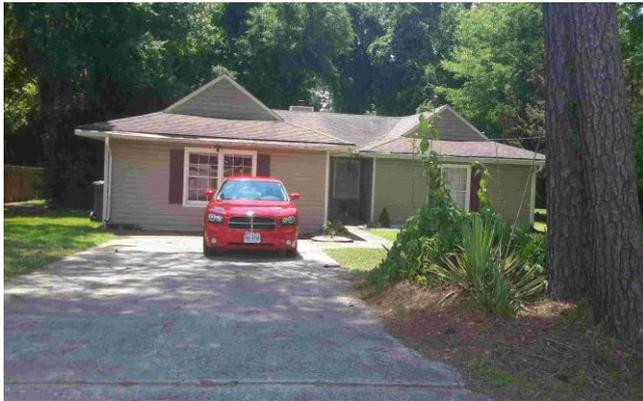
Property Locator / Repetitive Loss#: 3713-32-3903.000
Inspection Date: 6/11/2015 **Inspector:** Yuqi
No. of Stories: 1 **Basement:** No
Occupied: Yes **Neighborhood:** Single Family Residential
Fill: 0-1 Feet **Elevated:** 0-1 Feet
Observations: Has gutters, has HVAC, unobserved secondary structures,
Flooding: Unknown
Flooding Notes:
Land Use: Single-family residential
Land Use Notes:
Adequate Vents Present:
Spoke with: Owner Unavailable
Structure Type: Wood Frame
Structure Type Notes:
Condition of Structure:
Foundation Type: Slab-on-grade
Foundation Type Notes:
Condition of Foundation:

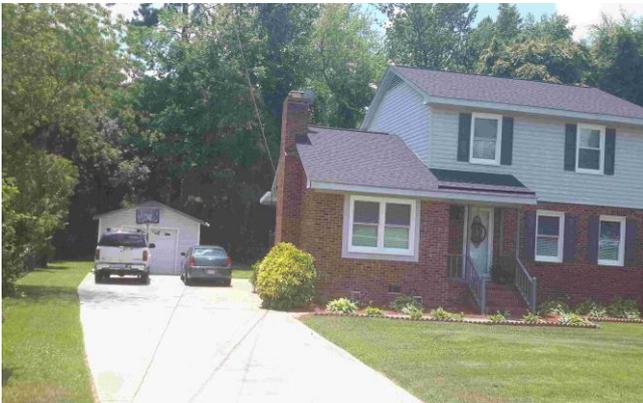
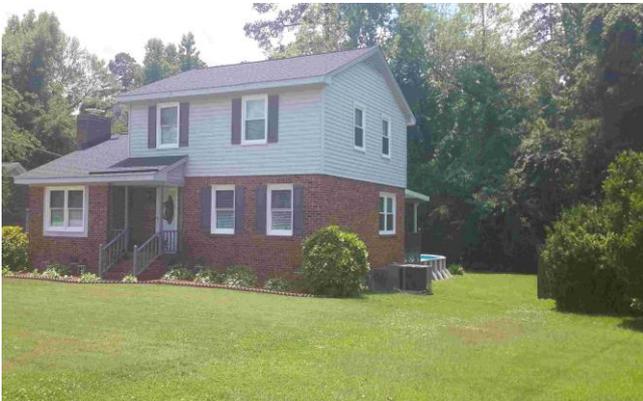
Property Locator / Repetitive Loss#: 3713-32-4754.000
Inspection Date: 6/11/2015 **Inspector:** Yuqi
No. of Stories: 2 **Basement:** Unknown
Occupied: Yes **Neighborhood:** Single Family Residential
Fill: Below Street **Elevated:** 3-4 Feet
Grads
Observations: Has HVAC, no gutters, has secondary structures detached garage and pool.
Flooding: Unknown
Flooding Notes:
Land Use: Single-family residential
Land Use Notes:
Adequate Vents Present: Yes
Spoke with: Owner Unavailable
Structure Type: Masonry
Structure Type Notes: Blend with wood and bricks, most are bricks.
Condition of Structure: Good (optional minor repairs)
Foundation Type: Crawlspace floor at or above grade on at least 1 side
Foundation Type Notes:
Condition of Foundation: Good (optional minor repairs)

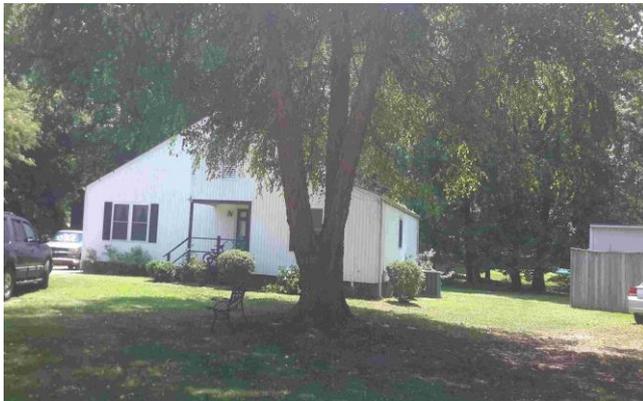
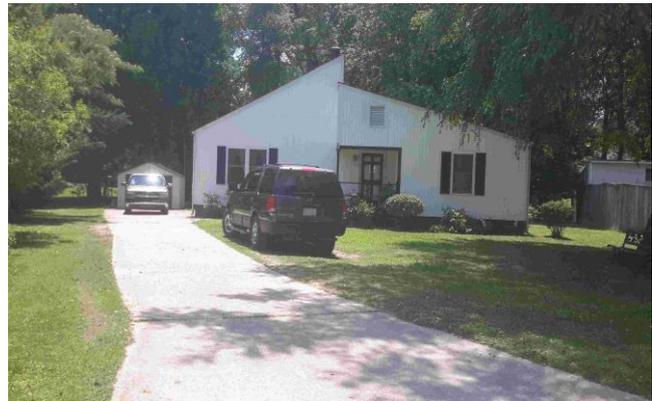
Property Locator / Repetitive Loss#: 3713-32-6331.000
Inspection Date: 6/11/2015 **Inspector:** Yuqi
No. of Stories: 1 **Basement:** No
Occupied: Yes **Neighborhood:** Single Family Residential
Fill: 0-1 Feet **Elevated:** 2-3 Feet
Observations: Has gutters, has secondary structure as detached garage, and has HVAC.
Flooding: Unknown
Flooding Notes:
Land Use: Single-family residential
Land Use Notes:
Adequate Vents Present: Yes
Spoke with: Owner Unavailable
Structure Type: Wood Frame
Structure Type Notes:
Condition of Structure: Good (optional minor repairs)
Foundation Type: Crawlspace floor at or above grade on at least 1 side
Foundation Type Notes:
Condition of Foundation: Good (optional minor repairs)

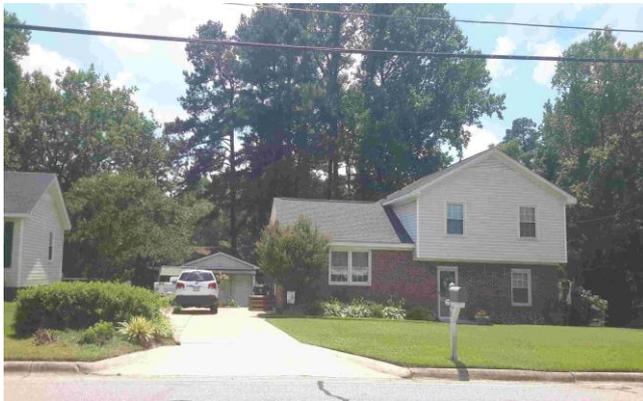
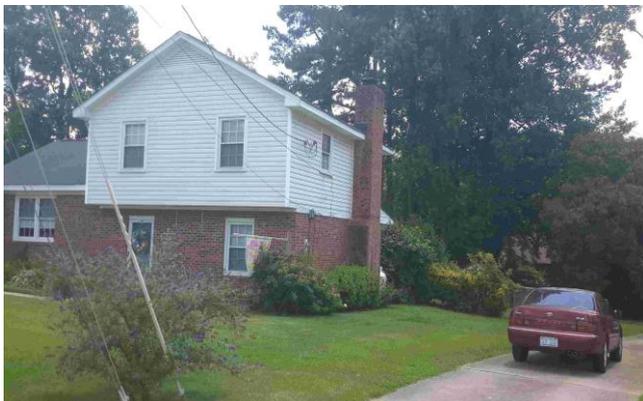
Property Locator / Repetitive Loss#: 3713-32-6685.000
Inspection Date: 6/11/2015 **Inspector:** Yuqi
No. of Stories: 2 **Basement:** Unknown
Occupied: Yes **Neighborhood:** Single Family Residential
Fill: 0-1 Feet **Elevated:** At Grade
Observations: No gutters, has HVAV, has secondary structure with detached garage and storage room, backyard slope towards to low point.
Flooding: Unknown
Flooding Notes:
Land Use: Single-family residential
Land Use Notes:
Adequate Vents Present: Yes
Spoke with: Owner Unavailable
Structure Type: Masonry
Structure Type Notes:
Condition of Structure: Good (optional minor repairs)
Foundation Type: Crawlspace floor at or above grade on at least 1 side
Foundation Type Notes:
Condition of Foundation: Good (optional minor repairs)

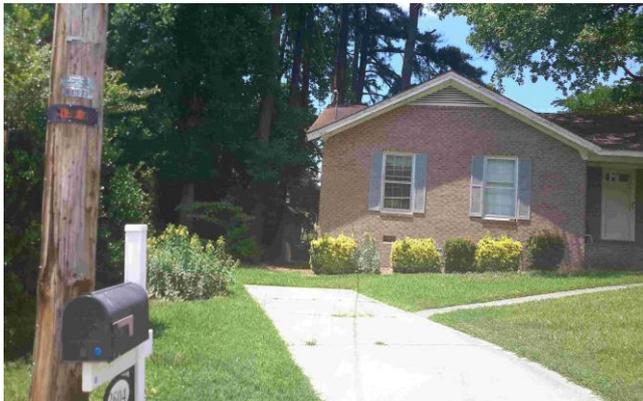
Property Locator / Repetitive Loss#: 3713-32-7512.000
Inspection Date: 6/11/2015 **Inspector:** Yuqi
No. of Stories: 1 **Basement:** No
Occupied: Yes **Neighborhood:** Single Family Residential
Fill: 2-3 Feet **Elevated:** 3-4 Feet
Observations: No gutters, has secondary structure as storage room, unobserved HVAC.
Flooding: Unknown
Flooding Notes:
Land Use: Single-family residential
Land Use Notes:
Adequate Vents Present: Yes
Spoke with: Owner Unavailable
Structure Type: Masonry
Structure Type Notes:
Condition of Structure: Good (optional minor repairs)
Foundation Type: Crawlspace floor at or above grade on at least 1 side
Foundation Type Notes:
Condition of Foundation: Good (optional minor repairs)

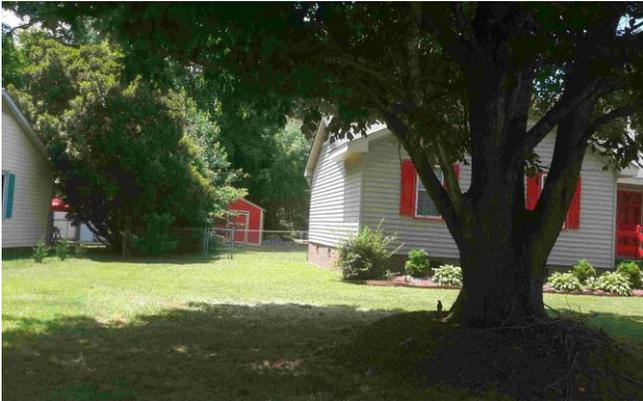
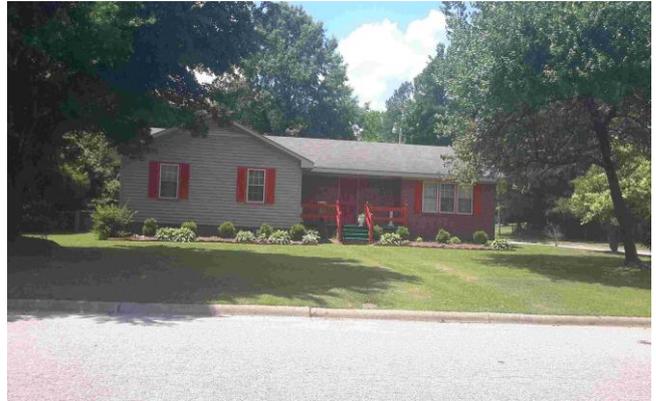
Property Locator / Repetitive Loss#: 3713-32-8360.000
Inspection Date: 6/11/2015 **Inspector:** Yuqi
No. of Stories: 1 **Basement:** No
Occupied: Yes **Neighborhood:** Single Family Residential
Fill: 0-1 Feet **Elevated:** 3-4 Feet
Observations: No gutters, has secondary structure as detached garage, unobserved HVAC
Flooding: Unknown
Flooding Notes:
Land Use: Single-family residential
Land Use Notes:
Adequate Vents Present: Yes
Spoke with: Owner Unavailable
Structure Type: Masonry
Structure Type Notes: Blend with wood and bricks.
Condition of Structure: Good (optional minor repairs)
Foundation Type: Crawlspace floor at or above grade on at least 1 side
Foundation Type Notes:
Condition of Foundation: Good (optional minor repairs)

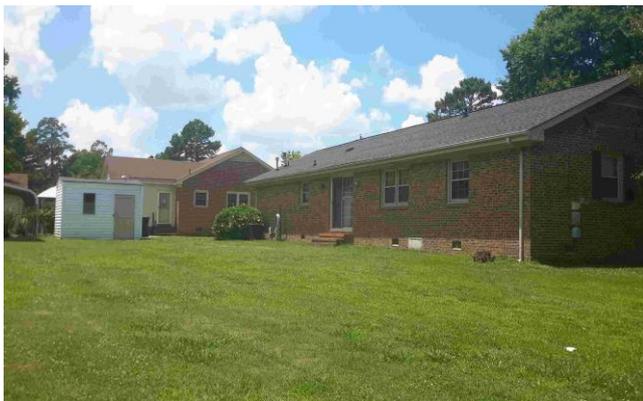
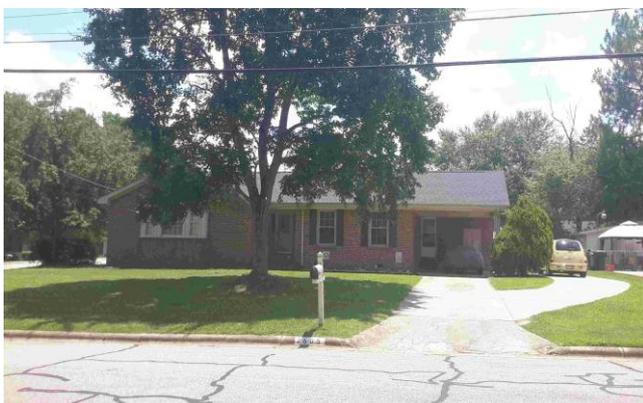
Property Locator / Repetitive Loss#: 3713-32-9634.000
Inspection Date: 6/11/2015 **Inspector:** Yuqi
No. of Stories: 1 **Basement:**
Occupied: Yes **Neighborhood:** Single Family Residential
Fill: 2-3 Feet **Elevated:** 3-4 Feet
Observations: Has gutters, has secondary structure as garage, has HVAC
Flooding: Unknown
Flooding Notes:
Land Use: Single-family residential
Land Use Notes:
Adequate Vents Present: Yes
Spoke with: Owner Unavailable
Structure Type: Masonry
Structure Type Notes:
Condition of Structure: Good (optional minor repairs)
Foundation Type: Crawlspace floor at or above grade on at least 1 side
Foundation Type Notes:
Condition of Foundation: Good (optional minor repairs)

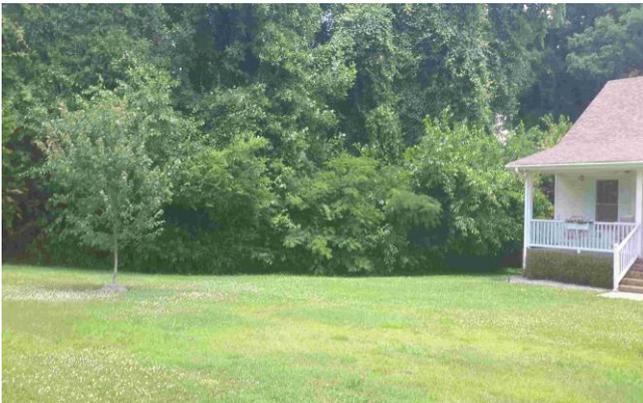
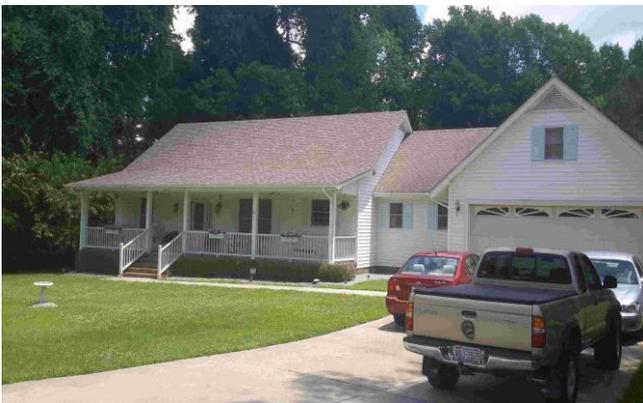
Property Locator / Repetitive Loss#: 3713-32-1776.000
Inspection Date: 6/11/2015 **Inspector:** Alex Magruder
No. of Stories: 2 **Basement:** No
Occupied: Yes **Neighborhood:** Single Family Residential
Fill: 0-1 Feet **Elevated:** 2-3 Feet
Observations: Has guttering. Hvac unit is on ground. Secondary structure. Creek to the left of property
Flooding: Unknown
Flooding Notes:
Land Use: Single-family residential
Land Use Notes:
Adequate Vents Present: Yes
Spoke with: Owner Unavailable
Structure Type: Wood Frame
Structure Type Notes:
Condition of Structure: Good (optional minor repairs)
Foundation Type: Crawlspace floor at or above grade on at least 1 side
Foundation Type Notes:
Condition of Foundation: Good (optional minor repairs)

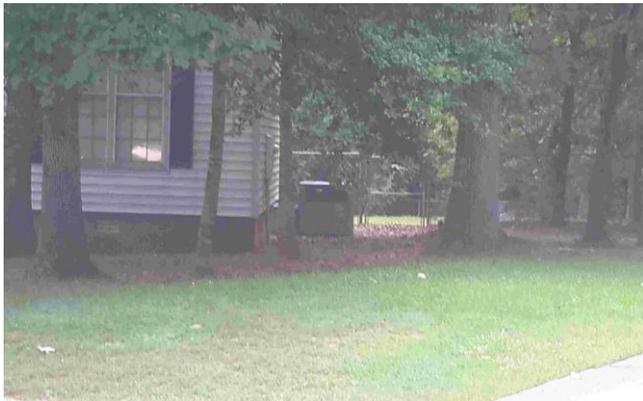
Property Locator / Repetitive Loss#: 3713-32-3640.000
Inspection Date: 6/11/2015 **Inspector:** Alex Magruder
No. of Stories: 1 **Basement:** Unknown
Occupied: **Neighborhood:** Single Family Residential
Fill: Below Street **Elevated:** 3-4 Feet
Grads
Observations: No gutters. Hvac unit on ground.
Flooding: Unknown
Flooding Notes:
Land Use: Single-family residential
Land Use Notes:
Adequate Vents Present: Yes
Spoke with: Owner Unavailable
Structure Type: Wood Frame
Structure Type Notes:
Condition of Structure: Good (optional minor repairs)
Foundation Type: Crawlspace floor at or above grade on at least 1 side
Foundation Type Notes:
Condition of Foundation: Good (optional minor repairs)

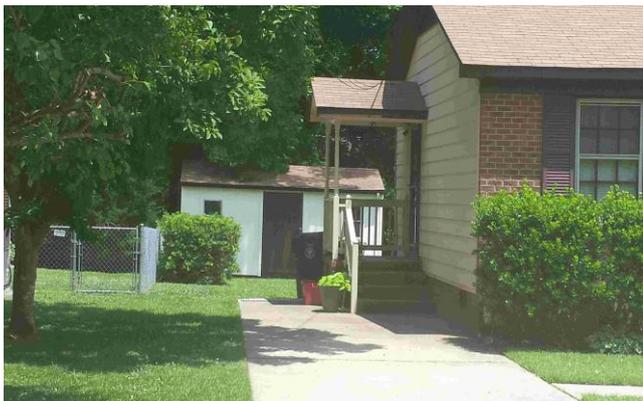
Property Locator / Repetitive Loss#: 3713-43-1519.000
Inspection Date: 6/11/2015 **Inspector:** Alex Magruder
No. of Stories: 2 **Basement:** No
Occupied: Yes **Neighborhood:** Single Family Residential
Fill: 0-1 Feet **Elevated:** 0-1 Feet
Observations: No guttering. Secondary structure. Hvac unit unknown.
Flooding: Unknown
Flooding Notes:
Land Use: Single-family residential
Land Use Notes:
Adequate Vents Present: Yes
Spoke with: Owner Unavailable
Structure Type: Masonry
Structure Type Notes:
Condition of Structure: Good (optional minor repairs)
Foundation Type: Crawlspace floor at or above grade on at least 1 side
Foundation Type Notes:
Condition of Foundation: Good (optional minor repairs)

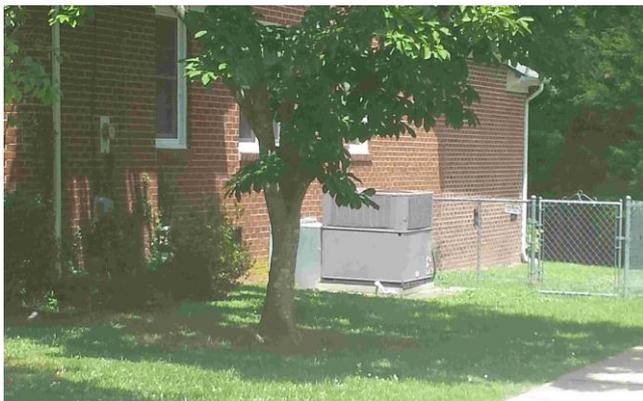
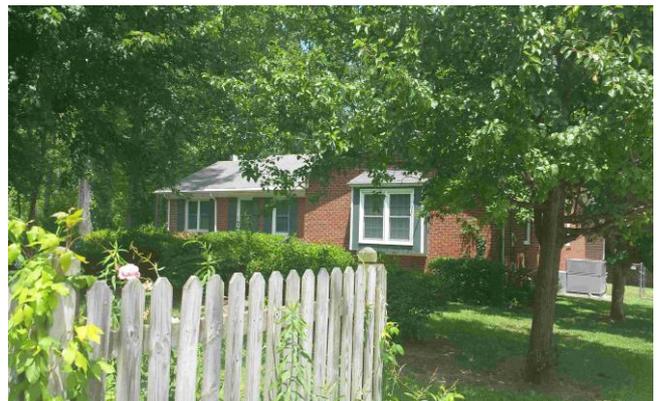
Property Locator / Repetitive Loss#: 3713-43-1605.000
Inspection Date: 6/11/2015 **Inspector:** Alex Magruder
No. of Stories: 1 **Basement:** No
Occupied: Yes **Neighborhood:** Single Family Residential
Fill: 0-1 Feet **Elevated:** 3-4 Feet
Observations: Has guttering. Hvac unit on ground.
Flooding: Unknown
Flooding Notes:
Land Use: Single-family residential
Land Use Notes:
Adequate Vents Present: Yes
Spoke with: Owner Unavailable
Structure Type: Masonry
Structure Type Notes:
Condition of Structure: Good (optional minor repairs)
Foundation Type: Crawlspace floor at or above grade on at least 1 side
Foundation Type Notes:
Condition of Foundation: Good (optional minor repairs)

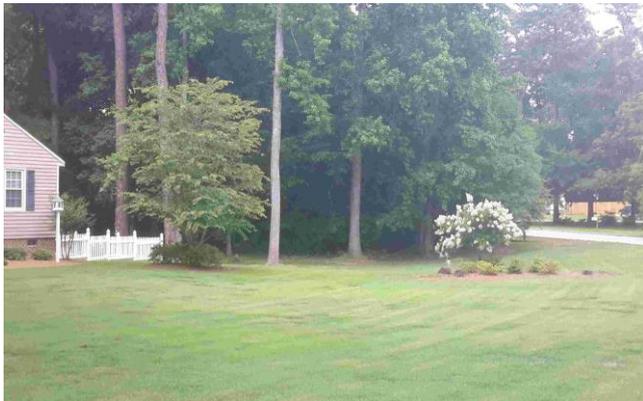
Property Locator / Repetitive Loss#: 3713-22-9858.000
Inspection Date: 6/10/2015 **Inspector:** Alex Magruder
No. of Stories: **Basement:** Yes
Occupied: Unknown **Neighborhood:** Commercial
Fill: None **Elevated:**
Observations: No building on property
Flooding:
Flooding Notes:
Land Use:
Land Use Notes:
Adequate Vents Present: Yes
Spoke with:
Structure Type:
Structure Type Notes:
Condition of Structure:
Foundation Type:
Foundation Type Notes:
Condition of Foundation:

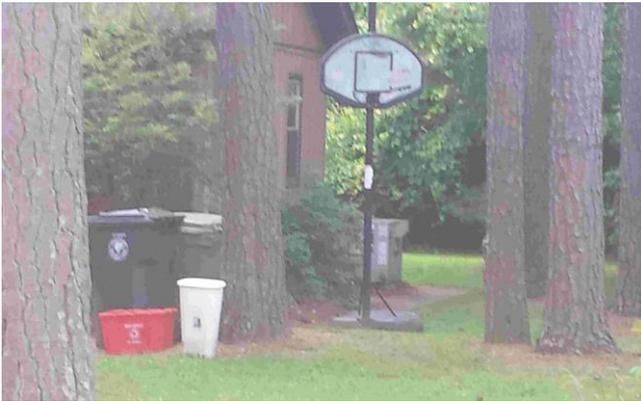
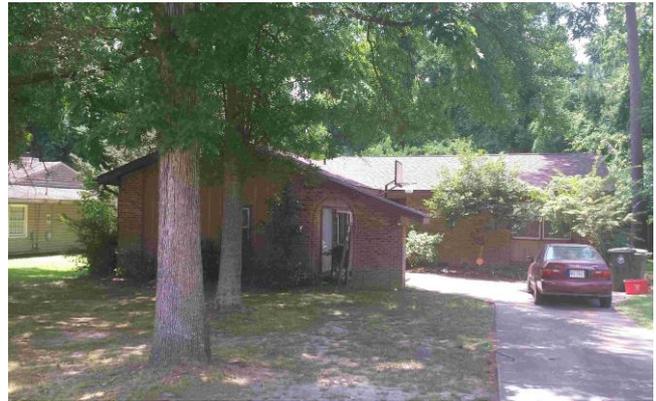
Property Locator / Repetitive Loss#: 3713-32-2927.000

Condition of Structure: Good (optional minor repairs)

Condition of Foundation: Good (optional minor repairs)

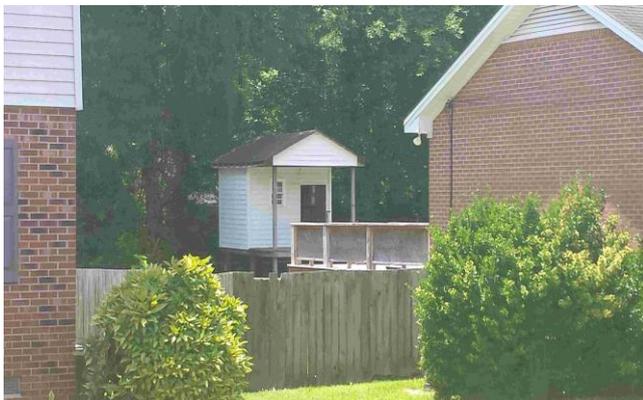
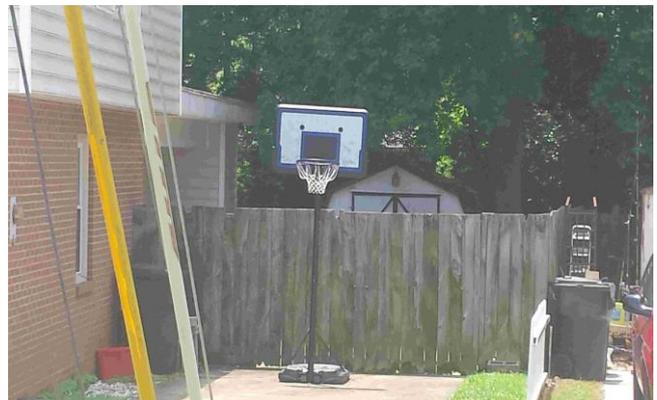
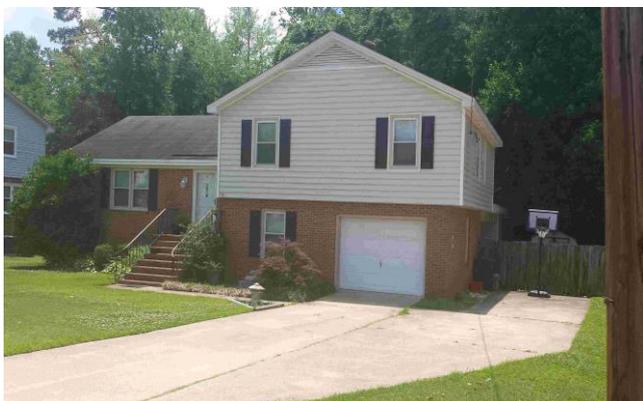
Property Locator / Repetitive Loss#: 3713-32-4800.000
Inspection Date: 6/11/2015 **Inspector:** Alex Magruder
No. of Stories: 2 **Basement:** No
Occupied: Yes **Neighborhood:** Single Family Residential
Fill: Below Street **Elevated:** 4-6 Feet
Grads
Observations: No guttering. Hvac unit unknown. Secondary structure.
Flooding: Unknown
Flooding Notes:
Land Use: Single-family residential
Land Use Notes:
Adequate Vents Present: Yes
Spoke with: Owner Unavailable
Structure Type: Masonry
Structure Type Notes:
Condition of Structure: Good (optional minor repairs)
Foundation Type: Split-level - slab-on-grade
Foundation Type Notes:
Condition of Foundation: Good (optional minor repairs)
