REPETITIVE LOSS AREA ANALYSIS

City of Wilson, North Carolina
Planning & Development Services

Prepared by:
Amec Foster Wheeler
Environment & Infrastructure, Inc.

October 2015

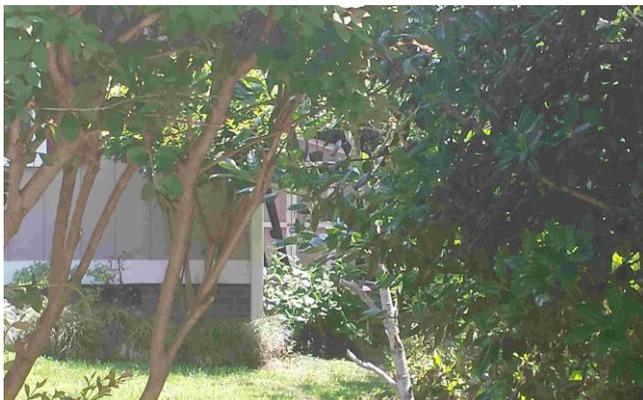
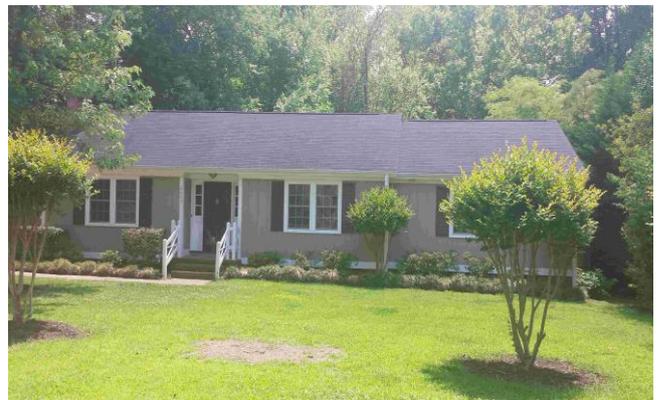
Property Locator / Repetitive Loss#: 3713-32-7249.000
Inspection Date: 6/11/2015 **Inspector:** Alex Magruder
No. of Stories: 1 **Basement:** No
Occupied: Yes **Neighborhood:** Single Family Residential
Fill: 0-1 Feet **Elevated:** 2-3 Feet
Observations: No guttering. Hvac unit unknown. Secondary structure. Fence blocking view.
Flooding: Unknown
Flooding Notes:
Land Use: Single-family residential
Land Use Notes:
Adequate Vents Present: Yes
Spoke with: Neighbor
Structure Type: Wood Frame
Structure Type Notes:
Condition of Structure: Good (optional minor repairs)
Foundation Type: Crawlspace floor at or above grade on at least 1 side
Foundation Type Notes:
Condition of Foundation: Good (optional minor repairs)

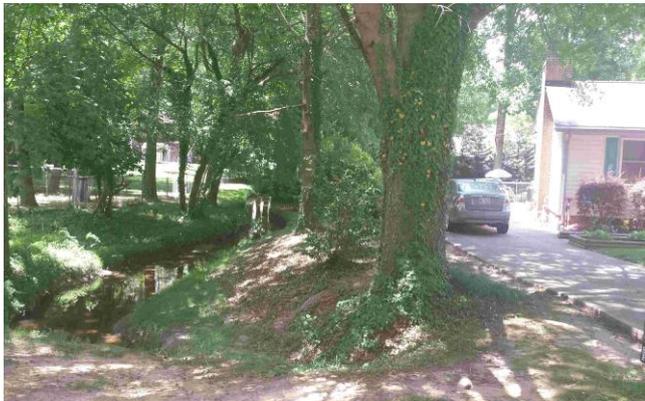
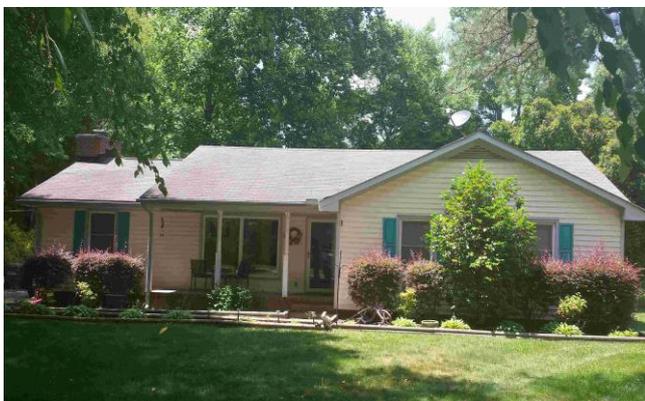
Property Locator / Repetitive Loss#: 3713-32-8201.000
Inspection Date: 6/11/2015 **Inspector:** Alex Magruder
No. of Stories: 1 **Basement:** No
Occupied: Yes **Neighborhood:** Single Family Residential
Fill: 0-1 Feet **Elevated:** 1-2 Feet
Observations: No guttering. Secondary structure. Unknown hvac. Adjacent to creek.
Flooding: Unknown
Flooding Notes:
Land Use: Single-family residential
Land Use Notes:
Adequate Vents Present: Yes
Spoke with: Owner Unavailable
Structure Type: Wood Frame
Structure Type Notes:
Condition of Structure: Good (optional minor repairs)
Foundation Type: Crawlspace floor at or above grade on at least 1 side
Foundation Type Notes:
Condition of Foundation: Good (optional minor repairs)

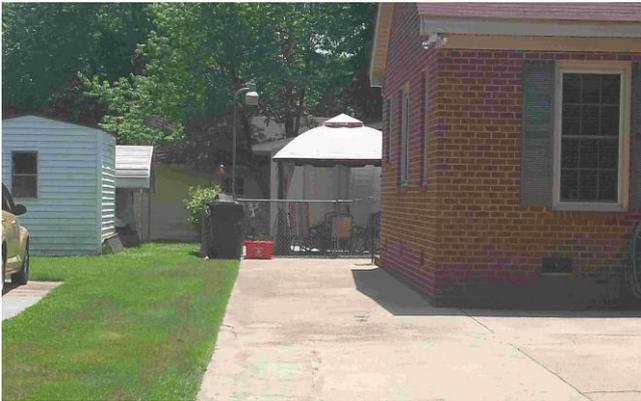
Property Locator / Repetitive Loss#: 3713-32-8644.000
Inspection Date: 6/11/2015 **Inspector:** Alex Magruder
No. of Stories: 1 **Basement:** No
Occupied: Yes **Neighborhood:** Single Family Residential
Fill: 0-1 Feet **Elevated:** 3-4 Feet
Observations: No guttering. Hvac unknown. Secondary structure.
Flooding: Unknown
Flooding Notes:
Land Use: Single-family residential
Land Use Notes:
Adequate Vents Present: Yes
Spoke with: Owner Unavailable
Structure Type: Masonry
Structure Type Notes:
Condition of Structure: Good (optional minor repairs)
Foundation Type: Crawlspace floor at or above grade on at least 1 side
Foundation Type Notes:
Condition of Foundation: Good (optional minor repairs)

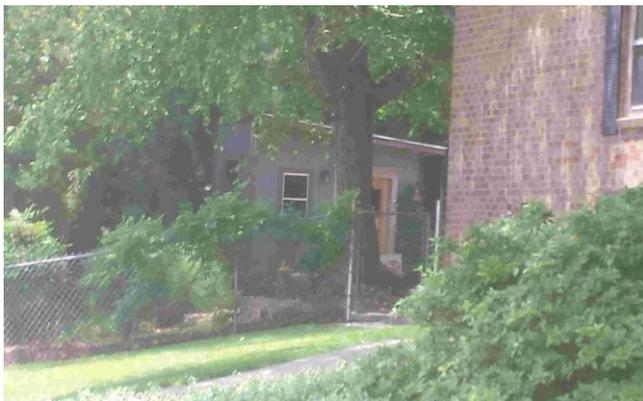
Property Locator / Repetitive Loss#: 3713-32-9403.000
Inspection Date: 6/11/2015 **Inspector:** Alex Magruder
No. of Stories: 1 **Basement:** No
Occupied: No **Neighborhood:** Single Family Residential
Fill: 2-3 Feet **Elevated:** 0-1 Feet
Observations: No guttering. Secondary structure. Hvac unit unknown.
Flooding: Unknown
Flooding Notes:
Land Use: Single-family residential
Land Use Notes:
Adequate Vents Present: Yes
Spoke with: Owner Unavailable
Structure Type: Masonry
Structure Type Notes:
Condition of Structure: Good (optional minor repairs)
Foundation Type: Crawlspace floor at or above grade on at least 1 side
Foundation Type Notes:
Condition of Foundation: Good (optional minor repairs)

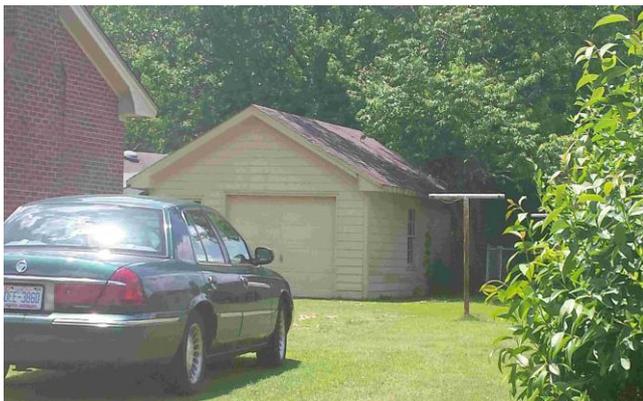
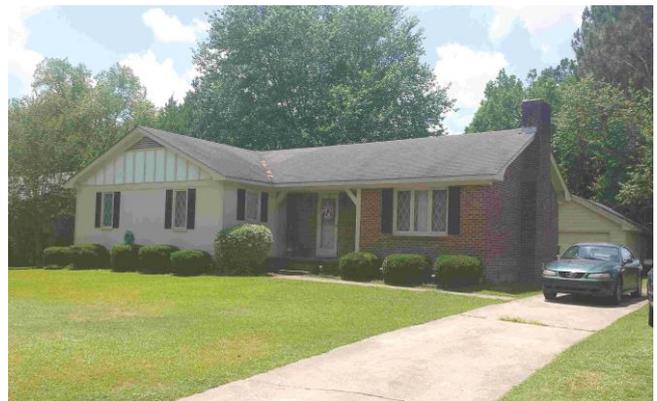
Property Locator / Repetitive Loss#: 3713-32-9512.000
Inspection Date: 6/11/2015 **Inspector:** Alex Magruder
No. of Stories: 1 **Basement:** No
Occupied: Yes **Neighborhood:** Single Family Residential
Fill: 2-3 Feet **Elevated:** 2-3 Feet
Observations: No guttering. Unknown hvac. Secondary structure.
Flooding: Unknown
Flooding Notes:
Land Use: Single-family residential
Land Use Notes:
Adequate Vents Present: Yes
Spoke with: Owner Unavailable
Structure Type: Masonry
Structure Type Notes:
Condition of Structure: Good (optional minor repairs)
Foundation Type: Crawlspace floor at or above grade on at least 1 side
Foundation Type Notes:
Condition of Foundation: Good (optional minor repairs)

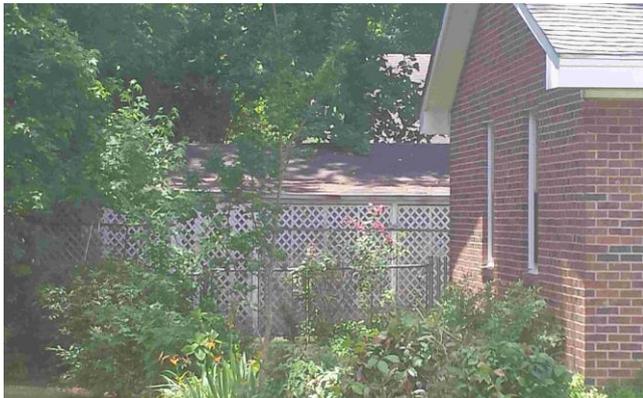
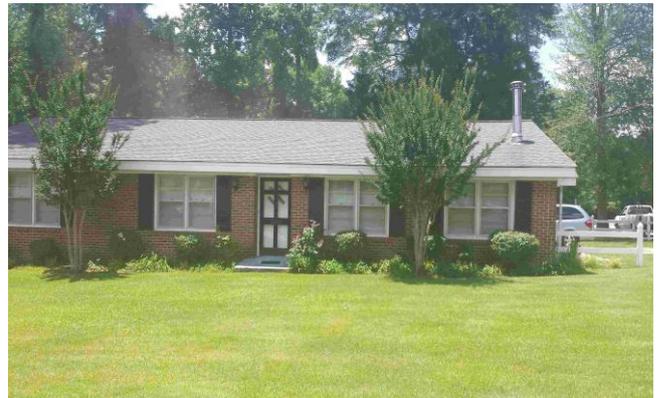
Property Locator / Repetitive Loss#: 3713-33-2016.000
Inspection Date: 6/11/2015 **Inspector:** Alex Magruder
No. of Stories: 1 **Basement:** No
Occupied: Yes **Neighborhood:** Single Family Residential
Fill: 0-1 Feet **Elevated:** 0-1 Feet
Observations: No guttering. Unknown hvac. Might be slab on grad. Secondary structure.
Flooding: Unknown
Flooding Notes:
Land Use: Single-family residential
Land Use Notes:
Adequate Vents Present: Unknown
Spoke with: Owner Unavailable
Structure Type: Masonry
Structure Type Notes:
Condition of Structure: Good (optional minor repairs)
Foundation Type: Unable to determine
Foundation Type Notes:
Condition of Foundation: Good (optional minor repairs)

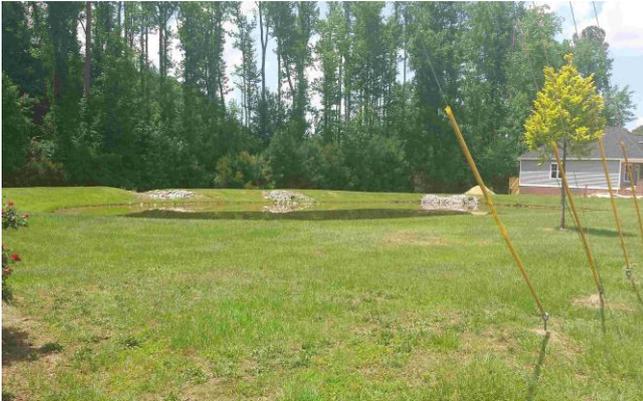
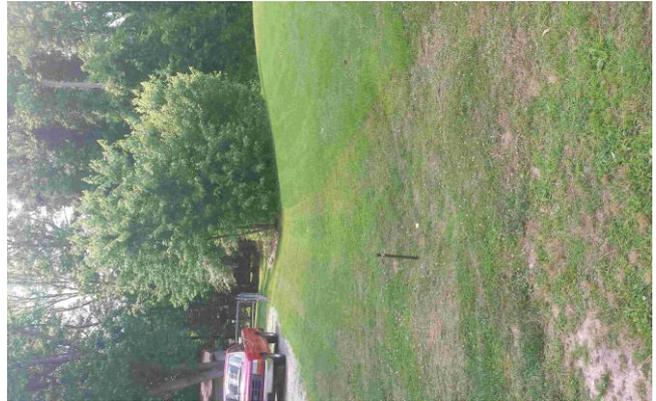
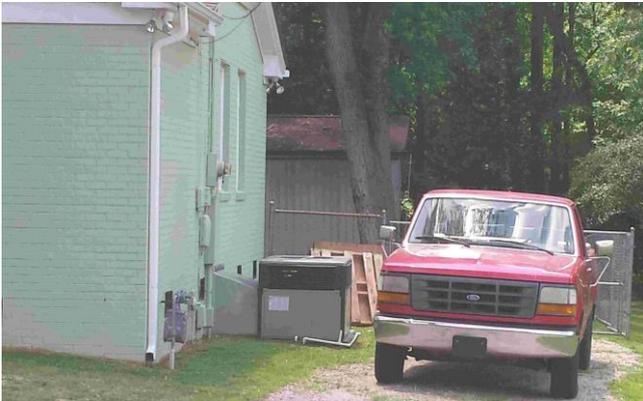
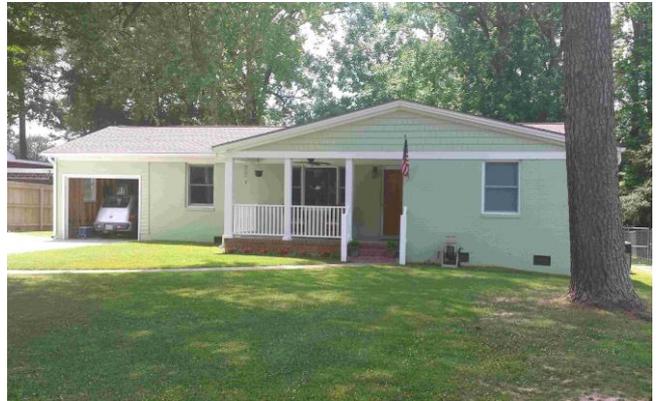
Property Locator / Repetitive Loss#: 3713-43-2680.000
Inspection Date: 6/11/2015 **Inspector:** Alex Magruder
No. of Stories: 1 **Basement:** No
Occupied: Yes **Neighborhood:** Single Family Residential
Fill: 0-1 Feet **Elevated:** 1-2 Feet
Observations: Has guttering. Hvac unit on ground. Secondary structure. Adjacent to pond. Drain on right side of property.
Flooding: Unknown
Flooding Notes:
Land Use: Single-family residential
Land Use Notes:
Adequate Vents Present: Yes
Spoke with: Owner Unavailable
Structure Type: Masonry
Structure Type Notes:
Condition of Structure: Good (optional minor repairs)
Foundation Type: Crawlspace floor at or above grade on at least 1 side
Foundation Type Notes:
Condition of Foundation: Good (optional minor repairs)

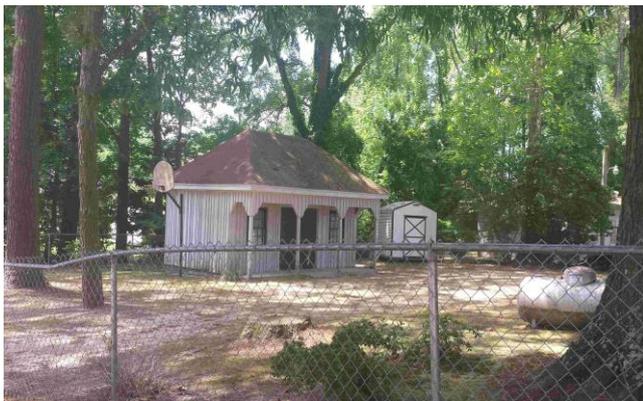
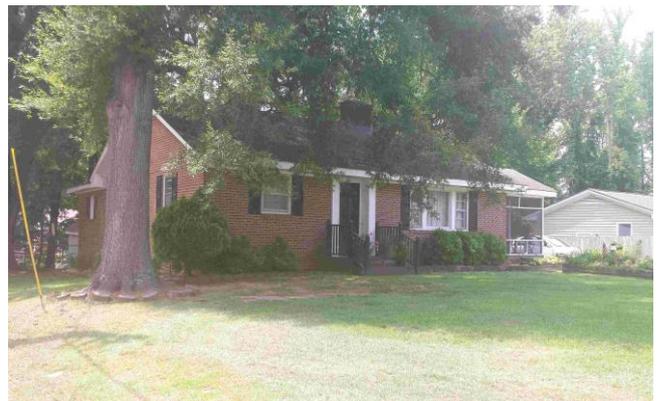
Property Locator / Repetitive Loss#: 3713-43-2582.000
Inspection Date: 6/11/2015 **Inspector:** Alex Magruder
No. of Stories: 1 **Basement:** No
Occupied: Yes **Neighborhood:** Single Family Residential
Fill: 2-3 Feet **Elevated:** 1-2 Feet
Observations: No guttering. Secondary structure. Hvac unit unknown.
Flooding: Yes
Flooding Notes: On street.
Land Use: Single-family residential
Land Use Notes:
Adequate Vents Present: Yes
Spoke with: Neighbor
Structure Type: Masonry
Structure Type Notes:
Condition of Structure: Good (optional minor repairs)
Foundation Type: Crawlspace floor at or above grade on at least 1 side
Foundation Type Notes:
Condition of Foundation: Good (optional minor repairs)

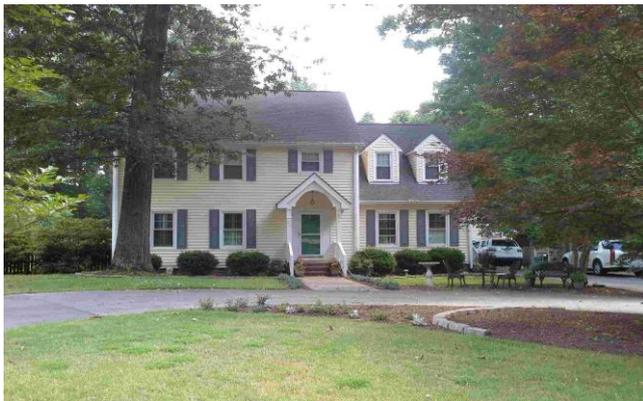
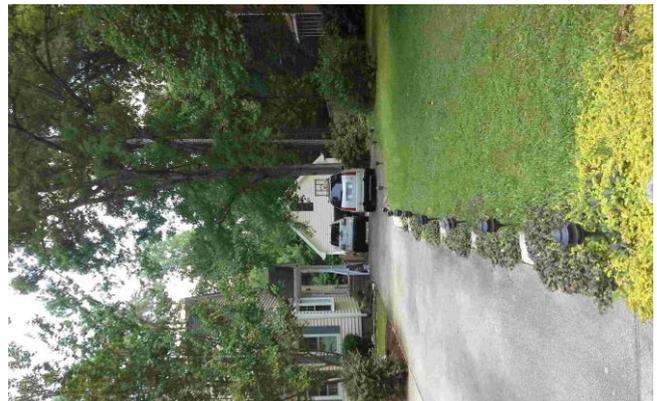
Property Locator / Repetitive Loss#: 3713-00-9982.000
Inspection Date: 6/11/2015 **Inspector:** Scott Gentry
No. of Stories: 2 **Basement:** No
Occupied: Yes **Neighborhood:** Single Family Residential
Fill: 0-1 Feet **Elevated:** 2-3 Feet
Observations: Has gutters. Has detached garage. Hvac not seen from street.
Flooding: Unknown
Flooding Notes:
Land Use: Single-family residential
Land Use Notes:
Adequate Vents Present: Yes
Spoke with: Owner Unavailable
Structure Type: Wood Frame
Structure Type Notes:
Condition of Structure: Good (optional minor repairs)
Foundation Type: Crawlspace floor at or above grade on at least 1 side
Foundation Type Notes:
Condition of Foundation: Good (optional minor repairs)

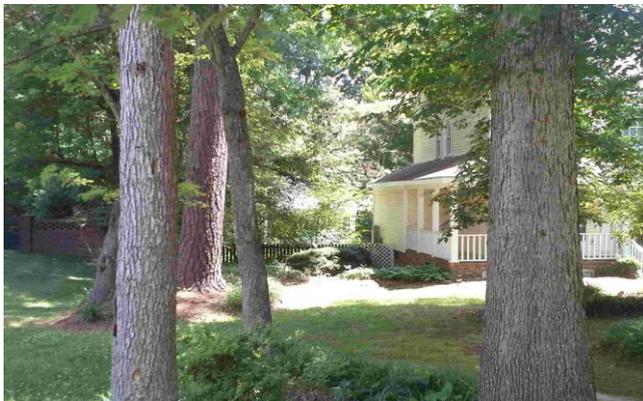
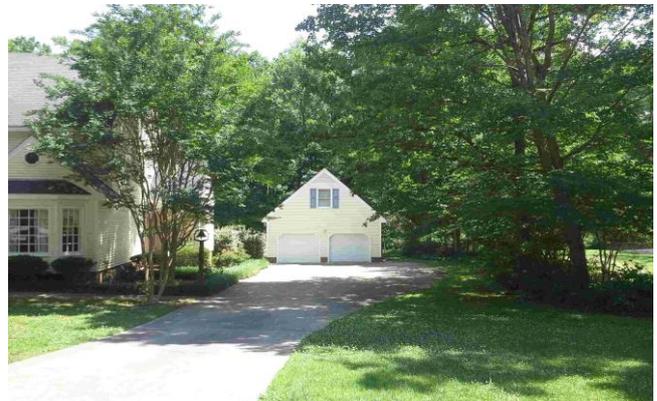
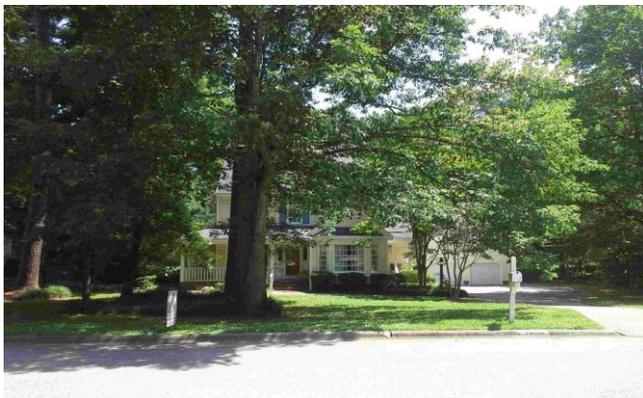
Property Locator / Repetitive Loss#: 3713-10-2721.000
Inspection Date: 6/11/2015 **Inspector:** Scott Gentry
No. of Stories: 3 **Basement:** No
Occupied: Yes **Neighborhood:** Single Family Residential
Fill: Below Street **Elevated:** 1-2 Feet
Grads
Observations: Has detached garage and a shed. No gutters on house. Hvac is on side of house. Street is curb and gutter.
Flooding: Unknown
Flooding Notes:
Land Use: Single-family residential
Land Use Notes:
Adequate Vents Present: Yes
Spoke with: Owner Unavailable
Structure Type: Wood Frame
Structure Type Notes:
Condition of Structure: Good (optional minor repairs)
Foundation Type: Crawlspace floor at or above grade on at least 1 side
Foundation Type Notes:
Condition of Foundation: Good (optional minor repairs)

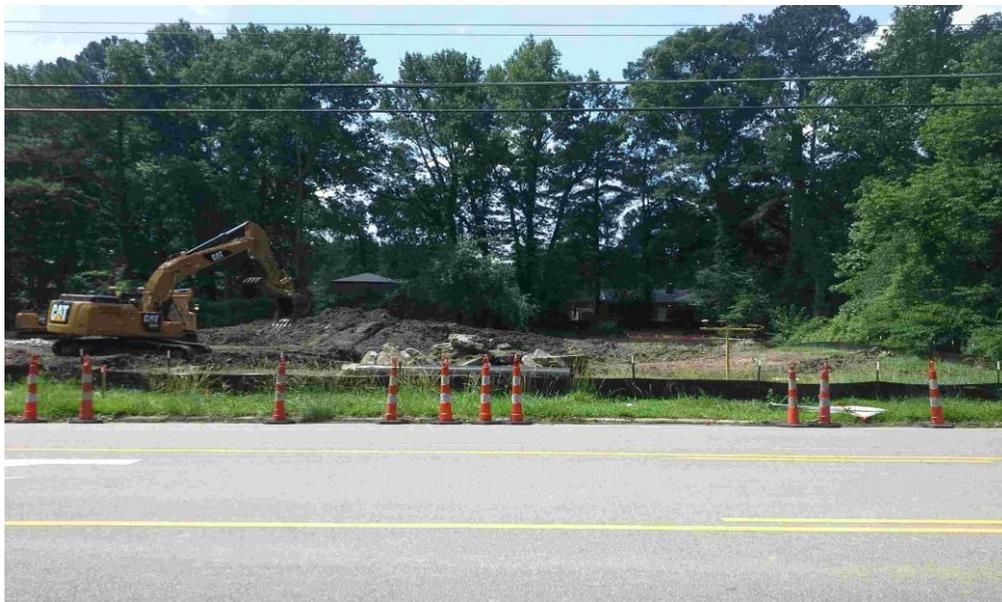
Property Locator / Repetitive Loss#: 3712-29-0134.000
Inspection Date: 6/11/2015 **Inspector:** Scott Gentry
No. of Stories: **Basement:**
Occupied: **Neighborhood:** Single Family Residential
Fill: **Elevated:**
Observations: No structure on property. There was an active demolition/grading effort at the time of the site visit.
Flooding:
Flooding Notes:
Land Use: Unable To Determine
Land Use Notes:
Adequate Vents Present:
Spoke with: Owner Unavailable
Structure Type:
Structure Type Notes:
Condition of Structure:
Foundation Type:
Foundation Type Notes:
Condition of Foundation:

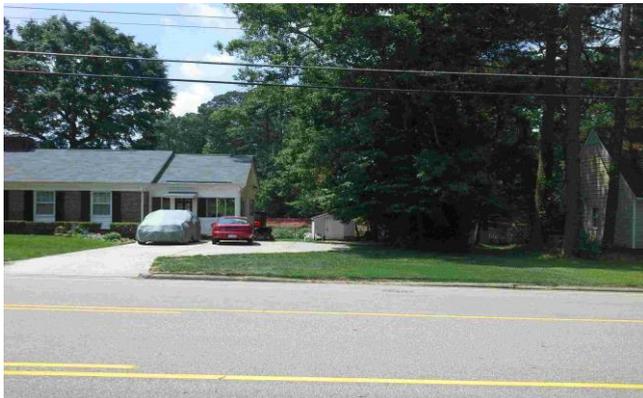
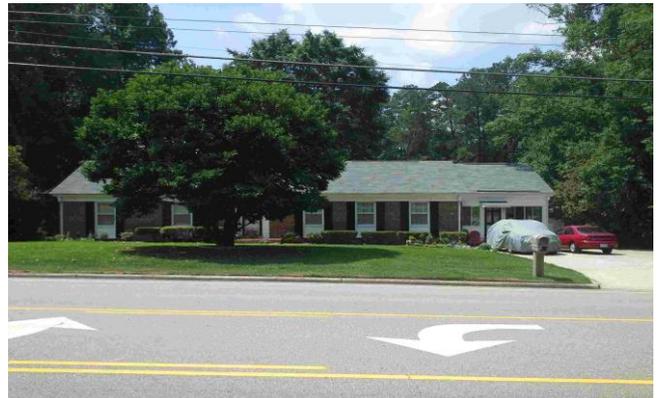
Property Locator / Repetitive Loss#: 3712-29-3176.000

Observations: Has gutters. Has shed. Hvac not seen from street. Observed heavy grading being done on the property behind the house.

Condition of Structure: Good (optional minor repairs)

Foundation Type: Crawlspace floor at or above grade on at least 1 side

Condition of Foundation: Good (optional minor repairs)

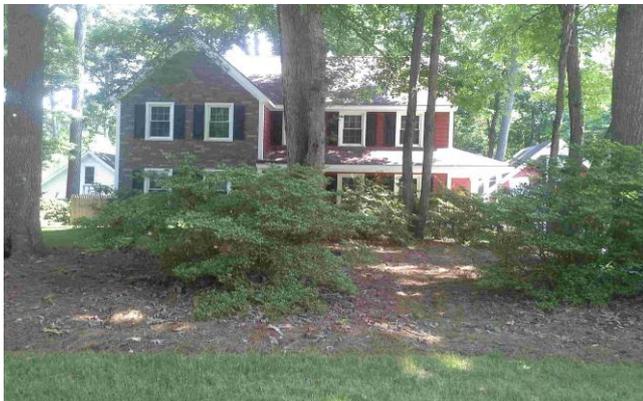
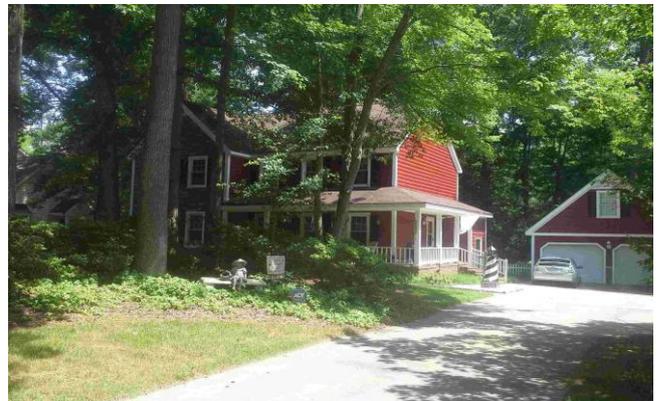
Property Locator / Repetitive Loss#: 3713-10-0876.000
Inspection Date: 6/11/2015 **Inspector:** Yuqi
No. of Stories: 2 **Basement:** No
Occupied: Yes **Neighborhood:** Single Family Residential
Fill: Below Street **Elevated:** 2-3 Feet
Grads
Observations: No gutters, has secondary structure as detached garage.
Unobserved HVAC
Flooding: Unknown
Flooding Notes:
Land Use: Single-family residential
Land Use Notes:
Adequate Vents Present: Yes
Spoke with: Owner Unavailable
Structure Type: Masonry
Structure Type Notes:
Condition of Structure: Good (optional minor repairs)
Foundation Type: Crawlspace floor at or above grade on at least 1 side
Foundation Type Notes:
Condition of Foundation: Good (optional minor repairs)

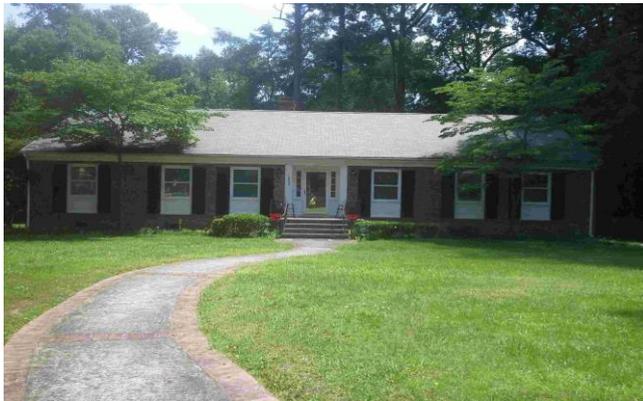
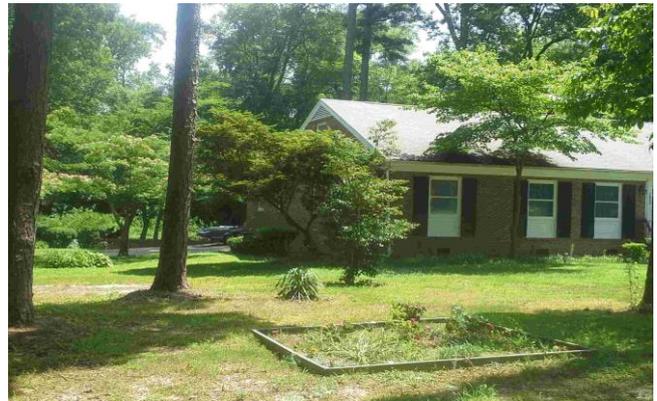
Property Locator / Repetitive Loss#: 3713-10-3623.000
Inspection Date: 6/11/2015 **Inspector:** Yuqi
No. of Stories: 1 **Basement:** No
Occupied: Yes **Neighborhood:** Single Family Residential
Fill: 0-1 Feet **Elevated:** 3-4 Feet
Observations: Has gutters, has HVAC, unobserved secondary structures, observed backyard slope towards low point.
Flooding: Unknown
Flooding Notes:
Land Use: Single-family residential
Land Use Notes:
Adequate Vents Present: Yes
Spoke with: Owner Unavailable
Structure Type: Masonry
Structure Type Notes:
Condition of Structure: Good (optional minor repairs)
Foundation Type: Crawlspace floor at or above grade on at least 1 side
Foundation Type Notes:
Condition of Foundation: Good (optional minor repairs)

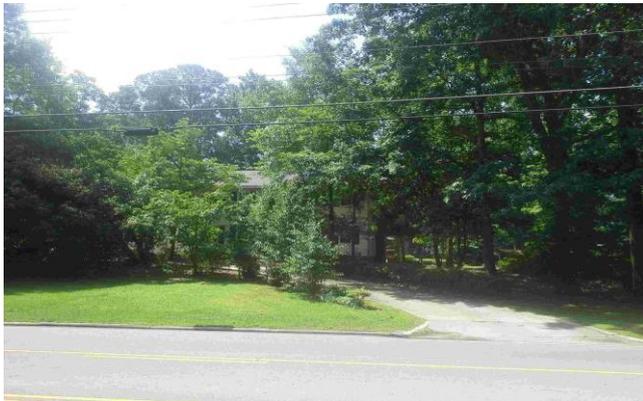
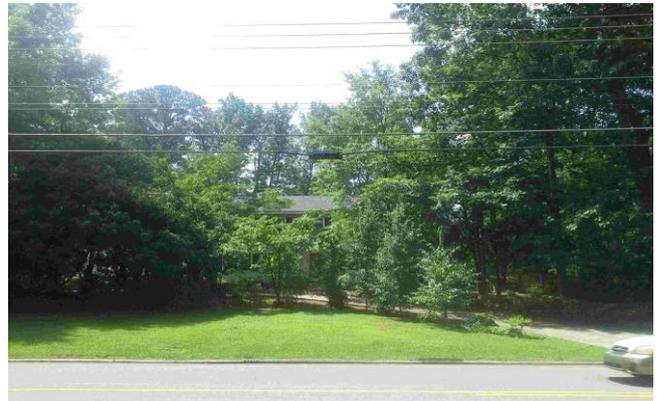
Property Locator / Repetitive Loss#: 3712-19-8183.000
Inspection Date: 6/11/2015 **Inspector:** Yuqi
No. of Stories: 2 **Basement:** No
Occupied: Yes **Neighborhood:** Single Family Residential
Fill: 2-3 Feet **Elevated:** 2-3 Feet
Observations: Visions blocked by lot of vegetation in front yard, unobserved gutters, unobserved HVAC. Fill is greater than 4 feet.
Flooding: Unknown
Flooding Notes:
Land Use: Single-family residential
Land Use Notes:
Adequate Vents Present: Yes
Spoke with: Owner Unavailable
Structure Type: Wood Frame
Structure Type Notes:
Condition of Structure: Good (optional minor repairs)
Foundation Type: Crawlspace floor at or above grade on at least 1 side
Foundation Type Notes:
Condition of Foundation: Good (optional minor repairs)

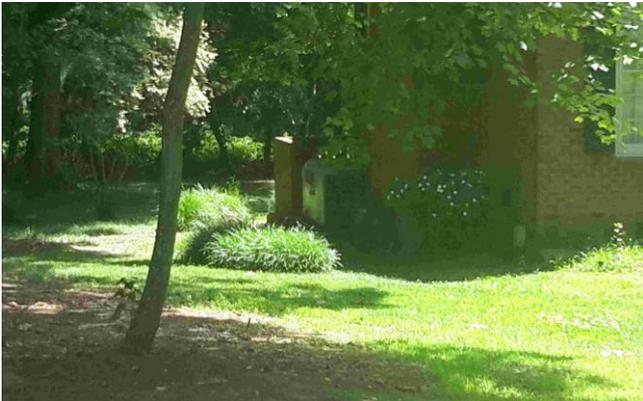
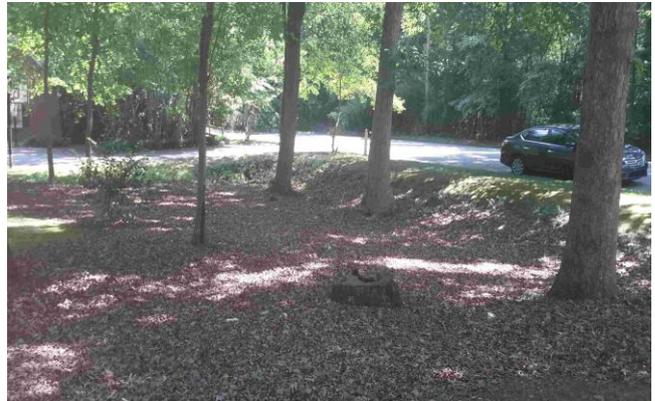
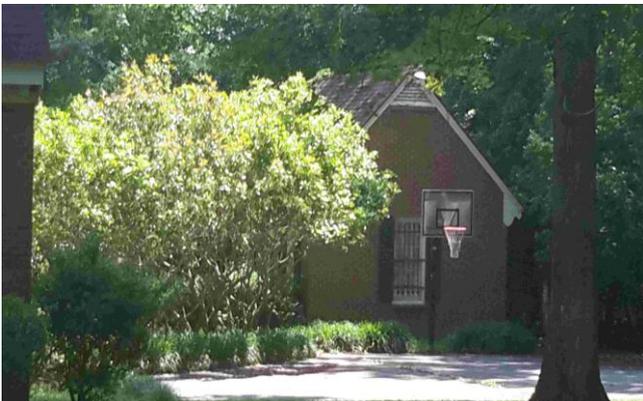
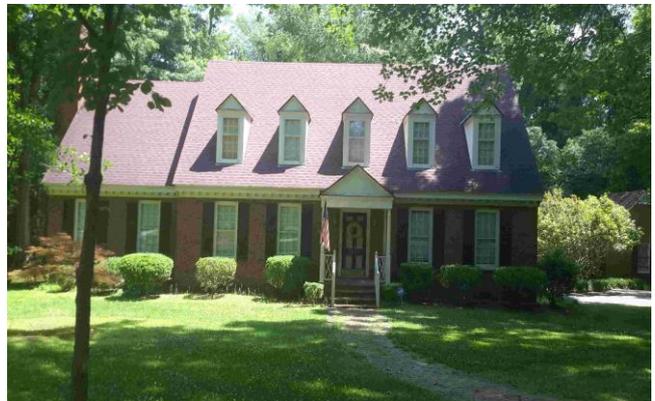
Property Locator / Repetitive Loss#: 3713-10-4523.000
Inspection Date: 6/11/2015 **Inspector:** Alex Magruder
No. of Stories: 2 **Basement:** No
Occupied: Yes **Neighborhood:** Single Family Residential
Fill: Below Street **Elevated:** 2-3 Feet
Grads
Observations: No gutters. Secondary structure. Hvac unit raised 1 foot. Drain to right of property.
Flooding: Unknown
Flooding Notes:
Land Use: Single-family residential
Land Use Notes:
Adequate Vents Present: Yes
Spoke with: Owner Unavailable
Structure Type: Masonry
Structure Type Notes:
Condition of Structure: Good (optional minor repairs)
Foundation Type: Crawlspace floor at or above grade on at least 1 side
Foundation Type Notes:
Condition of Foundation: Good (optional minor repairs)

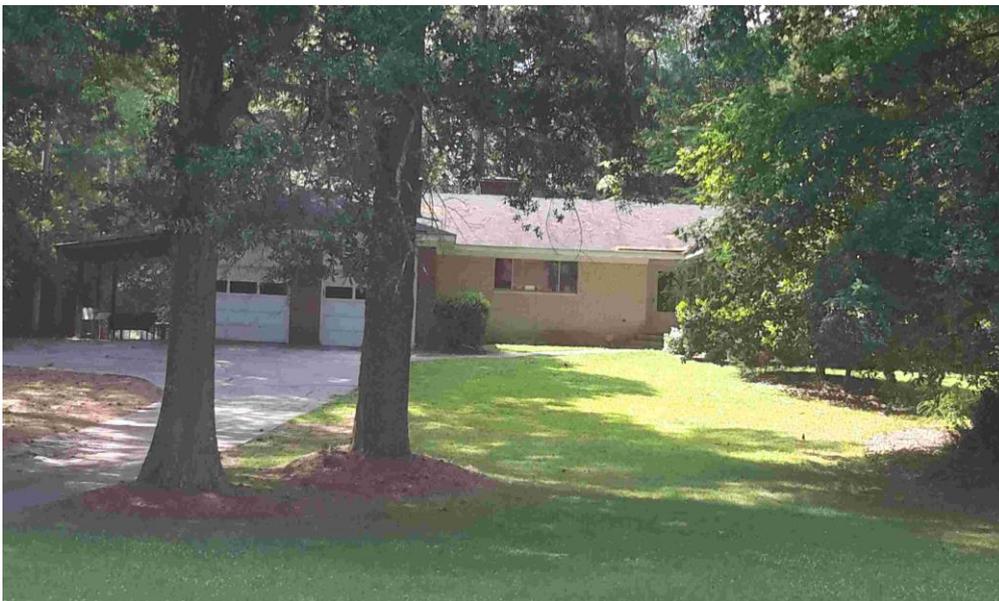
Property Locator / Repetitive Loss#: 3712-19-7143.000
Inspection Date: 6/11/2015 **Inspector:** Alex Magruder
No. of Stories: 1 **Basement:** No
Occupied: Yes **Neighborhood:** Single Family Residential
Fill: 2-3 Feet **Elevated:** 3-4 Feet
Observations: Minimal gutters. Unknown hvac. On hill.
Flooding: Unknown
Flooding Notes:
Land Use: Single-family residential
Land Use Notes:
Adequate Vents Present: Yes
Spoke with: Owner Unavailable
Structure Type: Masonry
Structure Type Notes:
Condition of Structure: Good (optional minor repairs)
Foundation Type: Crawlspace floor at or above grade on at least 1 side
Foundation Type Notes: !
Condition of Foundation: Good (optional minor repairs)

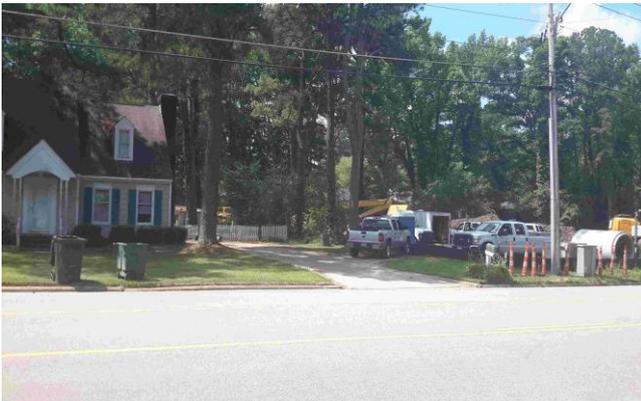
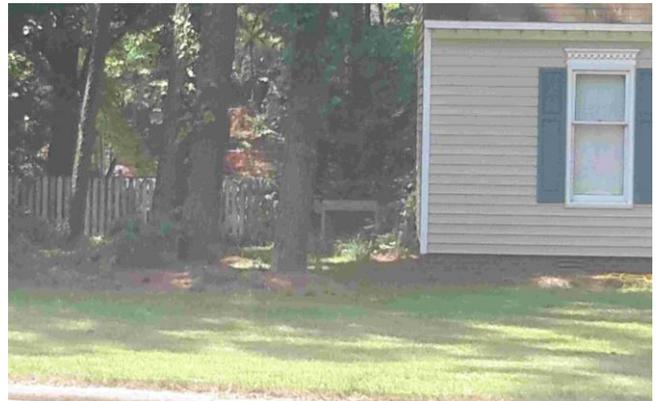
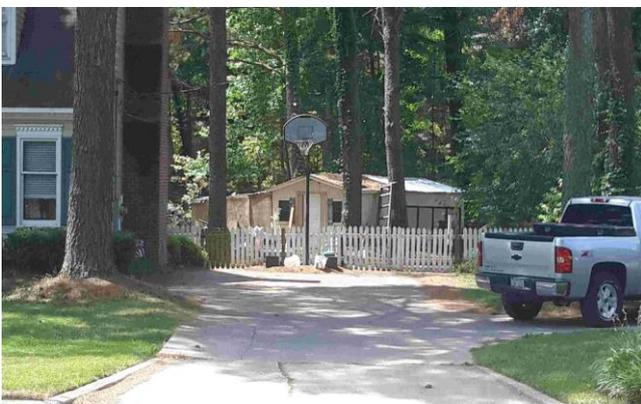
Property Locator / Repetitive Loss#: 3712-29-2156.000
Inspection Date: 6/11/2015 **Inspector:** Alex Magruder
No. of Stories: 2 **Basement:** No
Occupied: Yes **Neighborhood:** Single Family Residential
Fill: 2-3 Feet **Elevated:** 3-4 Feet
Observations: No gutters. Hvac unit on ground. Secondary structure. Construction adjacent and behind property.
Flooding: Unknown
Flooding Notes:
Land Use: Single-family residential
Land Use Notes:
Adequate Vents Present: Yes
Spoke with: Owner Unavailable
Structure Type: Wood Frame
Structure Type Notes:
Condition of Structure: Good (optional minor repairs)
Foundation Type: Crawlspace floor at or above grade on at least 1 side
Foundation Type Notes:
Condition of Foundation: Good (optional minor repairs)

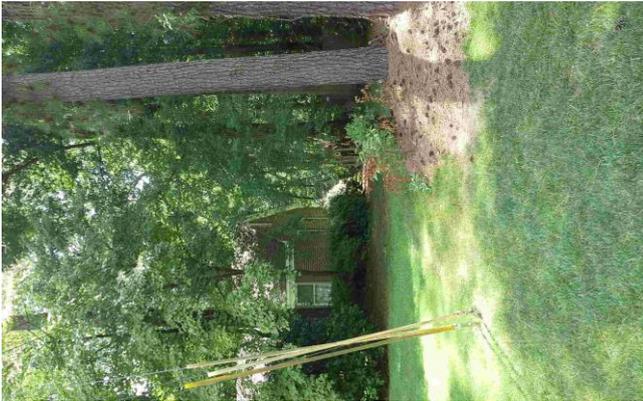
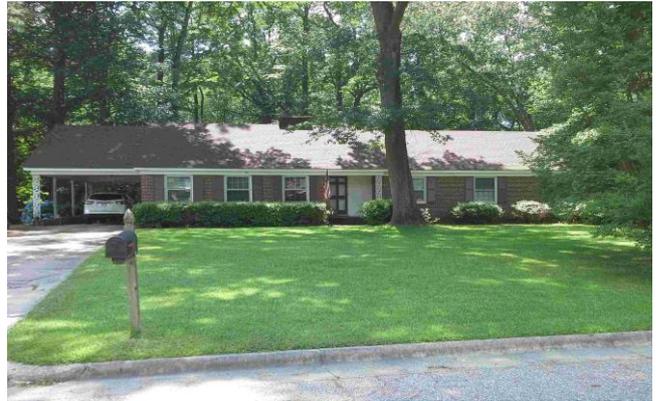
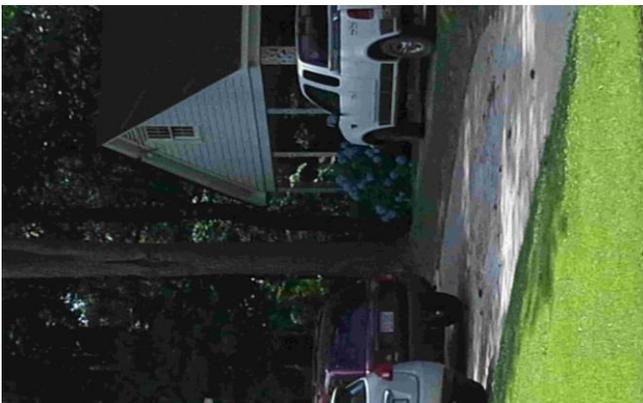
Property Locator / Repetitive Loss#: 3712-58-3588.000
Inspection Date: 6/11/2015 **Inspector:** Scott Gentry
No. of Stories: 1 **Basement:** No
Occupied: Yes **Neighborhood:** Single Family Residential
Fill: 0-1 Feet **Elevated:** 1-2 Feet
Observations: No gutter. Hvac not seen from street. Has shed.
Flooding: Unknown
Flooding Notes:
Land Use: Single-family residential
Land Use Notes:
Adequate Vents Present: Yes
Spoke with: Owner Unavailable
Structure Type: Masonry
Structure Type Notes:
Condition of Structure: Good (optional minor repairs)
Foundation Type: Crawlspace floor at or above grade on at least 1 side
Foundation Type Notes:
Condition of Foundation: Good (optional minor repairs)

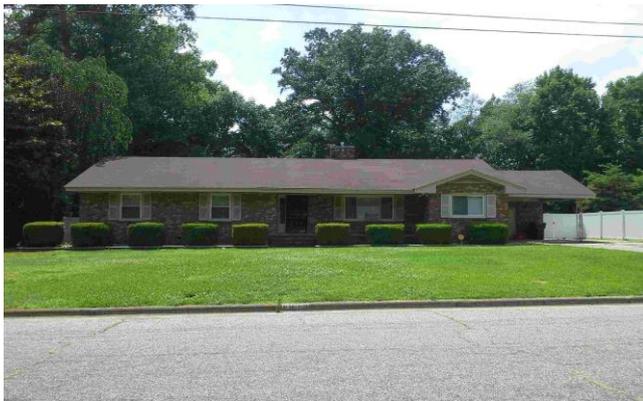
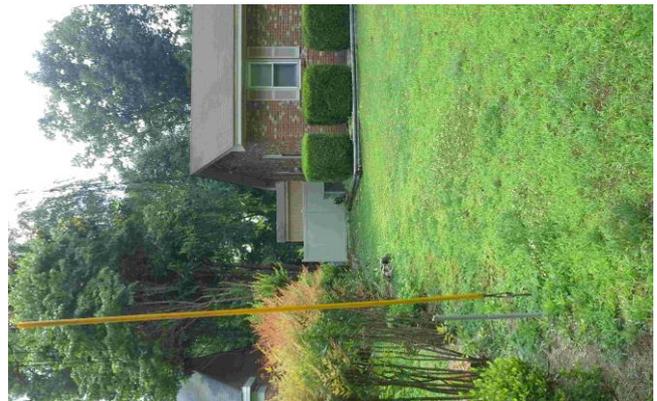
Property Locator / Repetitive Loss#: 3712-58-3971.000
Inspection Date: 6/11/2015 **Inspector:** Scott Gentry
No. of Stories: 1 **Basement:** No
Occupied: Yes **Neighborhood:** Single Family Residential
Fill: 2-3 Feet **Elevated:** 2-3 Feet
Observations: Has shed. Hvac is at grade on side of house. No gutters.
Flooding: Unknown
Flooding Notes:
Land Use: Single-family residential
Land Use Notes:
Adequate Vents Present: Yes
Spoke with: Owner Unavailable
Structure Type: Masonry
Structure Type Notes:
Condition of Structure: Good (optional minor repairs)
Foundation Type: Crawlspace floor at or above grade on at least 1 side
Foundation Type Notes:
Condition of Foundation: Good (optional minor repairs)

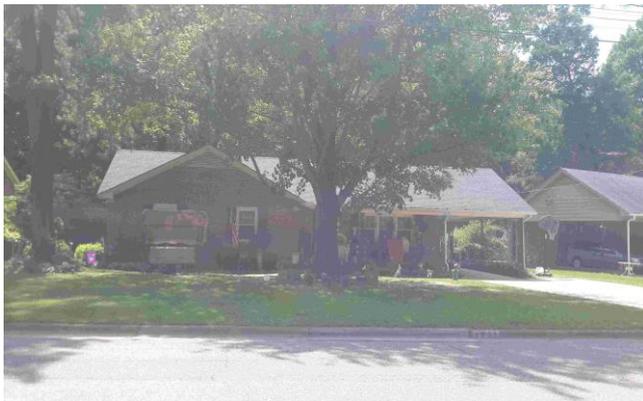
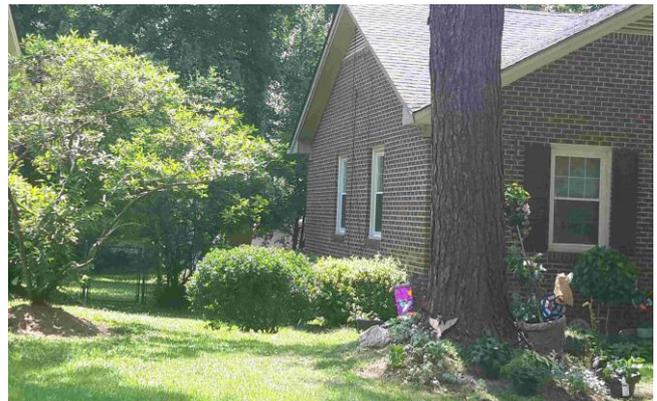
Property Locator / Repetitive Loss#: 3712-59-3218.000
Inspection Date: 6/11/2015 **Inspector:** Yuqi
No. of Stories: 1 **Basement:** No
Occupied: Yes **Neighborhood:** Single Family Residential
Fill: 0-1 Feet **Elevated:** 3-4 Feet
Observations: Has secondary structure, has gutters, unobserved HVAC.
Flooding: Unknown
Flooding Notes:
Land Use: Single-family residential
Land Use Notes:
Adequate Vents Present: Yes
Spoke with: Owner Unavailable
Structure Type: Masonry
Structure Type Notes:
Condition of Structure: Good (optional minor repairs)
Foundation Type: Crawlspace floor at or above grade on at least 1 side
Foundation Type Notes:
Condition of Foundation: Good (optional minor repairs)

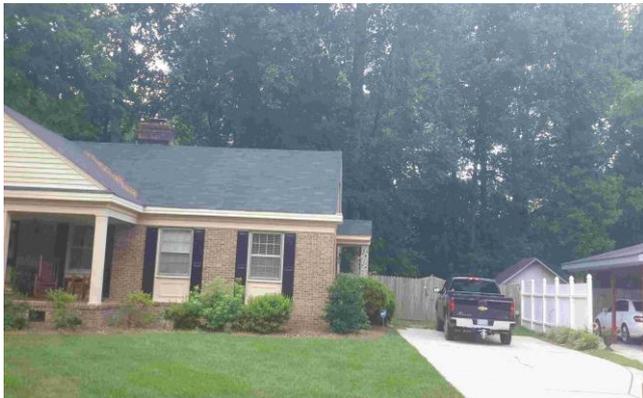
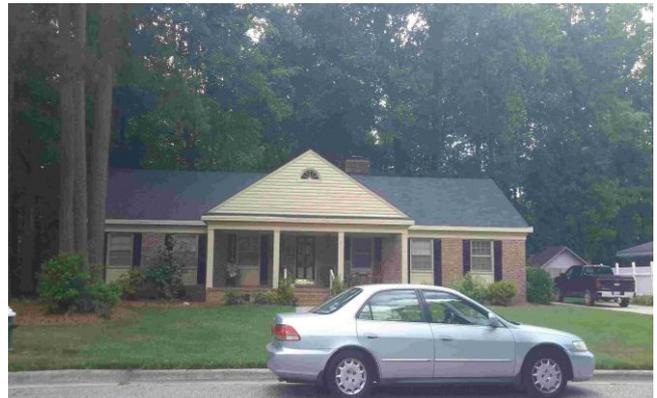
Property Locator / Repetitive Loss#: 3712-58-3679.000
Inspection Date: 6/11/2015 **Inspector:** Yuqi
No. of Stories: 1 **Basement:** No
Occupied: Yes **Neighborhood:** Single Family Residential
Fill: 0-1 Feet **Elevated:** 3-4 Feet
Observations: No gutters, has secondary structure as storage room, unobserved HVAC.
Flooding: Unknown
Flooding Notes:
Land Use: Single-family residential
Land Use Notes:
Adequate Vents Present: Yes
Spoke with: Owner Unavailable
Structure Type: Masonry
Structure Type Notes:
Condition of Structure: Good (optional minor repairs)
Foundation Type: Crawlspace floor at or above grade on at least 1 side
Foundation Type Notes:
Condition of Foundation: Good (optional minor repairs)

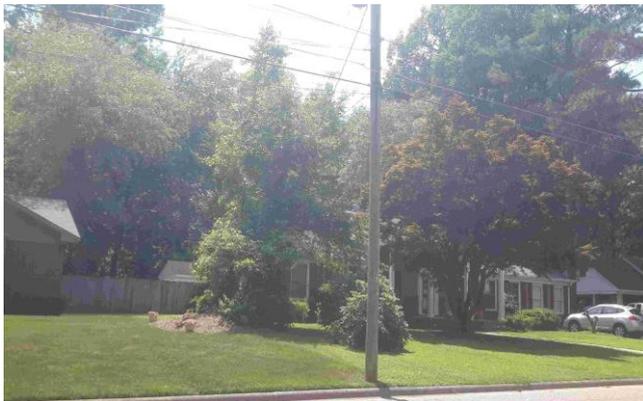
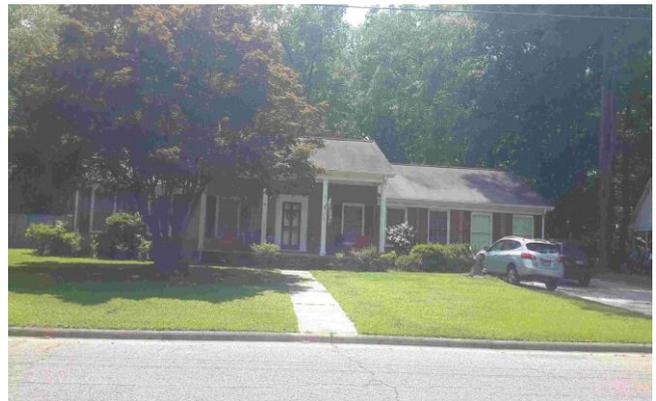
Property Locator / Repetitive Loss#: 3712-58-4468.000
Inspection Date: 6/11/2015 **Inspector:** Yuqi
No. of Stories: 1 **Basement:**
Occupied: Yes **Neighborhood:** Single Family Residential
Fill: 2-3 Feet **Elevated:** 2-3 Feet
Observations: Has gutters, has secondary structure shield, unobserved HVAC.
Flooding: Unknown
Flooding Notes:
Land Use: Single-family residential
Land Use Notes:
Adequate Vents Present: Yes
Spoke with: Owner Unavailable
Structure Type: Masonry
Structure Type Notes:
Condition of Structure: Good (optional minor repairs)
Foundation Type: Crawlspace floor at or above grade on at least 1 side
Foundation Type Notes:
Condition of Foundation: Good (optional minor repairs)

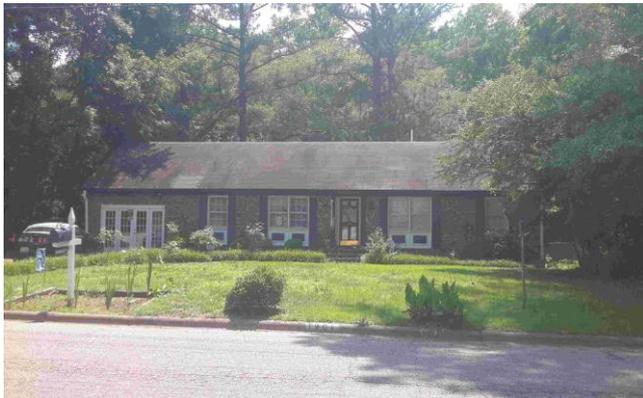
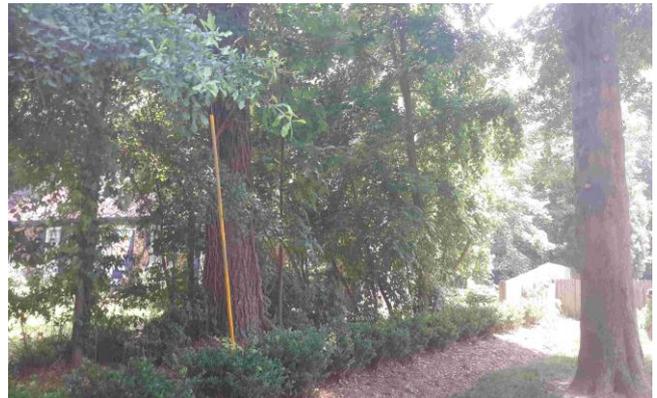
Property Locator / Repetitive Loss#: 3712-58-6321.000
Inspection Date: 6/11/2015 **Inspector:** Yuqi
No. of Stories: 1 **Basement:**
Occupied: Yes **Neighborhood:** Single Family Residential
Fill: 2-3 Feet **Elevated:** 2-3 Feet
Observations: Has gutters, has secondary structure as storage room, unobserved HVAC.
Flooding: Unknown
Flooding Notes:
Land Use: Single-family residential
Land Use Notes:
Adequate Vents Present: Yes
Spoke with: Owner Unavailable
Structure Type: Masonry
Structure Type Notes:
Condition of Structure: Good (optional minor repairs)
Foundation Type: Crawlspace floor at or above grade on at least 1 side
Foundation Type Notes:
Condition of Foundation: Good (optional minor repairs)

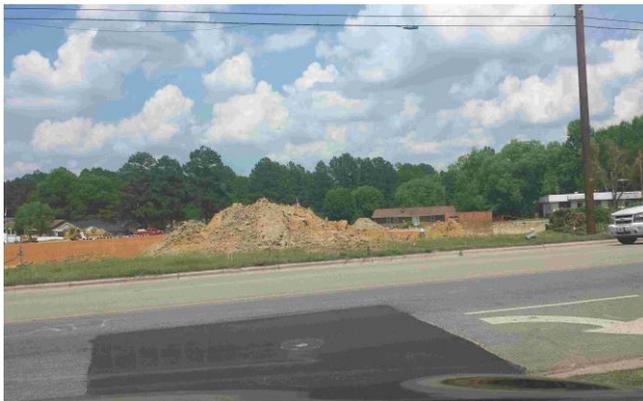
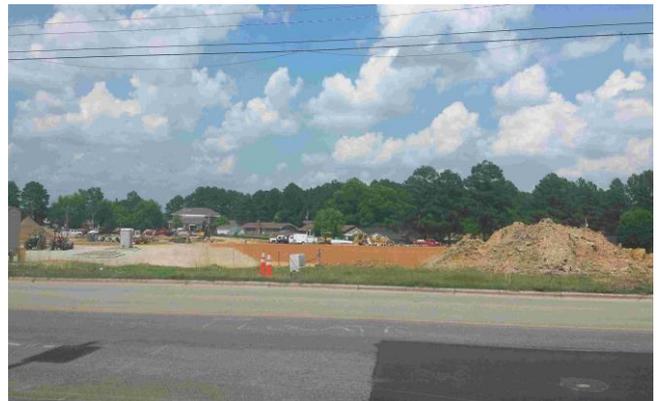
Property Locator / Repetitive Loss#: 3713-70-6386.000
Inspection Date: 6/11/2015 **Inspector:** Alex Magruder
No. of Stories: **Basement:**
Occupied: **Neighborhood:** Commercial
Fill: **Elevated:**
Observations: Under construction.
Flooding: Unknown
Flooding Notes:
Land Use: Commercial
Land Use Notes: Under construction.
Adequate Vents Present:
Spoke with: Owner Unavailable
Structure Type:
Structure Type Notes:
Condition of Structure:
Foundation Type:
Foundation Type Notes:
Condition of Foundation:

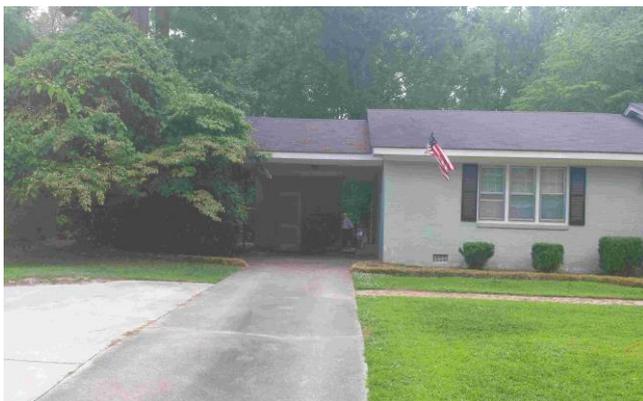
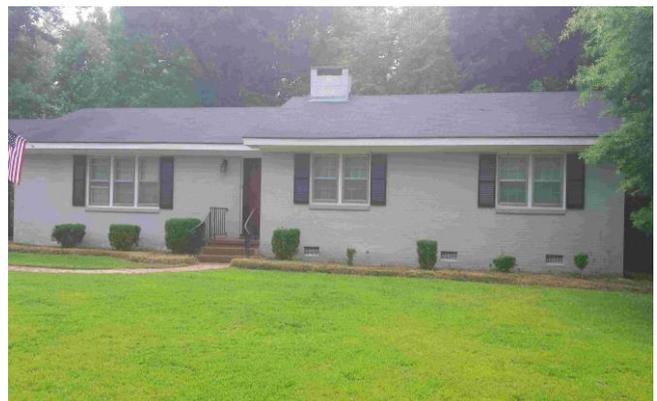
Property Locator / Repetitive Loss#: 3712-59-3101.000
Inspection Date: 6/11/2015 **Inspector:** Alex Magruder
No. of Stories: 1 **Basement:** No
Occupied: Yes **Neighborhood:** Single Family Residential
Fill: 0-1 Feet **Elevated:** 1-2 Feet
Observations: No guttering. Secondary structure. Hvac unit unknown.
Flooding: No
Flooding Notes: Owner states no flooding.
Land Use: Single-family residential
Land Use Notes:
Adequate Vents Present: Yes
Spoke with: Owner/Occupant
Structure Type: Masonry
Structure Type Notes:
Condition of Structure: Good (optional minor repairs)
Foundation Type: Crawlspace floor at or above grade on at least 1 side
Foundation Type Notes:
Condition of Foundation: Good (optional minor repairs)

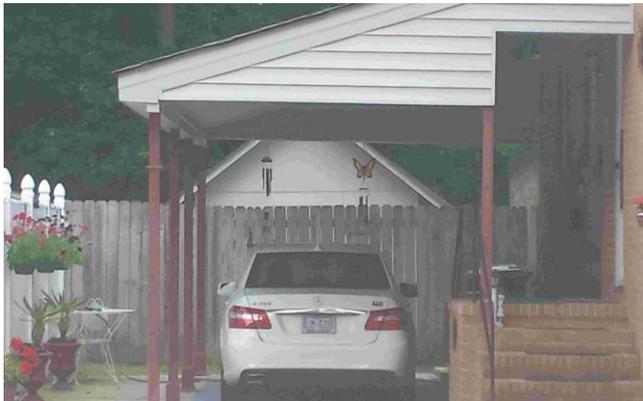
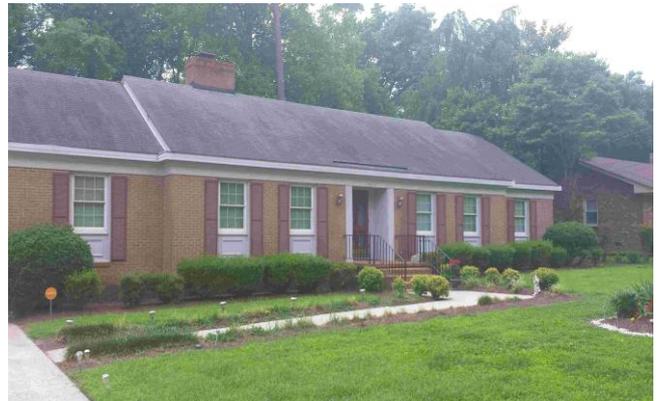
Property Locator / Repetitive Loss#: 3712-58-3871.000
Inspection Date: 6/11/2015 **Inspector:** Alex Magruder
No. of Stories: 1 **Basement:** No
Occupied: Yes **Neighborhood:** Single Family Residential
Fill: 0-1 Feet **Elevated:** 1-2 Feet
Observations: No guttering. Hvac unit unknown. Secondary structure. Fence blocking view.
Flooding: Unknown
Flooding Notes:
Land Use: Single-family residential
Land Use Notes:
Adequate Vents Present: Yes
Spoke with: Owner Unavailable
Structure Type: Masonry
Structure Type Notes:
Condition of Structure: Good (optional minor repairs)
Foundation Type: Crawlspace floor at or above grade on at least 1 side
Foundation Type Notes:
Condition of Foundation: Good (optional minor repairs)

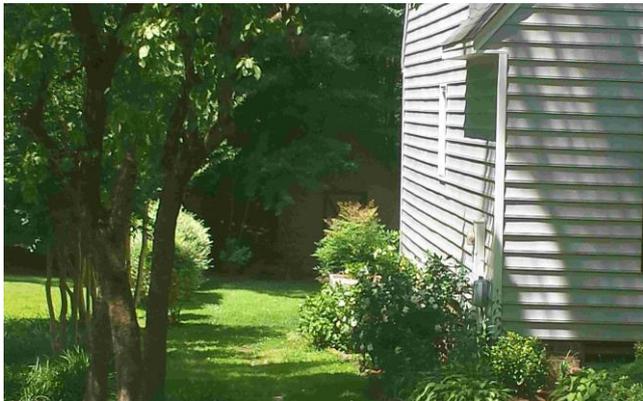
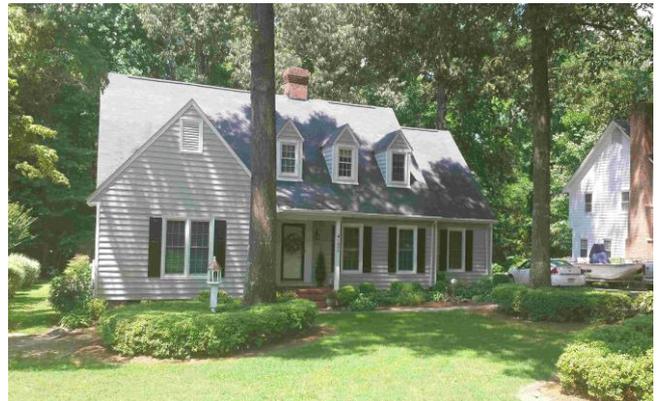
Property Locator / Repetitive Loss#: 3712-58-3156.000
Inspection Date: 6/11/2015 **Inspector:** Alex Magruder
No. of Stories: 2 **Basement:** No
Occupied: Yes **Neighborhood:** Single Family Residential
Fill: Below Street **Elevated:** 1-2 Feet
Grads
Observations: Partial guttering. Hvac unit on ground. Secondary structure.
Flooding: Unknown
Flooding Notes:
Land Use: Single-family residential
Land Use Notes:
Adequate Vents Present: Yes
Spoke with: Owner Unavailable
Structure Type: Wood Frame
Structure Type Notes:
Condition of Structure: Good (optional minor repairs)
Foundation Type: Crawlspace floor at or above grade on at least 1 side
Foundation Type Notes:
Condition of Foundation: Good (optional minor repairs)

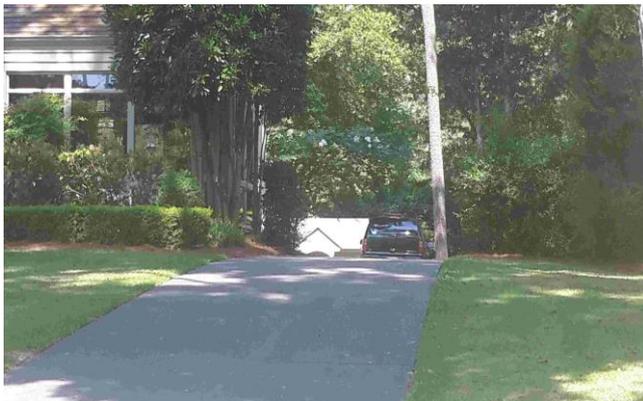
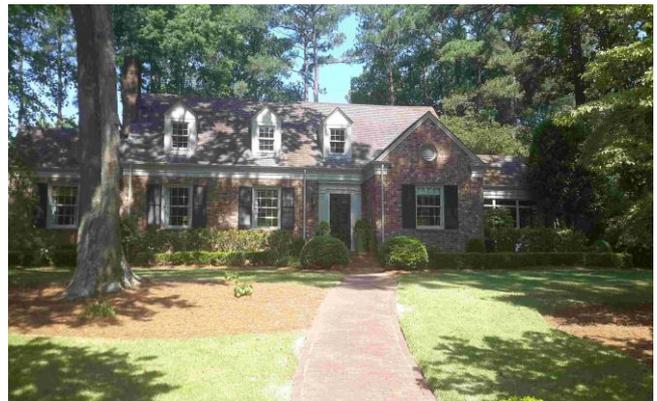
Property Locator / Repetitive Loss#: 3712-36-3565.000
Inspection Date: 6/11/2015 **Inspector:** Alex Magruder
No. of Stories: 2 **Basement:** No
Occupied: Yes **Neighborhood:** Single Family Residential
Fill: 2-3 Feet **Elevated:** 3-4 Feet
Observations: Has gutters. Unknown hvac. Secondary structure.
Flooding: Unknown
Flooding Notes:
Land Use: Single-family residential
Land Use Notes:
Adequate Vents Present: Yes
Spoke with: Owner Unavailable
Structure Type: Masonry
Structure Type Notes:
Condition of Structure: Good (optional minor repairs)
Foundation Type: Crawlspace floor at or above grade on at least 1 side
Foundation Type Notes:
Condition of Foundation: Good (optional minor repairs)
