REPETITIVE LOSS AREA ANALYSIS

City of Wilson, North Carolina
Planning & Development Services

Prepared by:
Amec Foster Wheeler
Environment & Infrastructure, Inc.

October 2015

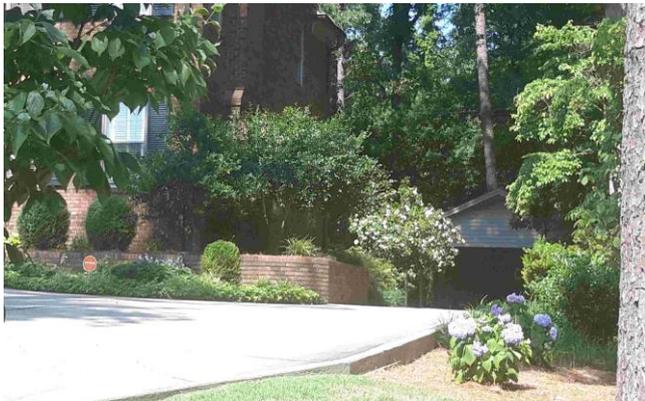
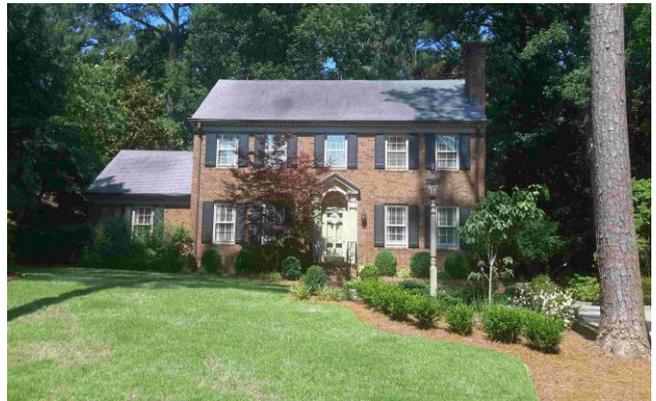
Property Locator / Repetitive Loss#: 3712-36-3775.000
Inspection Date: 6/11/2015 **Inspector:** Alex Magruder
No. of Stories: 2 **Basement:** No
Occupied: Yes **Neighborhood:** Single Family Residential
Fill: 2-3 Feet **Elevated:** 4-6 Feet
Observations: Has gutters. Unknown hvac unit. Secondary structure. House on hill.
Flooding: Unknown
Flooding Notes:
Land Use: Single-family residential
Land Use Notes:
Adequate Vents Present: Yes
Spoke with: Owner Unavailable
Structure Type: Masonry
Structure Type Notes:
Condition of Structure: Good (optional minor repairs)
Foundation Type: Crawlspace floor at or above grade on at least 1 side
Foundation Type Notes:
Condition of Foundation: Good (optional minor repairs)

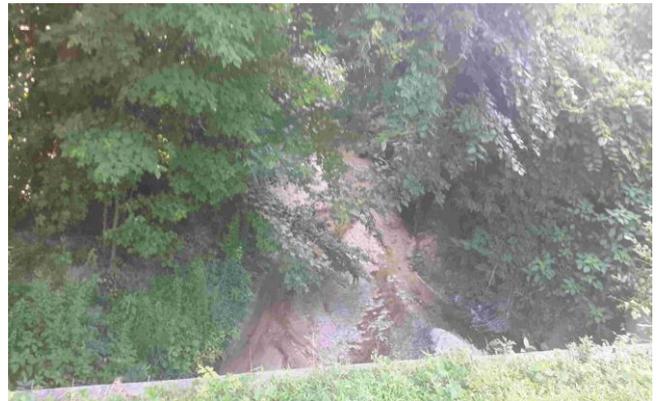
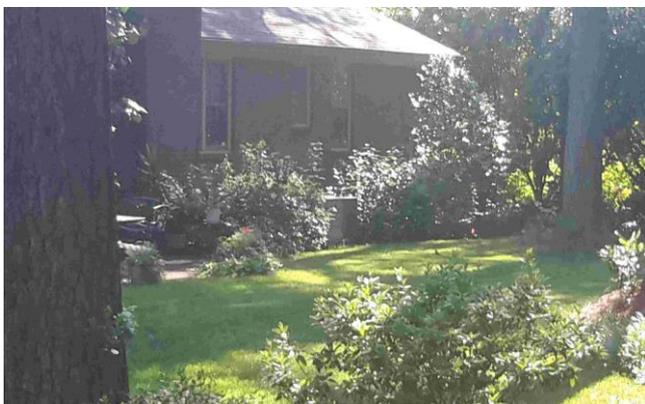
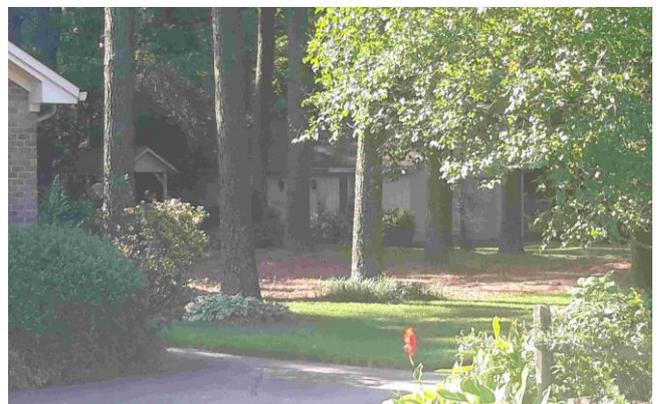
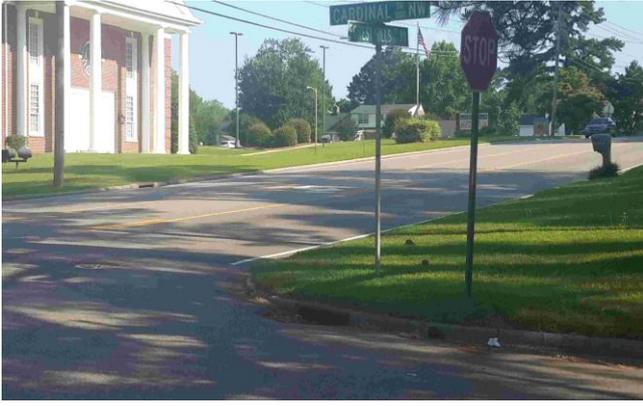
Property Locator / Repetitive Loss#: 3712-16-0799.000
Inspection Date: 6/11/2015 **Inspector:** Alex Magruder
No. of Stories: 1 **Basement:** No
Occupied: Yes **Neighborhood:** Single Family Residential
Fill: 0-1 Feet **Elevated:** 1-2 Feet
Observations: Has gutters. Has Hvac. Has secondary detached garage. Has channel adjacent. Large amount of water coming from main street.
Flooding: Unknown
Flooding Notes:
Land Use: Single-family residential
Land Use Notes:
Adequate Vents Present: Yes
Spoke with: Neighbor
Structure Type: Masonry
Structure Type Notes:
Condition of Structure: Good (optional minor repairs)
Foundation Type: Crawlspace floor at or above grade on at least 1 side
Foundation Type Notes:
Condition of Foundation: Good (optional minor repairs)

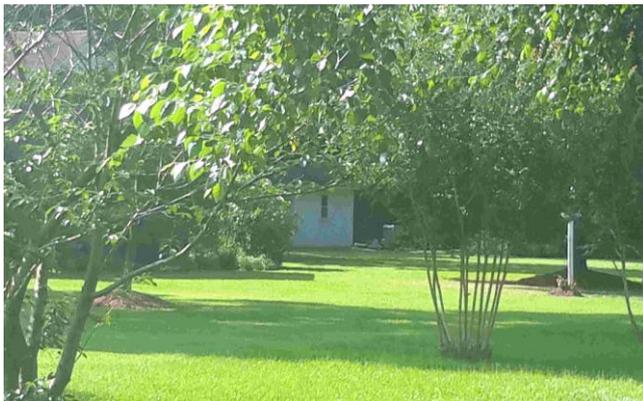
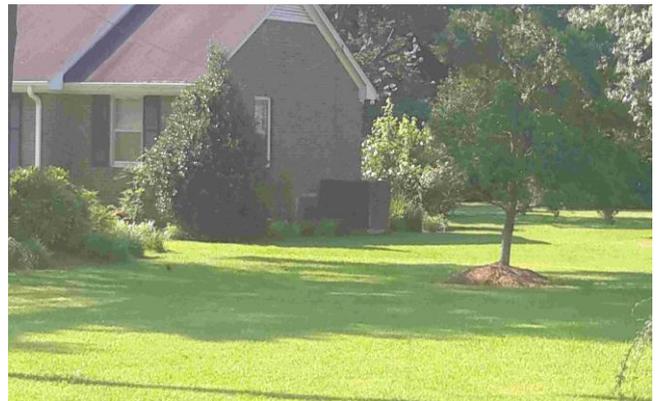
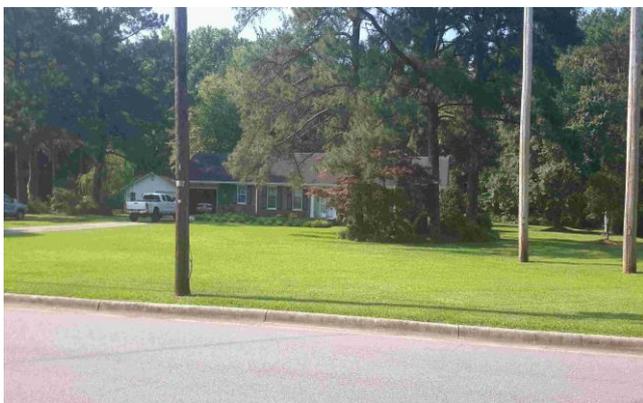
Property Locator / Repetitive Loss#: 3712-16-5726.000
Inspection Date: 6/11/2015 **Inspector:** Alex Magruder
No. of Stories: 1 **Basement:** No
Occupied: Yes **Neighborhood:** Single Family Residential
Fill: 0-1 Feet **Elevated:** 2-3 Feet
Observations: Has gutters. Has hvac on ground. Has secondary structure.
Flooding: Unknown
Flooding Notes:
Land Use: Single-family residential
Land Use Notes:
Adequate Vents Present: Yes
Spoke with: Neighbor
Structure Type: Masonry
Structure Type Notes:
Condition of Structure: Good (optional minor repairs)
Foundation Type: Crawlspace floor at or above grade on at least 1 side
Foundation Type Notes:
Condition of Foundation: Good (optional minor repairs)

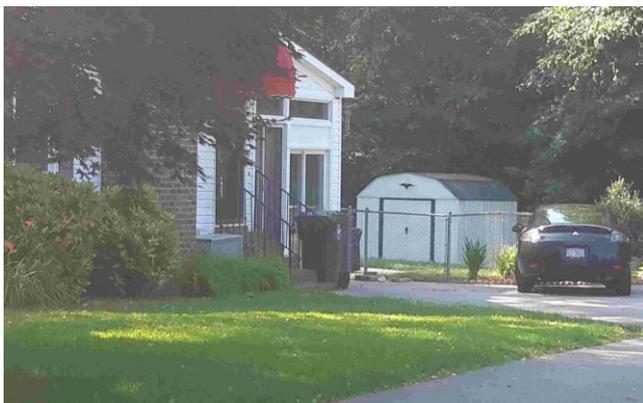
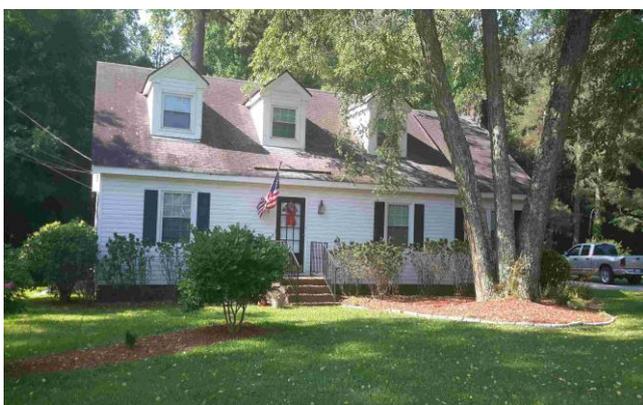
Property Locator / Repetitive Loss#: 3712-16-9843.000
Inspection Date: 6/11/2015 **Inspector:** Alex Magruder
No. of Stories: 2 **Basement:** No
Occupied: Yes **Neighborhood:** Single Family Residential
Fill: 0-1 Feet **Elevated:** 3-4 Feet
Observations: No gutters. Hvac unit on ground. Secondary structure.
Flooding: Unknown
Flooding Notes:
Land Use: Single-family residential
Land Use Notes:
Adequate Vents Present: Yes
Spoke with: Owner Unavailable
Structure Type: Wood Frame
Structure Type Notes:
Condition of Structure: Good (optional minor repairs)
Foundation Type: Crawlspace floor at or above grade on at least 1 side
Foundation Type Notes:
Condition of Foundation: Good (optional minor repairs)

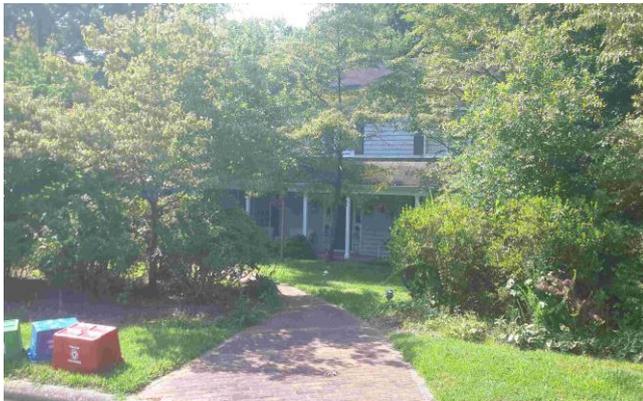
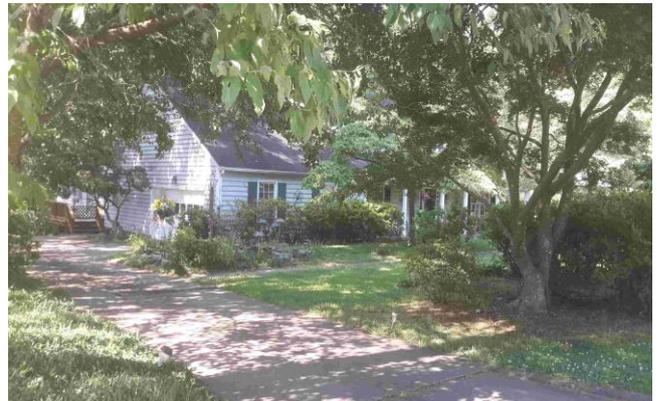
Property Locator / Repetitive Loss#: 3712-27-7201.000
Inspection Date: 6/11/2015 **Inspector:** Alex Magruder
No. of Stories: 2 **Basement:** Unknown
Occupied: Yes **Neighborhood:** Single Family Residential
Fill: Below Street **Elevated:** At Grade
Grads
Observations: Has gutters. Vegetation blocking view.
Flooding: Unknown
Flooding Notes:
Land Use: Single-family residential
Land Use Notes:
Adequate Vents Present: Unknown
Spoke with: Owner Unavailable
Structure Type: Wood Frame
Structure Type Notes:
Condition of Structure: Good (optional minor repairs)
Foundation Type: Unable to determine
Foundation Type Notes:
Condition of Foundation: Good (optional minor repairs)

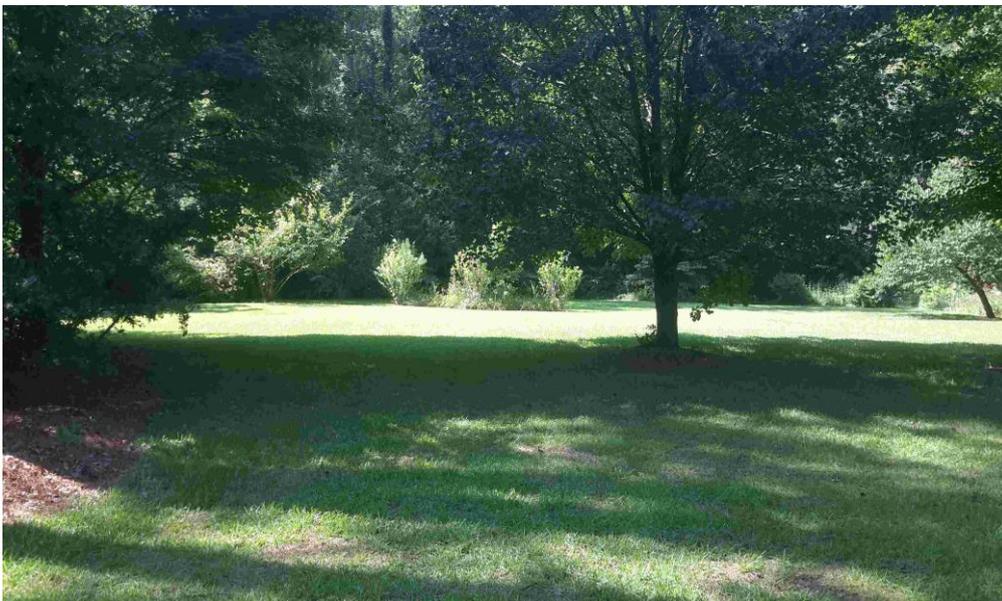
Property Locator / Repetitive Loss#: 3712-37-3197.000
Inspection Date: 6/11/2015 **Inspector:** Alex Magruder
No. of Stories: **Basement:**
Occupied: **Neighborhood:**
Fill: **Elevated:**
Observations: No building on property.
Flooding:
Flooding Notes:
Land Use:
Land Use Notes:
Adequate Vents Present:
Spoke with:
Structure Type:
Structure Type Notes:
Condition of Structure:
Foundation Type:
Foundation Type Notes:
Condition of Foundation:

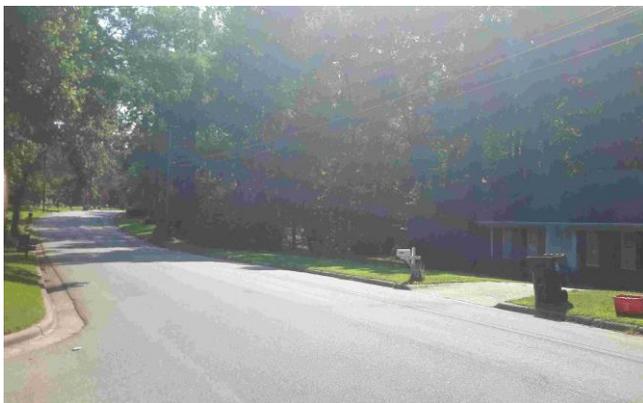
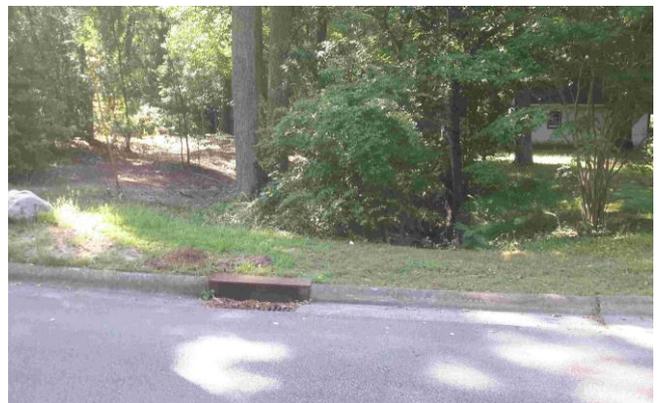
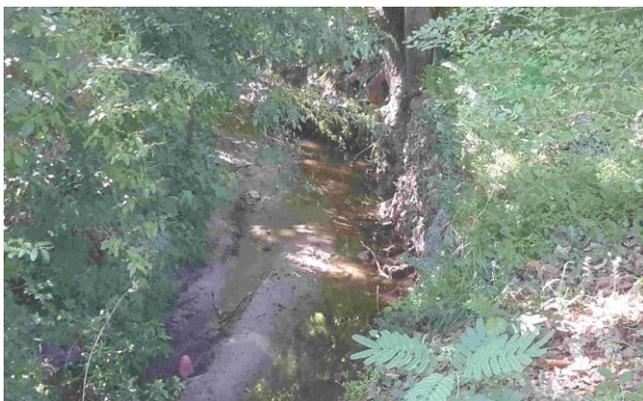
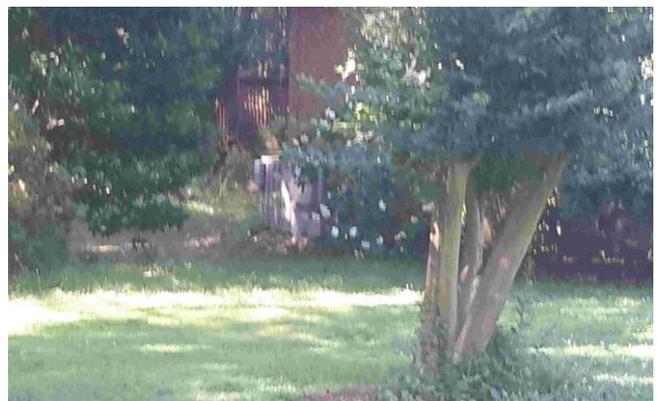
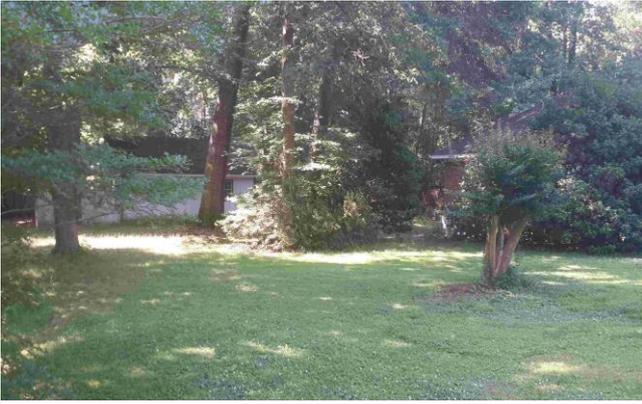
Condition of Structure: Good (optional minor repairs)

Foundation Type: Crawlspace floor at or above grade on at least 1 side

Condition of Foundation: Good (optional minor repairs)

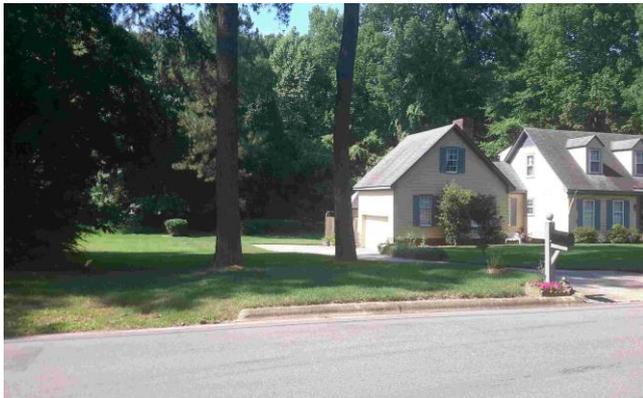
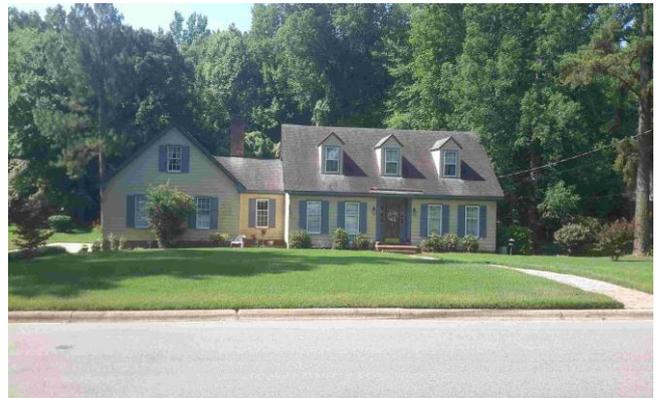
Property Locator / Repetitive Loss#: 3712-37-0158.000
Inspection Date: 6/11/2015 **Inspector:** Alex Magruder
No. of Stories: 2 **Basement:** No
Occupied: Yes **Neighborhood:** Single Family Residential
Fill: Below Street **Elevated:** 0-1 Feet
Grads
Observations: No gutters. Unknown hvac. Creek visible behind building.
Flooding: Unknown
Flooding Notes:
Land Use: Single-family residential
Land Use Notes:
Adequate Vents Present: Yes
Spoke with: Owner Unavailable
Structure Type: Wood Frame
Structure Type Notes:
Condition of Structure: Good (optional minor repairs)
Foundation Type: Crawlspace floor at or above grade on at least 1 side
Foundation Type Notes:
Condition of Foundation: Good (optional minor repairs)

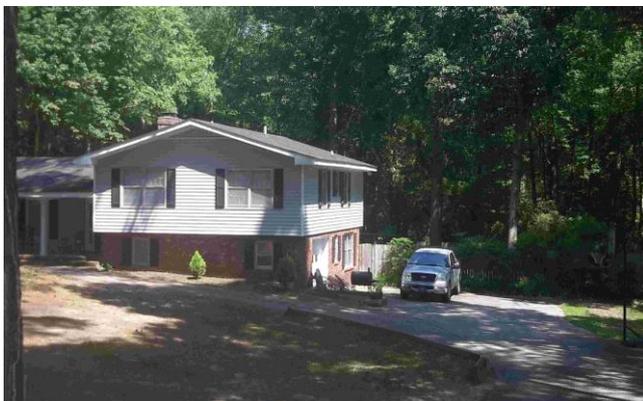
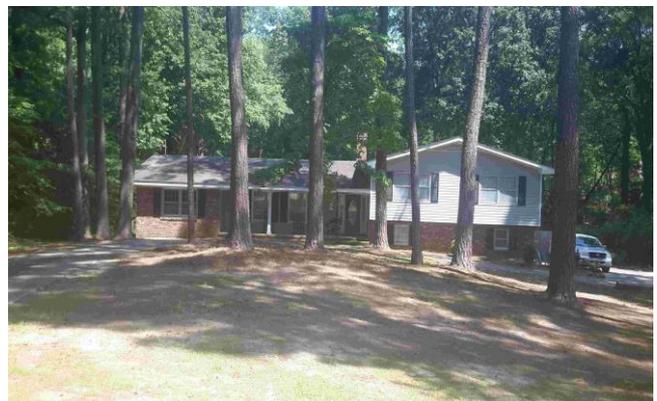
Property Locator / Repetitive Loss#: 3712-26-4888.000
Inspection Date: 6/11/2015 **Inspector:** Alex Magruder
No. of Stories: 2 **Basement:** Yes
Occupied: Yes **Neighborhood:** Single Family Residential
Fill: Below Street **Elevated:** 0-1 Feet
Grads
Observations: No gutters. Pool in backyard. Unknown hvac. Fence blocking view. Stream In backyard.
Flooding: Unknown
Flooding Notes:
Land Use: Single-family residential
Land Use Notes:
Adequate Vents Present: Unknown
Spoke with: Owner Unavailable
Structure Type: Masonry
Structure Type Notes:
Condition of Structure: Good (optional minor repairs)
Foundation Type: Unable to determine
Foundation Type Notes:
Condition of Foundation: Good (optional minor repairs)

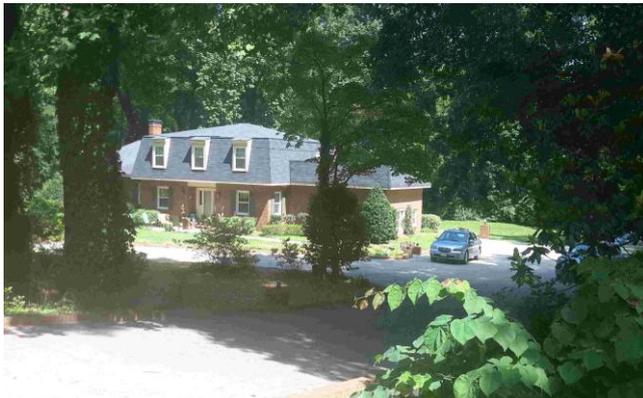
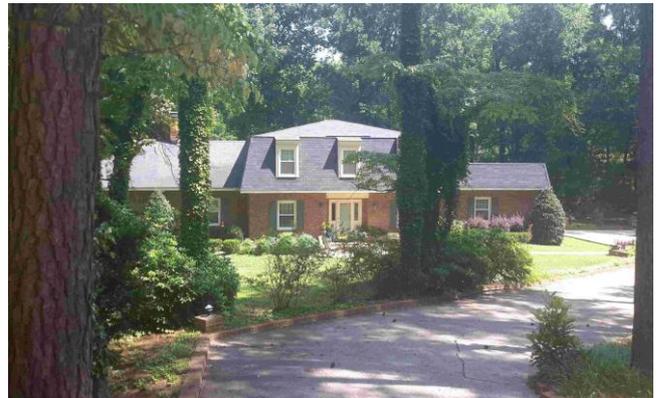
Property Locator / Repetitive Loss#: 3712-26-6994.000
Inspection Date: 6/11/2015 **Inspector:** Alex Magruder
No. of Stories: 2 **Basement:** No
Occupied: Yes **Neighborhood:** Single Family Residential
Fill: Below Street **Elevated:** 1-2 Feet
Grads
Observations: No gutters. Unknown hvac. Stream in behind house.
Flooding: Unknown
Flooding Notes:
Land Use: Single-family residential
Land Use Notes:
Adequate Vents Present: Yes
Spoke with: Owner Unavailable
Structure Type: Masonry
Structure Type Notes:
Condition of Structure: Good (optional minor repairs)
Foundation Type: Crawlspace floor at or above grade on at least 1 side
Foundation Type Notes:
Condition of Foundation: Good (optional minor repairs)

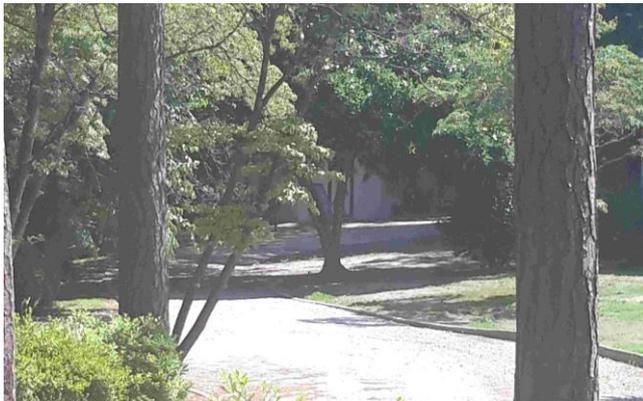
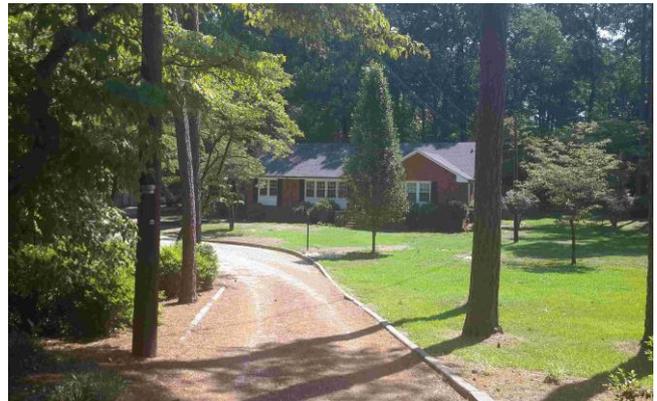
Property Locator / Repetitive Loss#: 3712-36-1656.000
Inspection Date: 6/11/2015 **Inspector:** Alex Magruder
No. of Stories: 1 **Basement:** No
Occupied: Yes **Neighborhood:** Single Family Residential
Fill: Below Street **Elevated:** 4-6 Feet
Grads
Observations: Has gutters. Secondary shed. Unknown hvac.
Flooding: Unknown
Flooding Notes:
Land Use: Single-family residential
Land Use Notes:
Adequate Vents Present: Yes
Spoke with: Owner Unavailable
Structure Type: Masonry
Structure Type Notes:
Condition of Structure: Good (optional minor repairs)
Foundation Type: Crawlspace floor at or above grade on at least 1 side
Foundation Type Notes:
Condition of Foundation: Good (optional minor repairs)

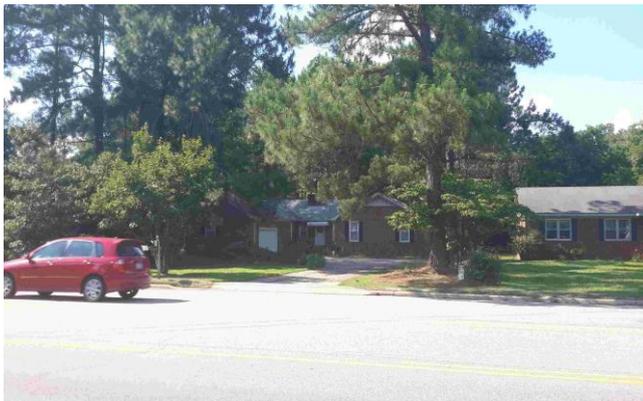
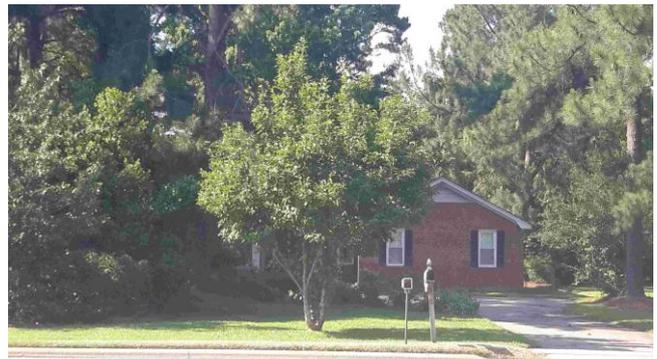
Property Locator / Repetitive Loss#: 3712-34-3024.000
Inspection Date: 6/11/2015 **Inspector:** Yuqi
No. of Stories: 1 **Basement:**
Occupied: Yes **Neighborhood:** Single Family Residential
Fill: 0-1 Feet **Elevated:** 3-4 Feet
Observations: Visions are blocked by vegetation, has HVAC,
Flooding: Unknown
Flooding Notes:
Land Use: Single-family residential
Land Use Notes:
Adequate Vents Present: Yes
Spoke with: Owner Unavailable
Structure Type: Masonry
Structure Type Notes:
Condition of Structure: Good (optional minor repairs)
Foundation Type: Crawlspace floor at or above grade on at least 1 side
Foundation Type Notes:
Condition of Foundation: Good (optional minor repairs)

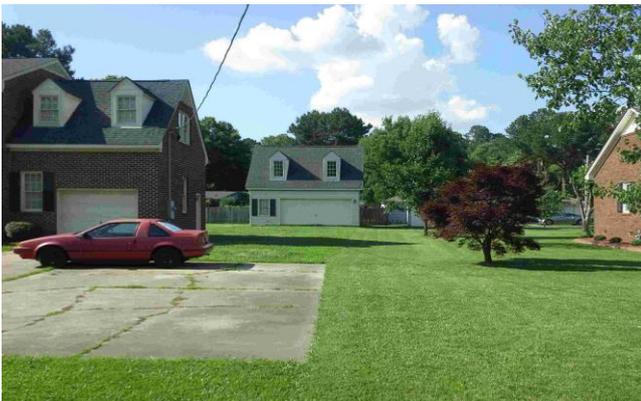
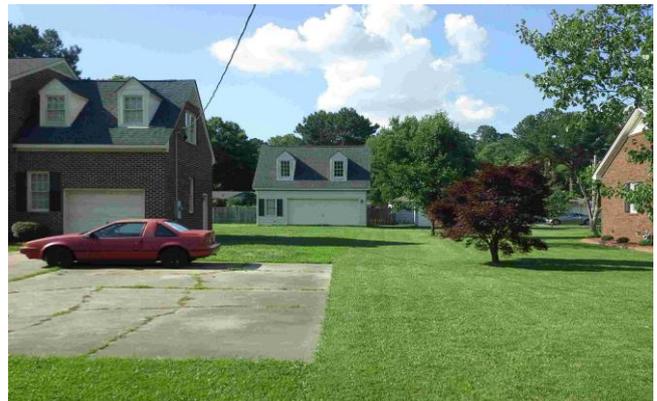
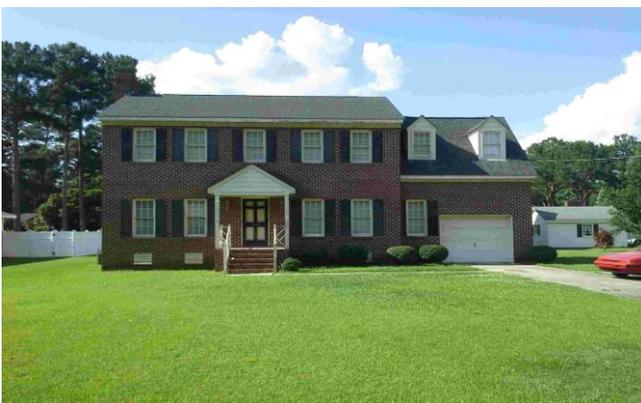
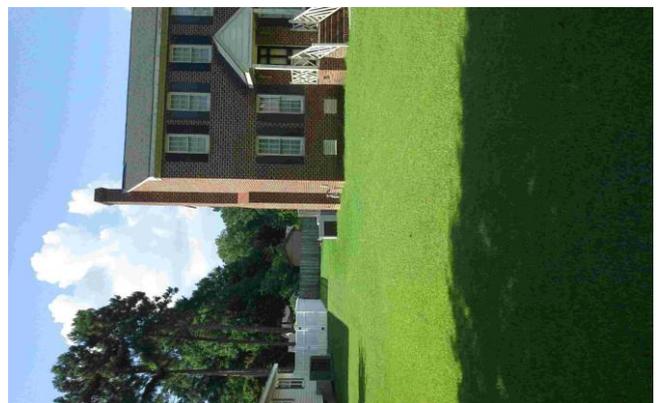
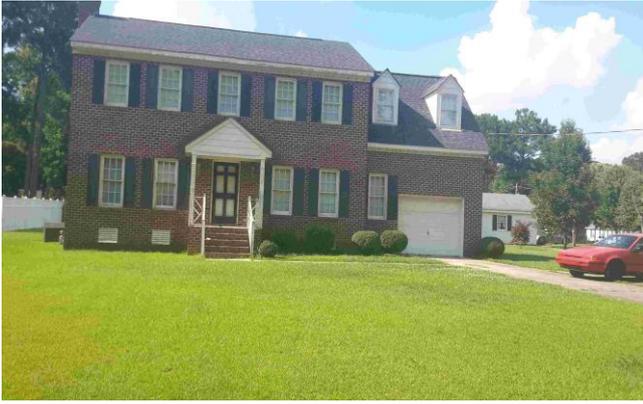
Property Locator / Repetitive Loss#: 3712-34-9041.000
Inspection Date: 6/11/2015 **Inspector:** Yuqi
No. of Stories: 2 **Basement:** Unknown
Occupied: Yes **Neighborhood:** Single Family Residential
Fill: 2-3 Feet **Elevated:** 4-6 Feet
Observations: Has HVAC, has
Flooding: Unknown
Flooding Notes:
Land Use: Single-family residential
Land Use Notes:
Adequate Vents Present: Yes
Spoke with: Owner Unavailable
Structure Type: Masonry
Structure Type Notes:
Condition of Structure: Good (optional minor repairs)
Foundation Type: Crawlspace floor at or above grade on at least 1 side
Foundation Type Notes:
Condition of Foundation: Good (optional minor repairs)

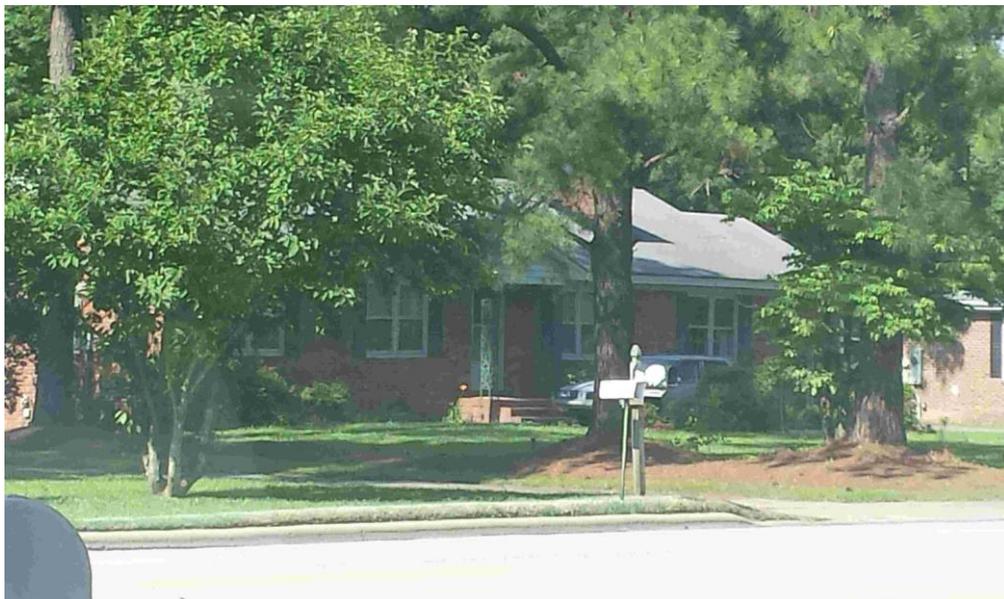
Property Locator / Repetitive Loss#: 3712-34-4024.000
Inspection Date: 6/11/2015 **Inspector:** Alex Magruder
No. of Stories: 1 **Basement:** No
Occupied: Yes **Neighborhood:** Single Family Residential
Fill: 0-1 Feet **Elevated:** 1-2 Feet
Observations: No guttering. Hvac unit unknown.
Flooding: Unknown
Flooding Notes:
Land Use: Single-family residential
Land Use Notes:
Adequate Vents Present: Yes
Spoke with: Owner Unavailable
Structure Type: Masonry
Structure Type Notes:
Condition of Structure: Good (optional minor repairs)
Foundation Type: Crawlspace floor at or above grade on at least 1 side
Foundation Type Notes:
Condition of Foundation: Good (optional minor repairs)

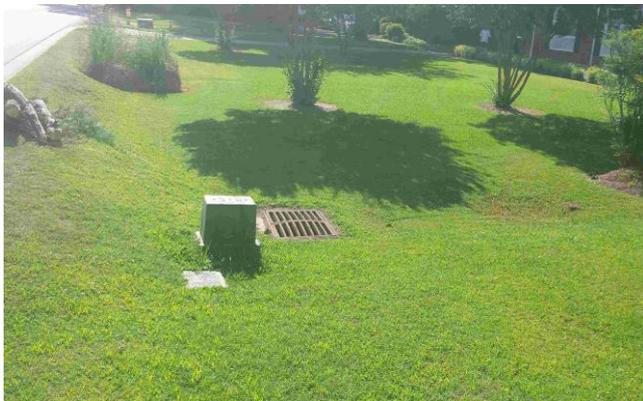
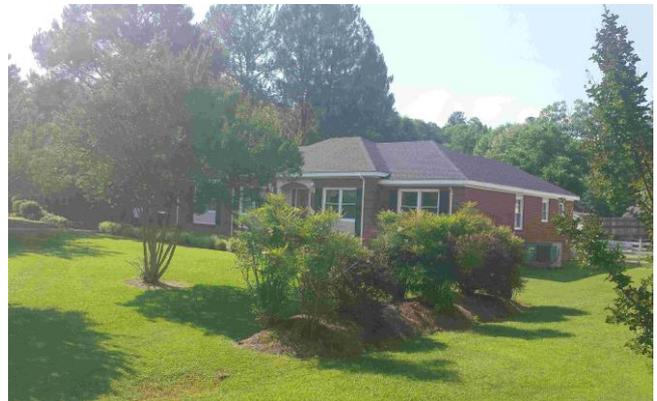
Property Locator / Repetitive Loss#: 3712-34-7023.000
Inspection Date: 6/11/2015 **Inspector:** Alex Magruder
No. of Stories: 1 **Basement:**
Occupied: Yes **Neighborhood:** Single Family Residential
Fill: Below Street **Elevated:** 2-3 Feet
Grads
Observations: No guttering. Hvac unit raised 1 ft. Secondary structure. Drain in front yard.
Flooding: Unknown
Flooding Notes:
Land Use: Single-family residential
Land Use Notes:
Adequate Vents Present: Yes
Spoke with: Owner Unavailable
Structure Type: Masonry
Structure Type Notes:
Condition of Structure: Good (optional minor repairs)
Foundation Type: Crawlspace floor at or above grade on at least 1 side
Foundation Type Notes:
Condition of Foundation: Good (optional minor repairs)

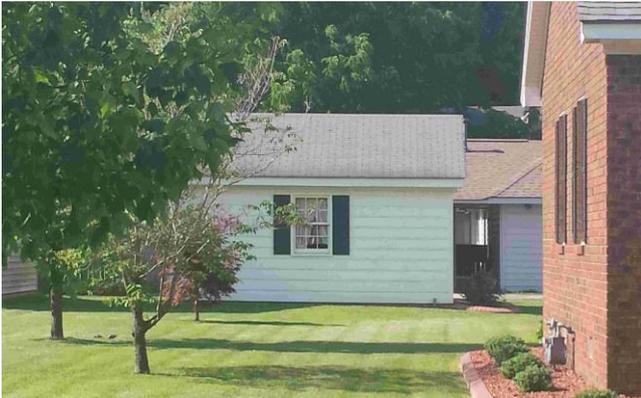
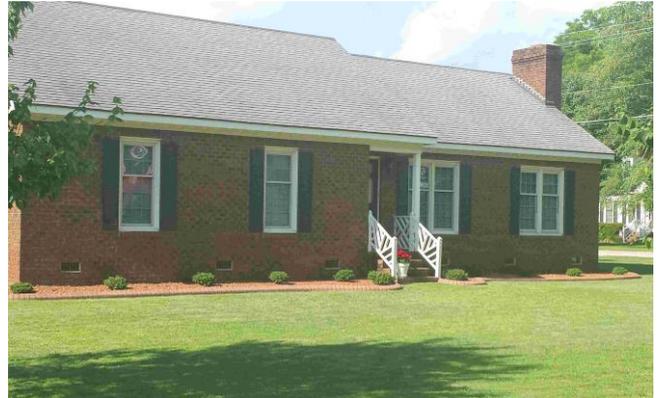
Property Locator / Repetitive Loss#: 3712-44-0050.000
Inspection Date: 6/11/2015 **Inspector:** Alex Magruder
No. of Stories: 1 **Basement:** No
Occupied: Yes **Neighborhood:** Single Family Residential
Fill: 0-1 Feet **Elevated:** 1-2 Feet
Observations: No guttering. Secondary structure. Hvac unit unknown.
Flooding: Unknown
Flooding Notes:
Land Use: Single-family residential
Land Use Notes:
Adequate Vents Present: Yes
Spoke with: Owner Unavailable
Structure Type: Masonry
Structure Type Notes:
Condition of Structure: Good (optional minor repairs)
Foundation Type: Crawlspace floor at or above grade on at least 1 side
Foundation Type Notes:
Condition of Foundation: Good (optional minor repairs)

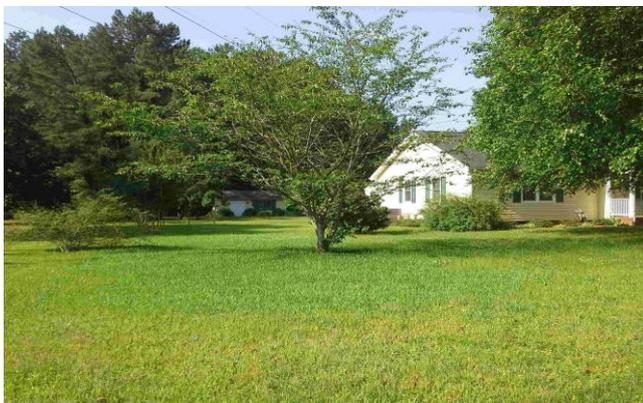
Flooding Notes: Spoke with resident. Stated that flooding occurred in creek in 1999, but the water didn't reach the foundation at that time.

Condition of Structure: Good (optional minor repairs)

Foundation Type: Crawlspace floor at or above grade on at least 1 side

Condition of Foundation: Good (optional minor repairs)

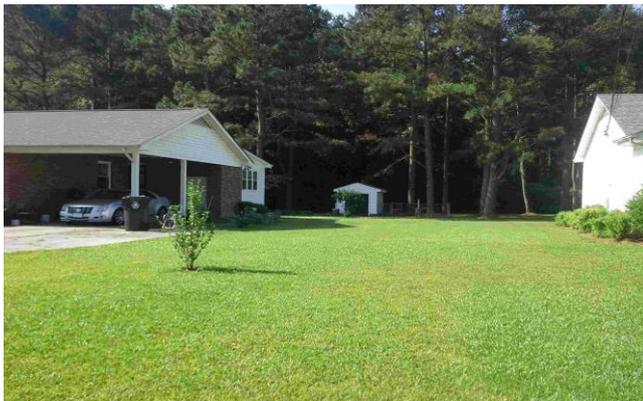
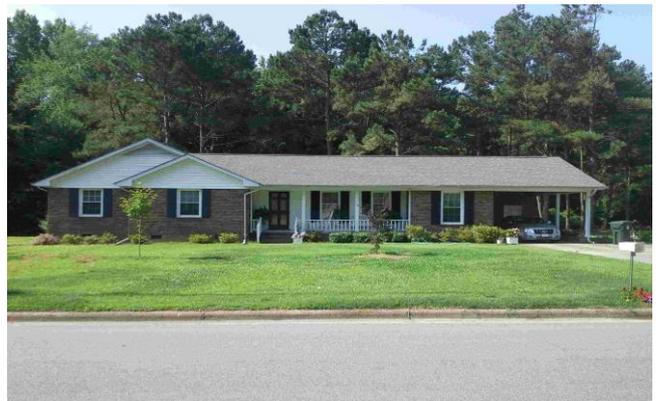
Property Locator / Repetitive Loss#: 3712-16-7799.000
Inspection Date: 6/11/2015 **Inspector:** Scott Gentry
No. of Stories: 1 **Basement:** No
Occupied: Yes **Neighborhood:** Single Family Residential
Fill: 0-1 Feet **Elevated:** 2-3 Feet
Observations: Has shed. Hvac not seen from road. Has gutters.
Flooding: Unknown
Flooding Notes:
Land Use: Single-family residential
Land Use Notes:
Adequate Vents Present: Yes
Spoke with: Neighbor
Structure Type: Masonry
Structure Type Notes:
Condition of Structure: Good (optional minor repairs)
Foundation Type: Crawlspace floor at or above grade on at least 1 side
Foundation Type Notes:
Condition of Foundation: Good (optional minor repairs)

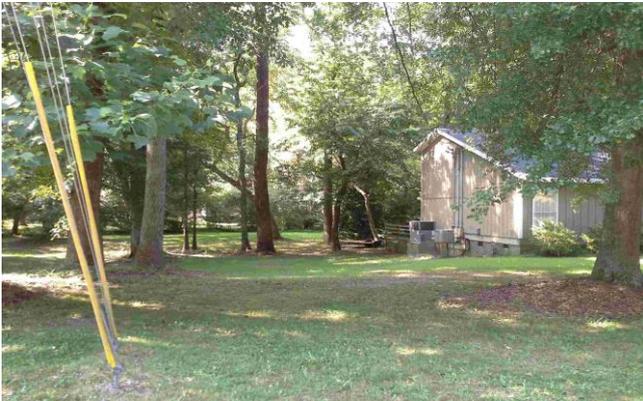
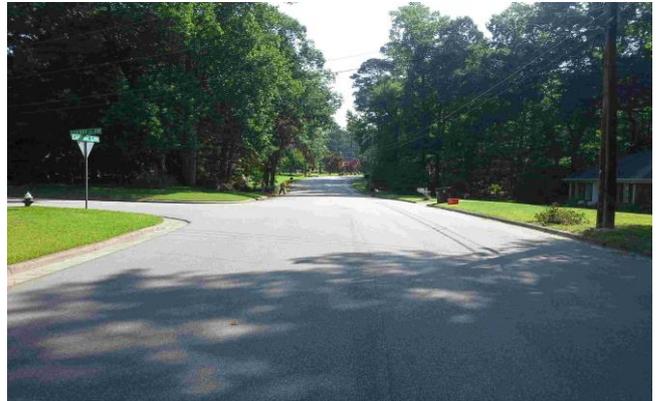
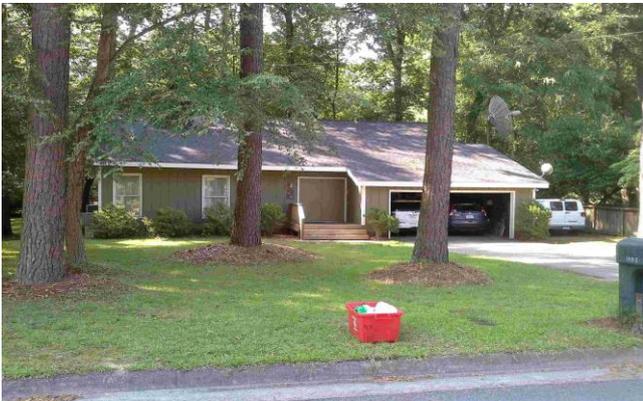
Property Locator / Repetitive Loss#: 3712-26-2932.000
Inspection Date: 6/11/2015 **Inspector:** Scott Gentry
No. of Stories: 1 **Basement:** No
Occupied: Yes **Neighborhood:** Single Family Residential
Fill: 0-1 Feet **Elevated:** 2-3 Feet
Observations: Has elevated hvac. No gutters. Spoke with a neighbor who said the street was closed due to flooding about 10 years ago. The flooding occurred during a hurricane.
Flooding: Unknown
Flooding Notes:
Land Use: Single-family residential
Land Use Notes:
Adequate Vents Present: Yes
Spoke with: Owner Unavailable
Structure Type: Wood Frame
Structure Type Notes:
Condition of Structure: Good (optional minor repairs)
Foundation Type: Crawlspace floor at or above grade on at least 1 side
Foundation Type Notes:
Condition of Foundation: Good (optional minor repairs)

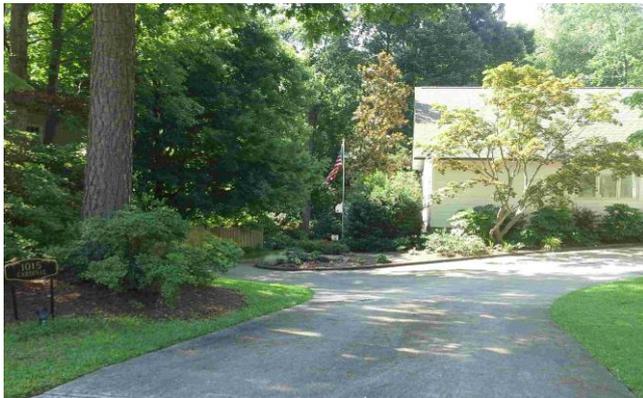
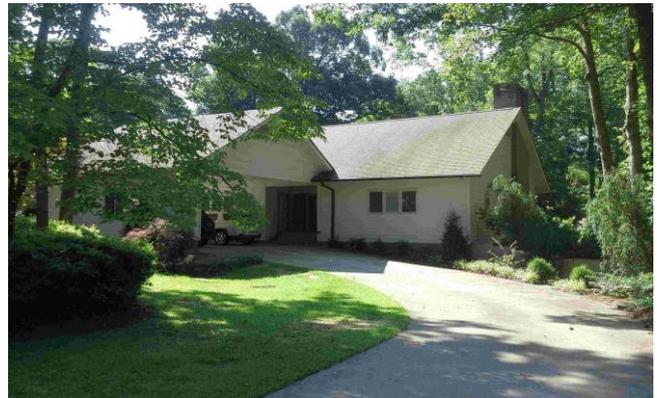
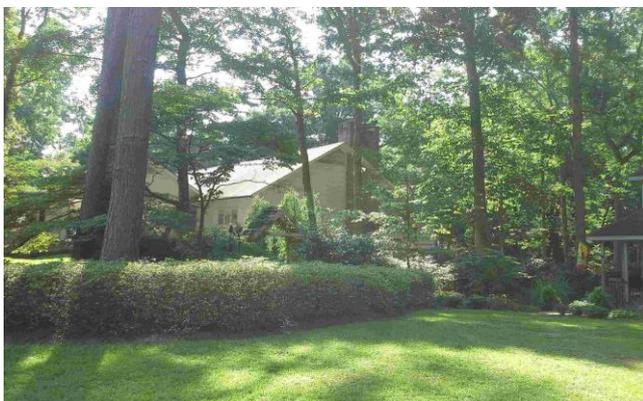
Observations: Hvac not observed. Has gutters.

Condition of Structure: Good (optional minor repairs)

Foundation Type: Elevated foundation walls w/full or partial enclosure

Foundation Type Notes: Observed driveway going around side of house. Possible sub-level (basement) below first floor.

Condition of Foundation: Good (optional minor repairs)

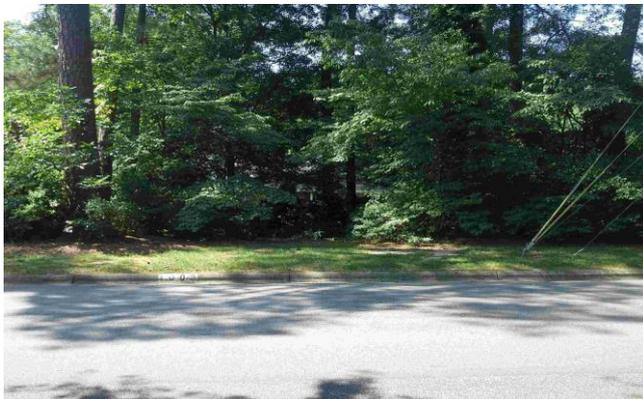
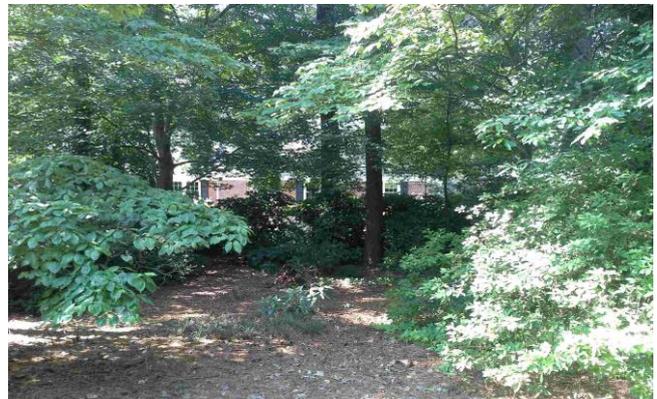
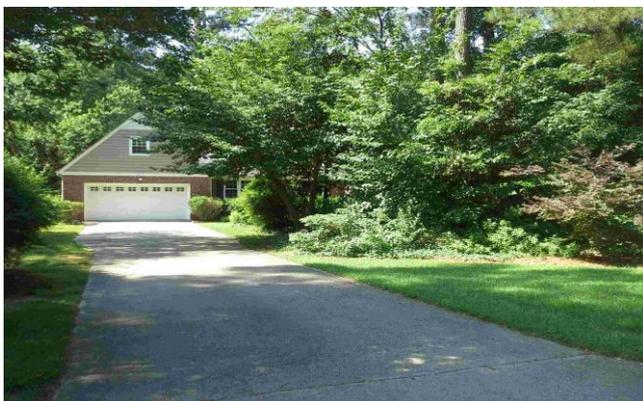
Property Locator / Repetitive Loss#: 3712-37-2176.000
Inspection Date: 6/11/2015 **Inspector:** Scott Gentry
No. of Stories: 2 **Basement:** Unknown
Occupied: Yes **Neighborhood:** Single Family Residential
Fill: 0-1 Feet **Elevated:** Unable To Determine
Observations: Has gutters. Hvac is on side of house. Neighbor said that the house next door, on the corner of Lakeside Dr was torn down after Hurricane Floyd, due to flooding damage.
Flooding: Unknown
Flooding Notes:
Land Use: Single-family residential
Land Use Notes:
Adequate Vents Present: Unknown
Spoke with: Owner Unavailable
Structure Type: Masonry
Structure Type Notes:
Condition of Structure: Good (optional minor repairs)
Foundation Type: Unable to determine
Foundation Type Notes: Yard is heavily landscaped. Unable to determine information about foundation.
Condition of Foundation: Unable To Determine

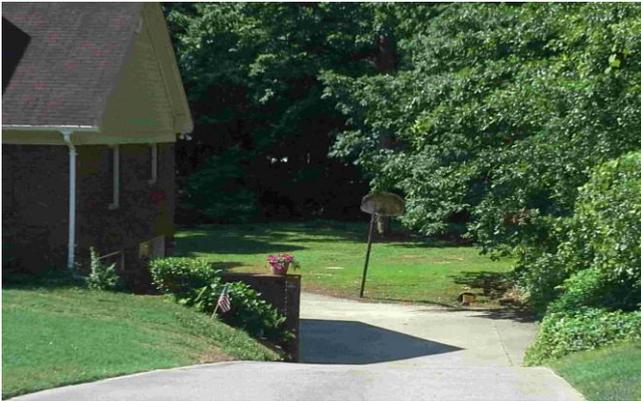
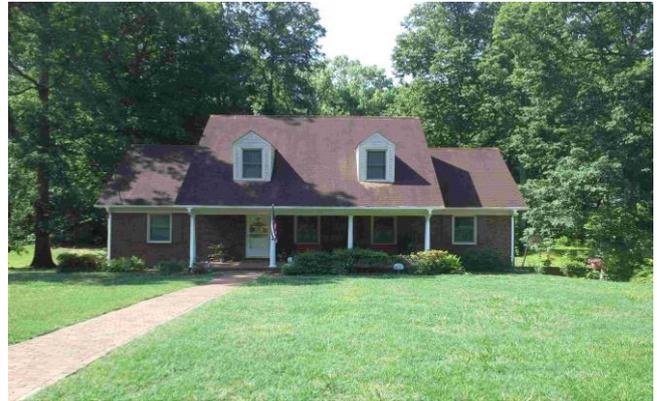
Condition of Structure: Good (optional minor repairs)

Foundation Type: Basement with walkout

Foundation Type Notes: Listed as fair because owner stated there is a mold issue in basement.

Condition of Foundation: Fair (needs minor repairs)

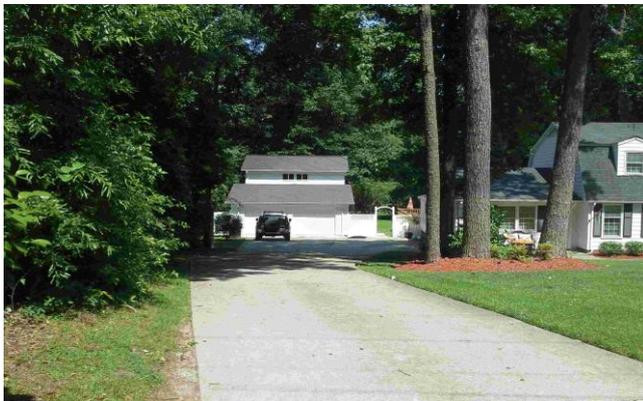
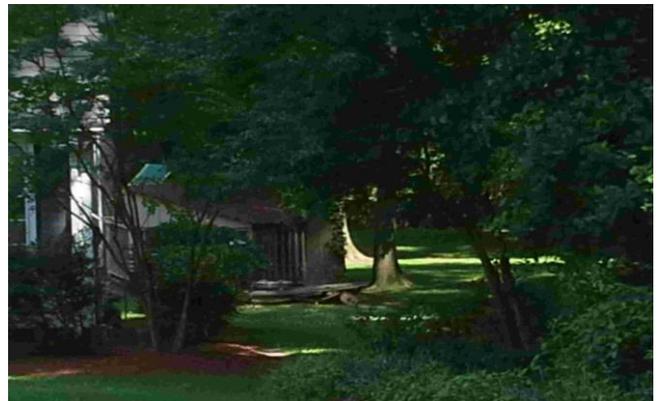
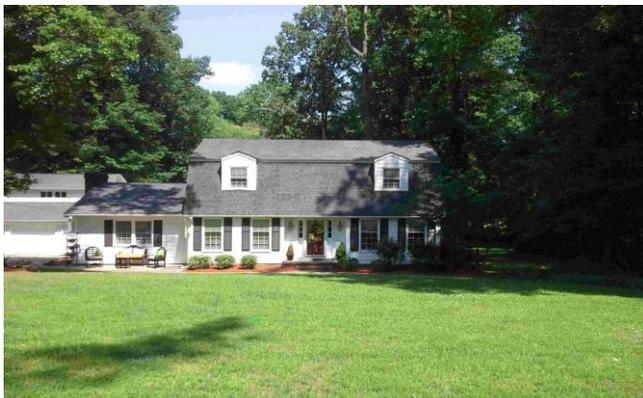
Property Locator / Repetitive Loss#: 3712-26-4721.000
Inspection Date: 6/11/2015 **Inspector:** Scott Gentry
No. of Stories: 2 **Basement:** No
Occupied: Yes **Neighborhood:** Single Family Residential
Fill: Below Street **Elevated:** 1-2 Feet
Grads
Observations: Has gutter. Hvac not seen from street. Separate garage/shed structure observed. Activity in back of house sounds like a pool.
Flooding: Unknown
Flooding Notes:
Land Use: Single-family residential
Land Use Notes:
Adequate Vents Present: Yes
Spoke with: Owner Unavailable
Structure Type: Wood Frame
Structure Type Notes:
Condition of Structure: Good (optional minor repairs)
Foundation Type: Crawlspace floor at or above grade on at least 1 side
Foundation Type Notes:
Condition of Foundation: Good (optional minor repairs)

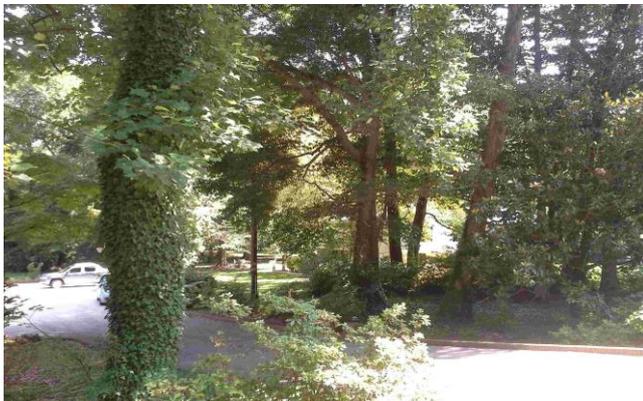
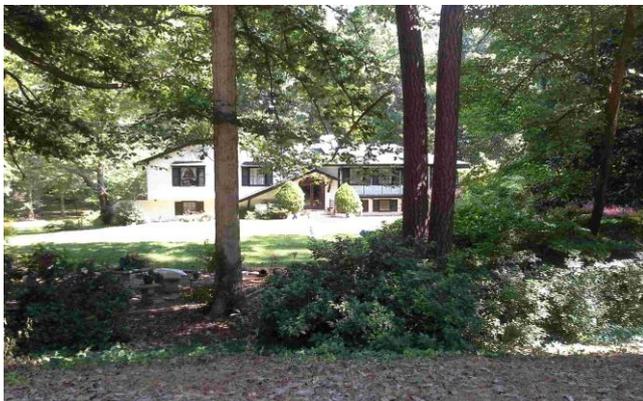
Property Locator / Repetitive Loss#: 3712-26-9922.000
Inspection Date: 6/11/2015 **Inspector:** Scott Gentry
No. of Stories: 2 **Basement:** Yes
Occupied: Yes **Neighborhood:** Single Family Residential
Fill: Below Street **Elevated:** 1-2 Feet
Grads
Observations: Has gutters. Hvac not seen from street. Curb and gutter street drainage.
Flooding: Unknown
Flooding Notes:
Land Use: Single-family residential
Land Use Notes:
Adequate Vents Present: Unknown
Spoke with: Owner Unavailable
Structure Type: Wood Frame
Structure Type Notes:
Condition of Structure: Good (optional minor repairs)
Foundation Type: Basement sub-grade with windows
Foundation Type Notes:
Condition of Foundation: Good (optional minor repairs)

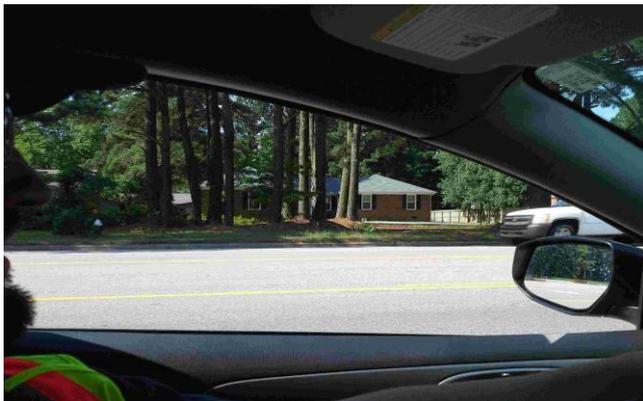
Property Locator / Repetitive Loss#: 3712-34-5023.000
Inspection Date: 6/11/2015 **Inspector:** Scott Gentry
No. of Stories: **Basement:** No
Occupied: Yes **Neighborhood:** Single Family Residential
Fill: 0-1 Feet **Elevated:** 1-2 Feet
Observations: Has gutters.
Flooding: Unknown
Flooding Notes:
Land Use: Single-family residential
Land Use Notes:
Adequate Vents Present: Yes
Spoke with: Owner Unavailable
Structure Type: Masonry
Structure Type Notes:
Condition of Structure: Good (optional minor repairs)
Foundation Type: Crawlspace floor at or above grade on at least 1 side
Foundation Type Notes:
Condition of Foundation: Unable To Determine

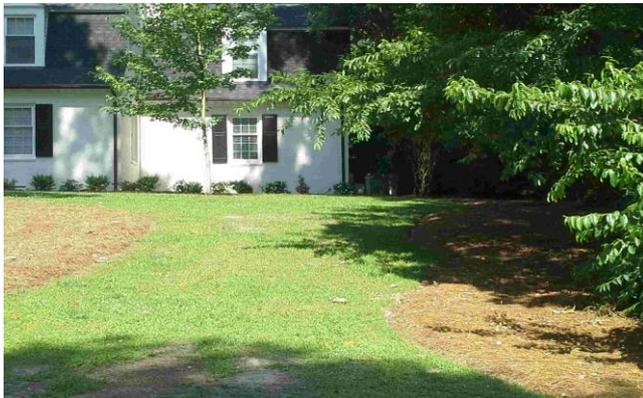
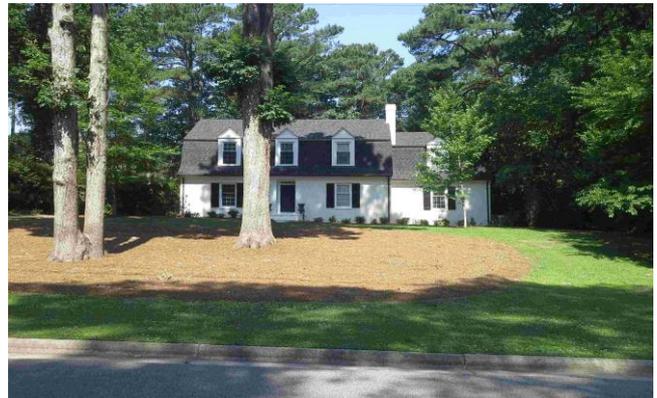
Property Locator / Repetitive Loss#: 3712-36-3675.000
Inspection Date: 6/11/2015 **Inspector:** Yuqi
No. of Stories: 2 **Basement:** Unknown
Occupied: Yes **Neighborhood:** Single Family Residential
Fill: 2-3 Feet **Elevated:** 2-3 Feet
Observations: Has gutters, has HVAC, unobserved secondary structure. For the fill, it's greater than 4 feet.
Flooding: Unknown
Flooding Notes:
Land Use: Single-family residential
Land Use Notes:
Adequate Vents Present: Yes
Spoke with: Owner Unavailable
Structure Type: Masonry
Structure Type Notes:
Condition of Structure: Good (optional minor repairs)
Foundation Type: Crawlspace floor at or above grade on at least 1 side
Foundation Type Notes:
Condition of Foundation: Good (optional minor repairs)

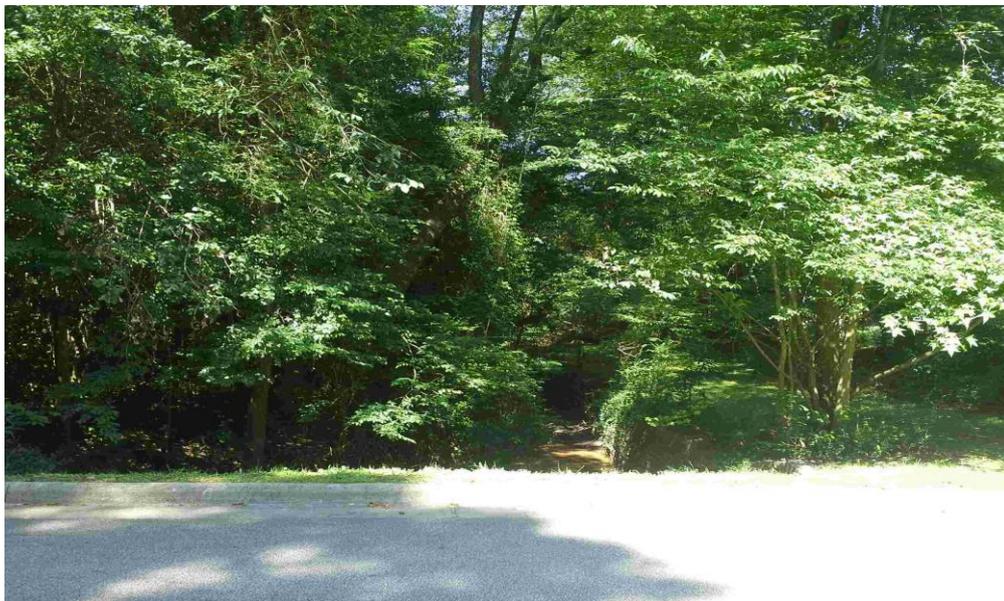
Property Locator / Repetitive Loss#: 3712-36-3958.000
Inspection Date: 6/11/2015 **Inspector:** Yuqi
No. of Stories: **Basement:**
Occupied: **Neighborhood:**
Fill: **Elevated:**
Observations: No house on this property, adjacent to creek.
Flooding:
Flooding Notes:
Land Use:
Land Use Notes:
Adequate Vents Present:
Spoke with:
Structure Type:
Structure Type Notes:
Condition of Structure:
Foundation Type:
Foundation Type Notes:
Condition of Foundation:

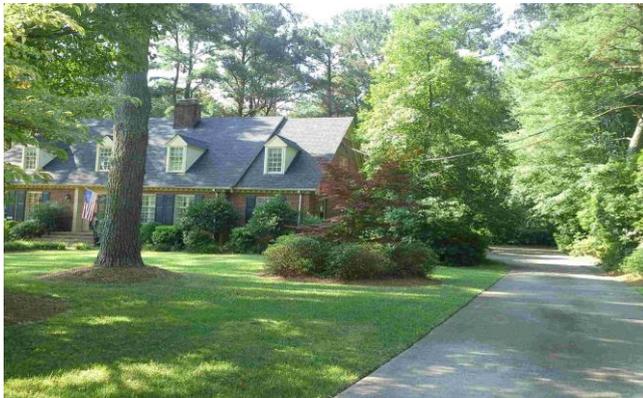
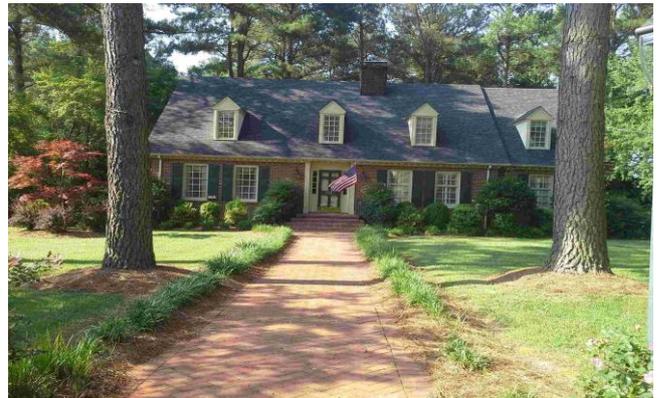
Property Locator / Repetitive Loss#: 3712-16-2736.000
Inspection Date: 6/11/2015 **Inspector:** Yuqi
No. of Stories: 2 **Basement:** No
Occupied: Yes **Neighborhood:** Single Family Residential
Fill: 0-1 Feet **Elevated:** 3-4 Feet
Observations: Has gutters, cannot see HVAC, cannot see secondary structures, neighbor has seen flooding on street for 4 to 6 inches at curb
Flooding: No
Flooding Notes:
Land Use: Single-family residential
Land Use Notes:
Adequate Vents Present: Yes
Spoke with: Neighbor
Structure Type: Masonry
Structure Type Notes:
Condition of Structure: Good (optional minor repairs)
Foundation Type: Crawlspace floor at or above grade on at least 1 side
Foundation Type Notes:
Condition of Foundation: Good (optional minor repairs)
