REPETITIVE LOSS AREA ANALYSIS

City of Wilson, North Carolina
Planning & Development Services

Prepared by:
Amec Foster Wheeler
Environment & Infrastructure, Inc.

October 2015

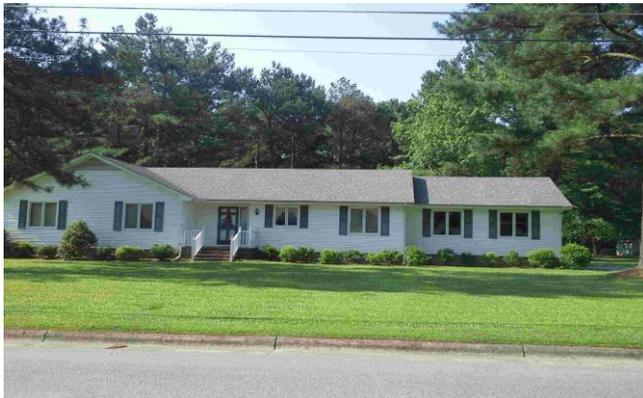
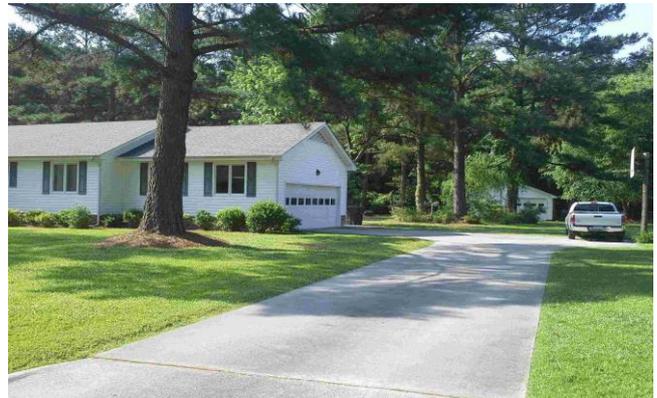
Property Locator / Repetitive Loss#: 3712-16-6767.000
Inspection Date: 6/11/2015 **Inspector:** Yuqi
No. of Stories: 1 **Basement:** No
Occupied: Yes **Neighborhood:** Single Family Residential
Fill: 0-1 Feet **Elevated:** 2-3 Feet
Observations: Has gutters, has secondary structure with garage, cannot see HVAC.
Flooding: Unknown
Flooding Notes:
Land Use: Single-family residential
Land Use Notes:
Adequate Vents Present: Yes
Spoke with: Owner Unavailable
Structure Type: Wood Frame
Structure Type Notes:
Condition of Structure: Good (optional minor repairs)
Foundation Type: Crawlspace floor at or above grade on at least 1 side
Foundation Type Notes:
Condition of Foundation: Good (optional minor repairs)

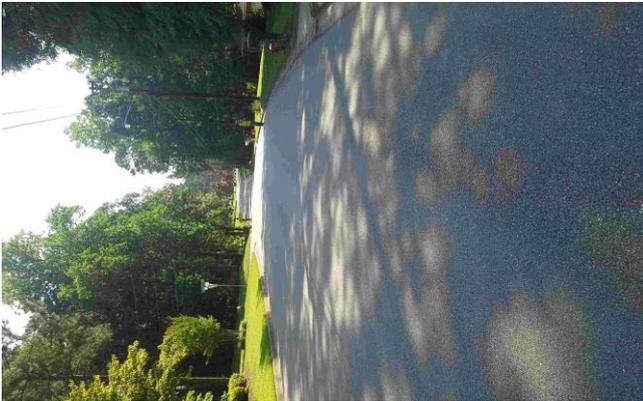
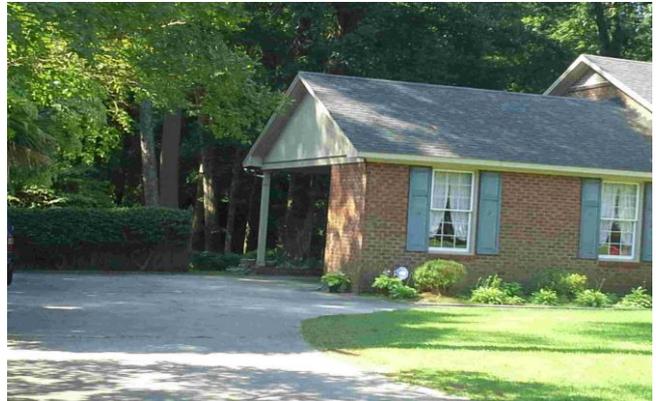
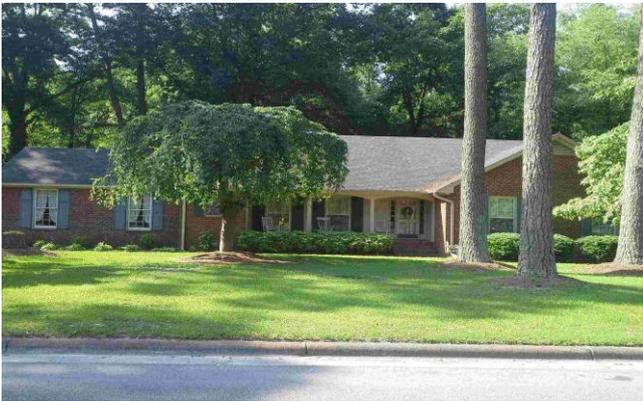
Property Locator / Repetitive Loss#: 3712-26-0886.000
Inspection Date: 6/11/2015 **Inspector:** Yuqi
No. of Stories: 1 **Basement:** No
Occupied: Yes **Neighborhood:** Single Family Residential
Fill: 0-1 Feet **Elevated:** 3-4 Feet
Observations: Has gutters, cannot see HVAC, and cannot see secondary structures, observed backyard slopes towards the creek. The neighbor said the street was closed due to the flooding about ten years ago.
Flooding: Unknown
Flooding Notes:
Land Use: Single-family residential
Land Use Notes:
Adequate Vents Present: Yes
Spoke with: Neighbor
Structure Type: Masonry
Structure Type Notes:
Condition of Structure: Good (optional minor repairs)
Foundation Type: Crawlspace floor at or above grade on at least 1 side
Foundation Type Notes:
Condition of Foundation: Good (optional minor repairs)

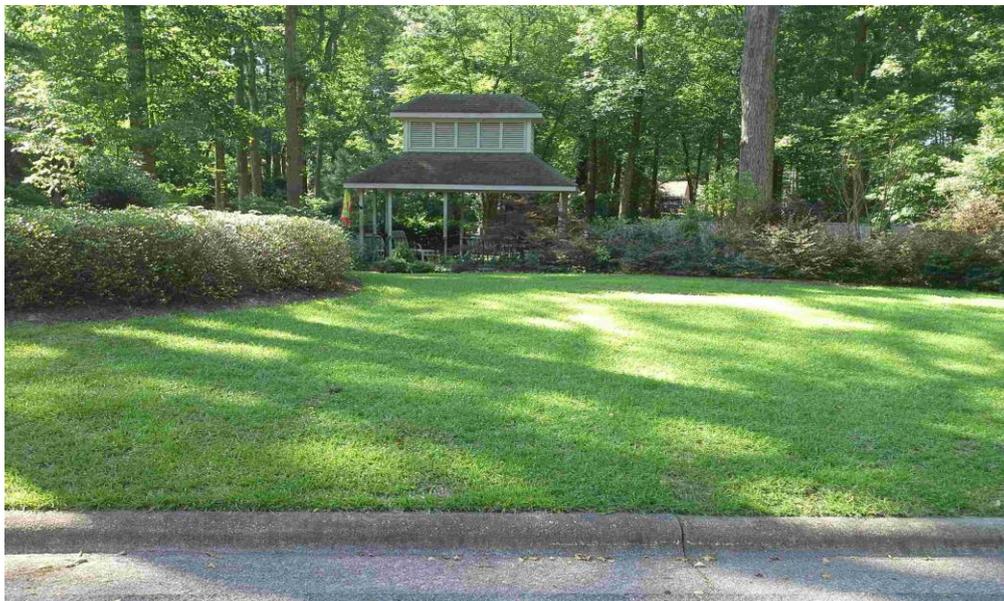
Property Locator / Repetitive Loss#: 3712-27-4162.000
Inspection Date: 6/11/2015 **Inspector:** Yuqi
No. of Stories: 0 **Basement:**
Occupied: **Neighborhood:**
Fill: **Elevated:**
Observations: Housed removed, assume this belongs to the property next to it.
Flooding:
Flooding Notes:
Land Use:
Land Use Notes:
Adequate Vents Present:
Spoke with: Owner Unavailable
Structure Type:
Structure Type Notes:
Condition of Structure:
Foundation Type:
Foundation Type Notes:
Condition of Foundation:

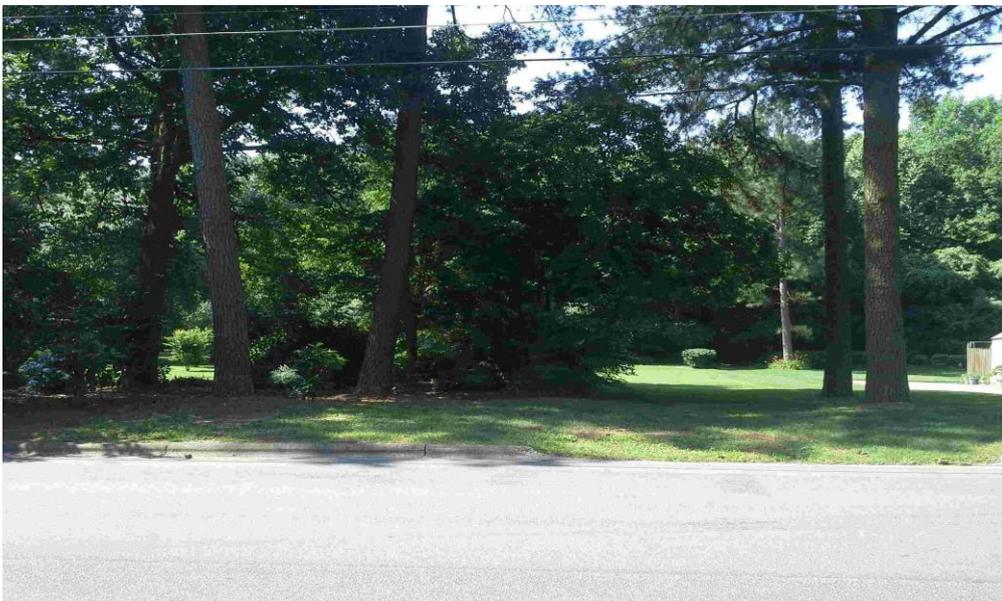
Property Locator / Repetitive Loss#: 3712-37-1166.000
Inspection Date: 6/11/2015 **Inspector:** Yuqi
No. of Stories: **Basement:**
Occupied: **Neighborhood:**
Fill: **Elevated:**
Observations: No house on property.
Flooding:
Flooding Notes:
Land Use:
Land Use Notes:
Adequate Vents Present:
Spoke with:
Structure Type:
Structure Type Notes:
Condition of Structure:
Foundation Type:
Foundation Type Notes:
Condition of Foundation:

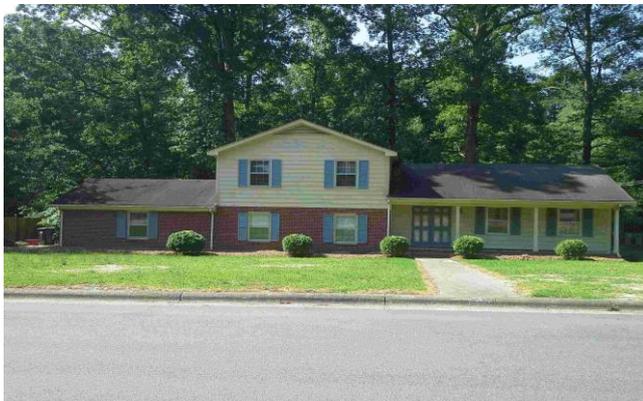
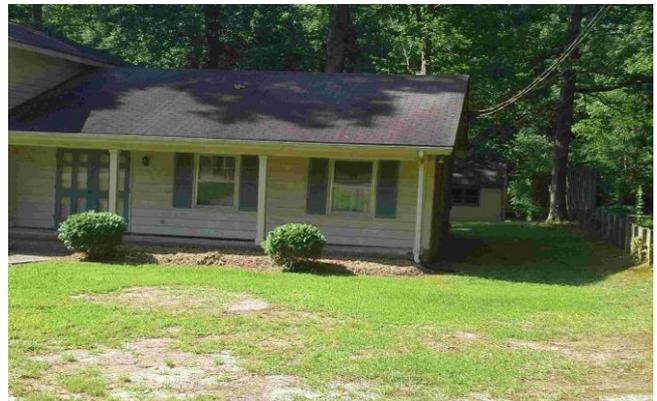
Property Locator / Repetitive Loss#: 3712-27-8221.000
Inspection Date: 6/11/2015 **Inspector:** Yuqi
No. of Stories: 2 **Basement:**
Occupied: Unknown **Neighborhood:** Single Family Residential
Fill: Below Street **Elevated:** 0-1 Feet
Grads
Observations: Has gutters, has secondary structures, unobserved HVAC.
Flooding: Unknown
Flooding Notes:
Land Use: Single-family residential
Land Use Notes:
Adequate Vents Present: Yes
Spoke with: Owner Unavailable
Structure Type: Wood Frame
Structure Type Notes: Blend with wood and bricks, but most are wood.
Condition of Structure: Fair (needs minor repairs)
Foundation Type: Crawlspace floor at or above grade on at least 1 side
Foundation Type Notes: There are damages and the house is a little separate from the foundation.
Condition of Foundation: Fair (needs minor repairs)

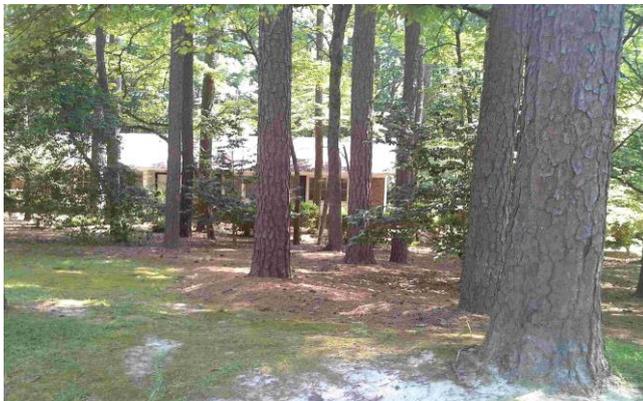
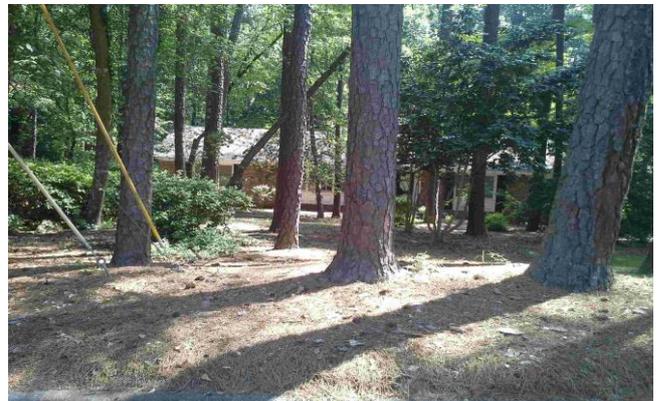
Property Locator / Repetitive Loss#: 3712-36-1806.000
Inspection Date: 6/11/2015 **Inspector:** Yuqi
No. of Stories: 1 **Basement:** No
Occupied: Yes **Neighborhood:** Single Family Residential
Fill: Below Street **Elevated:** 1-2 Feet
Grads
Observations: No gutters, unobserved secondary structures, unobserved HVAC. Visions are blocked by a lot of vegetation.
Flooding: Unknown
Flooding Notes:
Land Use: Single-family residential
Land Use Notes:
Adequate Vents Present: Yes
Spoke with: Owner Unavailable
Structure Type: Masonry
Structure Type Notes:
Condition of Structure: Good (optional minor repairs)
Foundation Type: Crawlspace floor at or above grade on at least 1 side
Foundation Type Notes:
Condition of Foundation: Good (optional minor repairs)

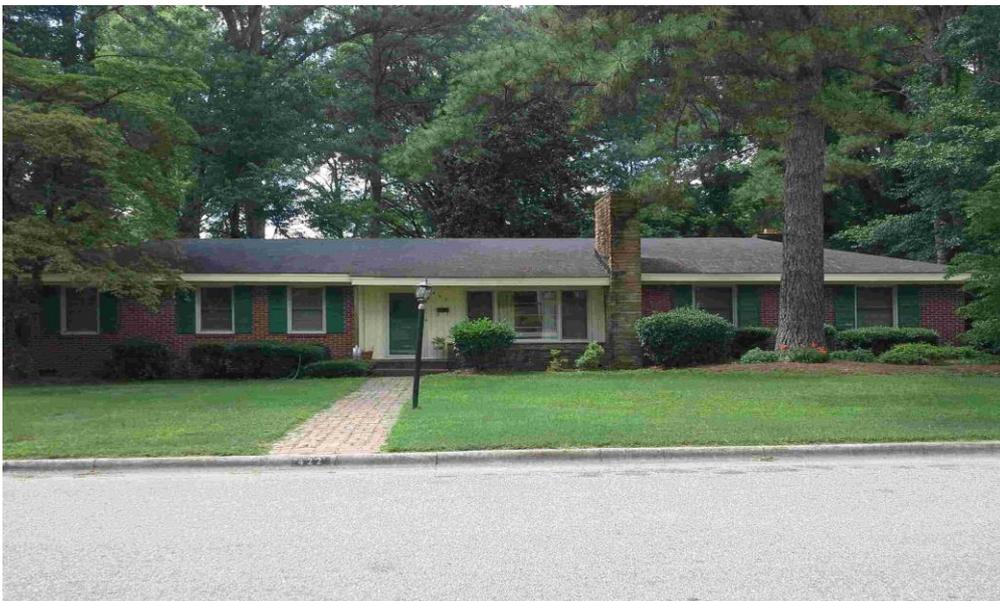
Property Locator / Repetitive Loss#: 3712-93-0154.000
Inspection Date: 6/11/2015 **Inspector:** Scott Gentry
No. of Stories: 1 **Basement:** No
Occupied: Yes **Neighborhood:** Single Family Residential
Fill: 0-1 Feet **Elevated:** 1-2 Feet
Observations: No gutter. HVAC not seen from street.
Flooding: Unknown
Flooding Notes:
Land Use: Single-family residential
Land Use Notes:
Adequate Vents Present: Yes
Spoke with: Owner Unavailable
Structure Type: Masonry
Structure Type Notes:
Condition of Structure: Good (optional minor repairs)
Foundation Type: Crawlspace floor at or above grade on at least 1 side
Foundation Type Notes:
Condition of Foundation: Good (optional minor repairs)

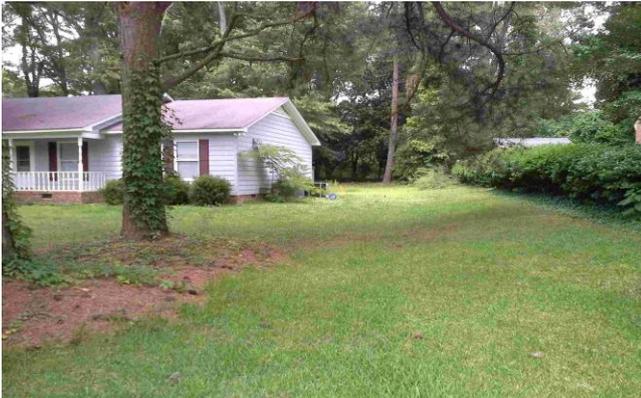
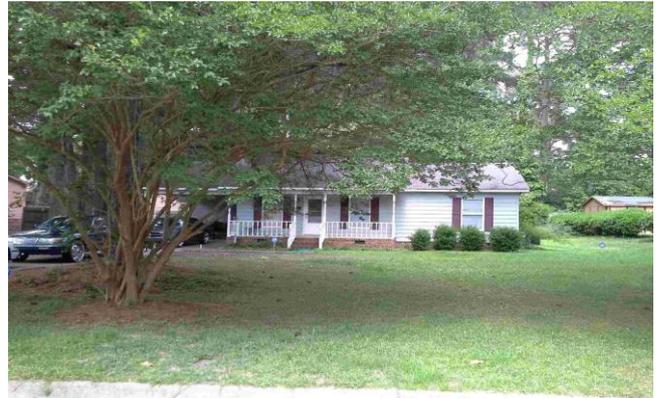
Property Locator / Repetitive Loss#: 3712-83-9126.000

Condition of Structure: Good (optional minor repairs)

Foundation Type: Crawlspace floor at or above grade on at least 1 side

Condition of Foundation: Good (optional minor repairs)

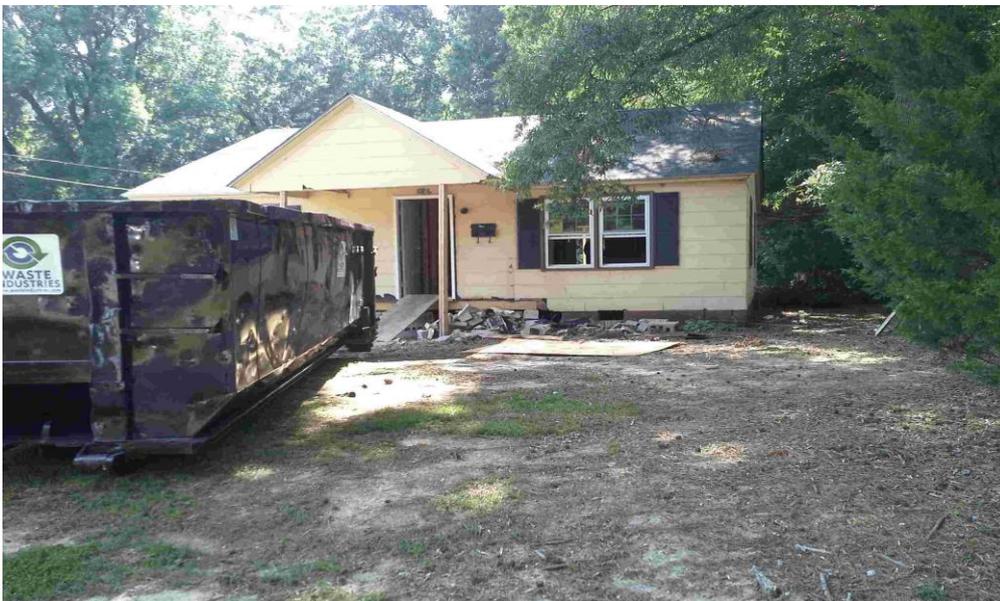
Property Locator / Repetitive Loss#: 3711-99-0782.000
Inspection Date: 6/11/2015 **Inspector:** Scott Gentry
No. of Stories: 1 **Basement:** No
Occupied: **Neighborhood:** Single Family Residential
Fill: 2-3 Feet **Elevated:** 2-3 Feet
Observations: House is being gutted and restored. No gutter.
Flooding: Unknown
Flooding Notes:
Land Use: Single-family residential
Land Use Notes:
Adequate Vents Present: Yes
Spoke with: Owner Unavailable
Structure Type: Wood Frame
Structure Type Notes:
Condition of Structure: Poor (needs significant repairs)
Foundation Type: Elevated foundation walls w/full or partial enclosure
Foundation Type Notes:
Condition of Foundation: Poor (needs significant repairs)

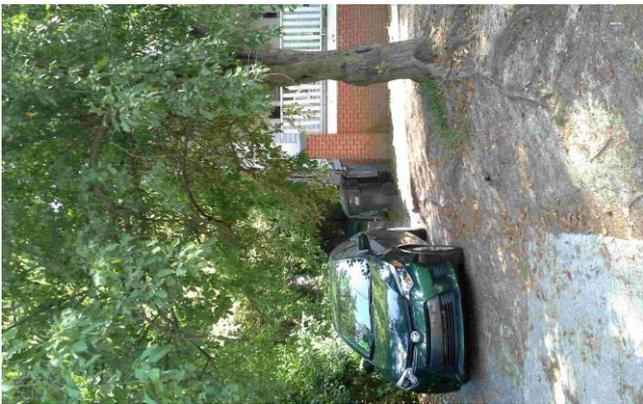
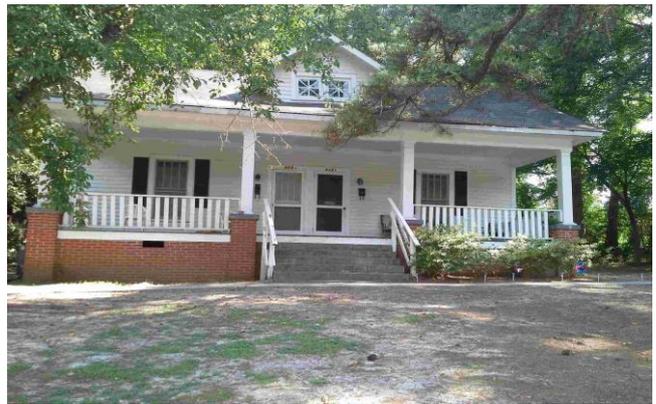
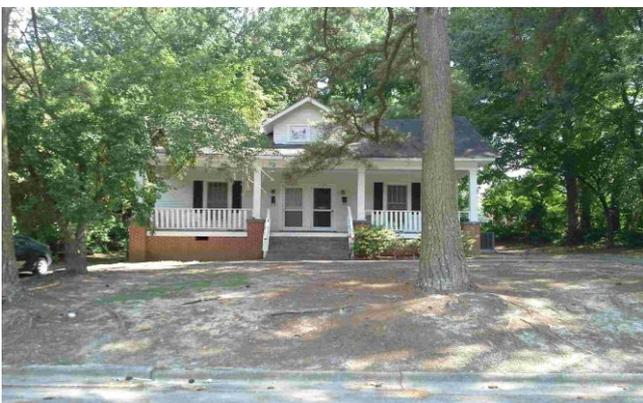
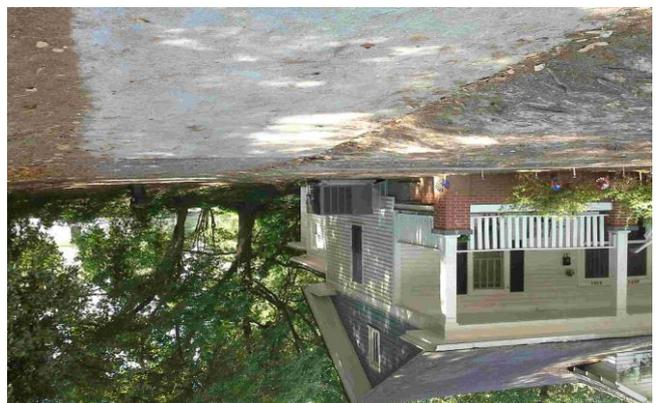
Property Locator / Repetitive Loss#: 3711-99-1412.000
Inspection Date: 6/11/2015 **Inspector:** Scott Gentry
No. of Stories: 2 **Basement:** No
Occupied: Yes **Neighborhood:** Single Family Residential
Fill: 2-3 Feet **Elevated:** 4-6 Feet
Observations: No gutter. Hvac on ground. Street is curb and gutter.
Flooding: No
Flooding Notes: Resident stated that the street floods during heavy rains
Land Use: 2-4 family residential
Land Use Notes:
Adequate Vents Present: Yes
Spoke with: Owner/Occupant
Structure Type: Wood Frame
Structure Type Notes:
Condition of Structure: Fair (needs minor repairs)
Foundation Type: Crawlspace floor at or above grade on at least 1 side
Foundation Type Notes:
Condition of Foundation: Fair (needs minor repairs)

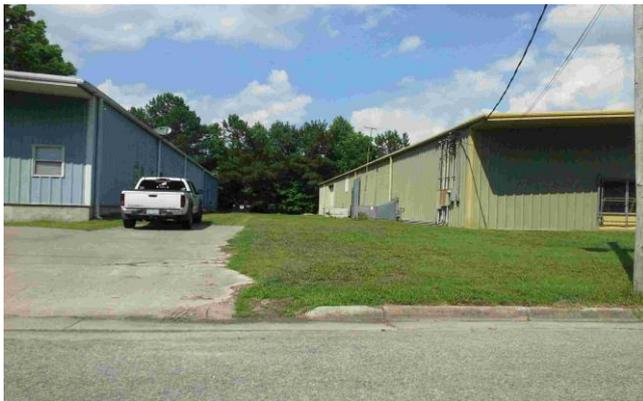
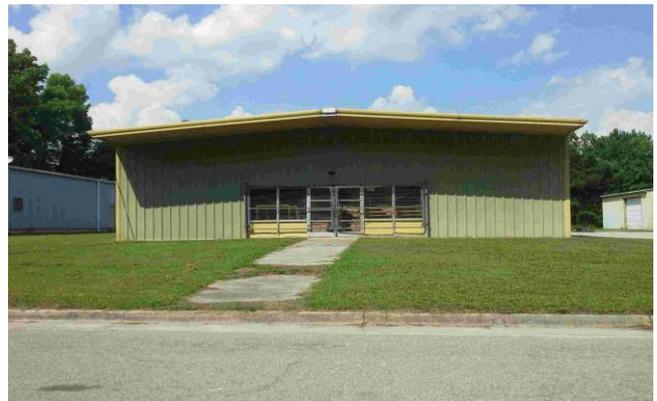
Property Locator / Repetitive Loss#: 3721-09-1944.000
Inspection Date: 6/11/2015 **Inspector:** Scott Gentry
No. of Stories: 1 **Basement:** No
Occupied: Unknown **Neighborhood:** Industrial
Fill: 0-1 Feet **Elevated:** At Grade
Observations: Has gutters. Hvac at grade.
Flooding: Unknown
Flooding Notes:
Land Use: Industrial
Land Use Notes:
Adequate Vents Present: No
Spoke with: Owner Unavailable
Structure Type: Steel
Structure Type Notes:
Condition of Structure: Fair (needs minor repairs)
Foundation Type: Slab-on-grade
Foundation Type Notes:
Condition of Foundation: Unable To Determine

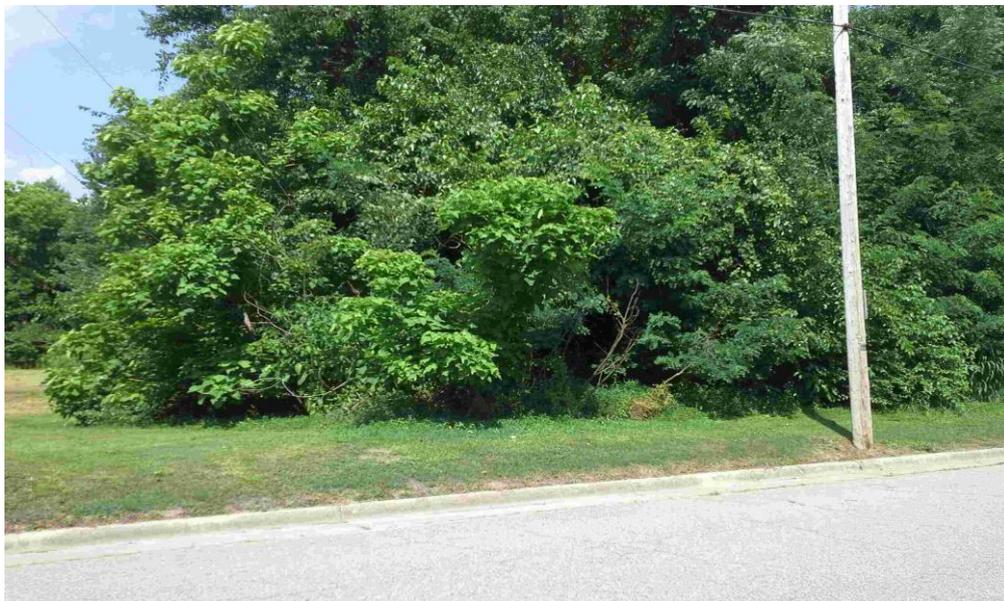
Property Locator / Repetitive Loss#: 3712-90-8260.000
Inspection Date: 6/11/2015 **Inspector:** Scott Gentry
No. of Stories: **Basement:**
Occupied: **Neighborhood:**
Fill: **Elevated:**
Observations: Wooded lot.
Flooding:
Flooding Notes:
Land Use:
Land Use Notes:
Adequate Vents Present:
Spoke with: Owner Unavailable
Structure Type:
Structure Type Notes:
Condition of Structure:
Foundation Type:
Foundation Type Notes:
Condition of Foundation:

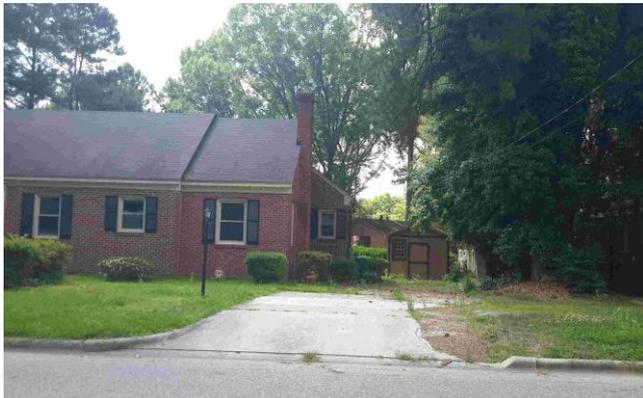
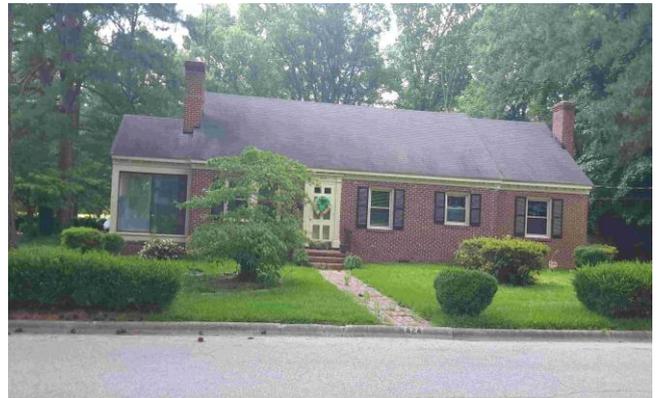
Property Locator / Repetitive Loss#: 3712-83-9058.000
Inspection Date: 6/11/2015 **Inspector:** Yuqi
No. of Stories: 1 **Basement:**
Occupied: Yes **Neighborhood:** Single Family Residential
Fill: 0-1 Feet **Elevated:** 2-3 Feet
Observations: No gutters, has secondary structure as storage room, unobserved HVAC.
Flooding: Unknown
Flooding Notes:
Land Use: Single-family residential
Land Use Notes:
Adequate Vents Present: Yes
Spoke with: Owner Unavailable
Structure Type: Masonry
Structure Type Notes:
Condition of Structure: Good (optional minor repairs)
Foundation Type: Crawlspace floor at or above grade on at least 1 side
Foundation Type Notes:
Condition of Foundation: Good (optional minor repairs)

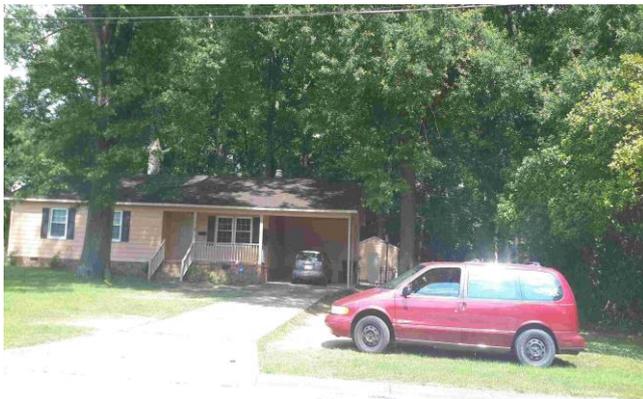
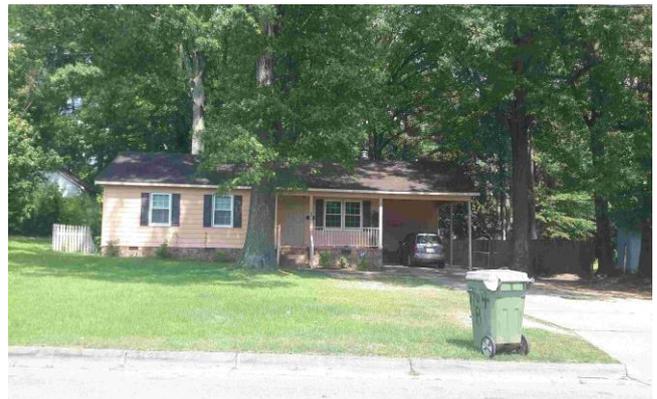
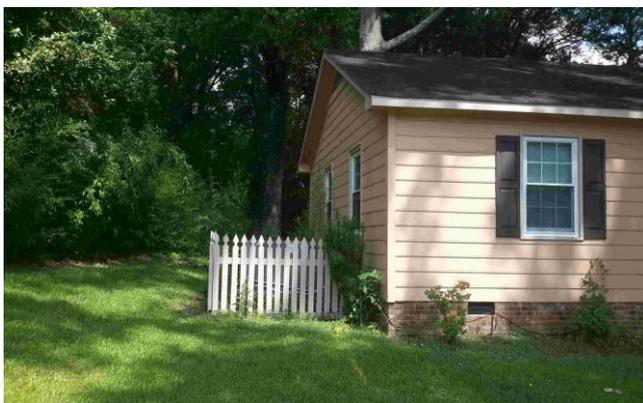
Property Locator / Repetitive Loss#: 3712-83-9238.000
Inspection Date: 6/11/2015 **Inspector:** Yuqi
No. of Stories: 1 **Basement:** No
Occupied: Yes **Neighborhood:** Single Family Residential
Fill: 0-1 Feet **Elevated:** 3-4 Feet
Observations: No gutters, has HVAC, has secondary structures as storage room.
Flooding: Unknown
Flooding Notes:
Land Use: Single-family residential
Land Use Notes:
Adequate Vents Present: Yes
Spoke with: Owner Unavailable
Structure Type: Wood Frame
Structure Type Notes:
Condition of Structure: Good (optional minor repairs)
Foundation Type: Crawlspace floor at or above grade on at least 1 side
Foundation Type Notes:
Condition of Foundation: Good (optional minor repairs)

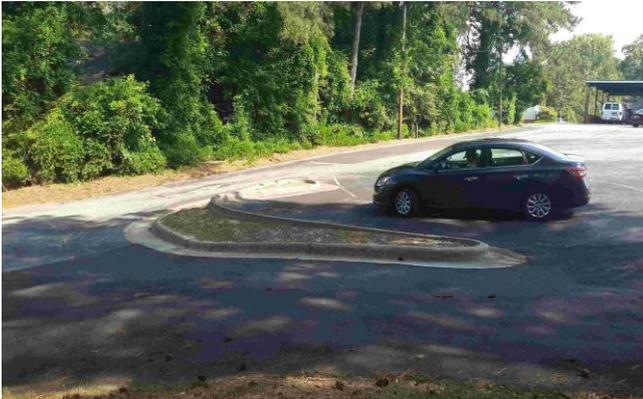
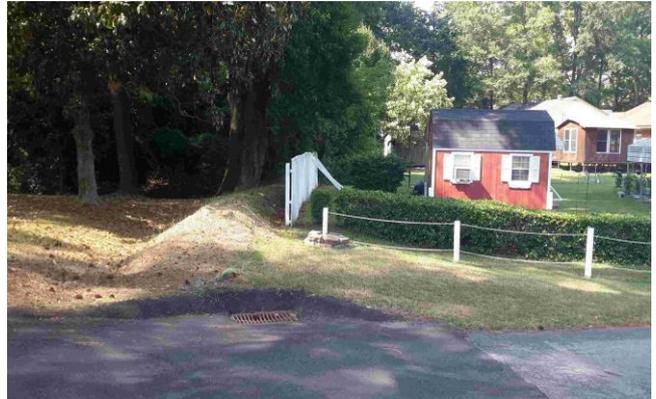
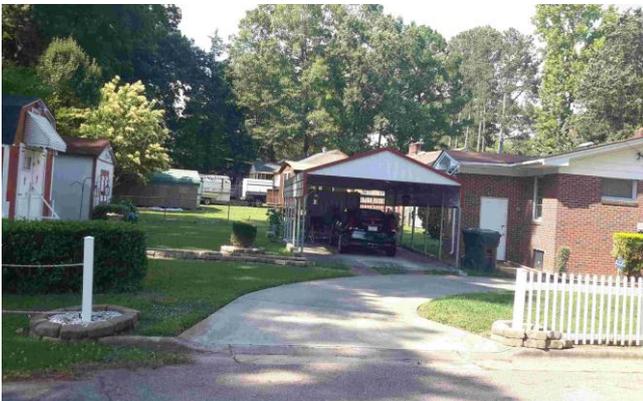
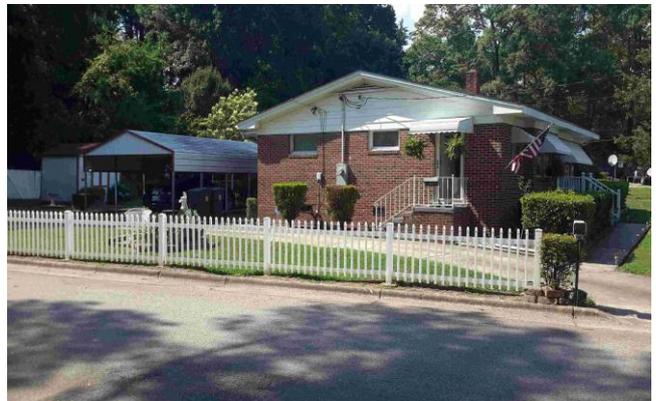
Property Locator / Repetitive Loss#: 3711-99-0599.000
Inspection Date: 6/11/2015 **Inspector:** Yuqi
No. of Stories: 1 **Basement:**
Occupied: Yes **Neighborhood:** Single Family Residential
Fill: 2-3 Feet **Elevated:** 3-4 Feet
Observations: Has secondary structures, has gutters, unobserved HVAC, raised berm, hill on the other side
Flooding: Unknown
Flooding Notes:
Land Use: Single-family residential
Land Use Notes:
Adequate Vents Present: Yes
Spoke with: Owner Unavailable
Structure Type: Masonry
Structure Type Notes:
Condition of Structure: Good (optional minor repairs)
Foundation Type: Crawlspace floor at or above grade on at least 1 side
Foundation Type Notes:
Condition of Foundation: Good (optional minor repairs)

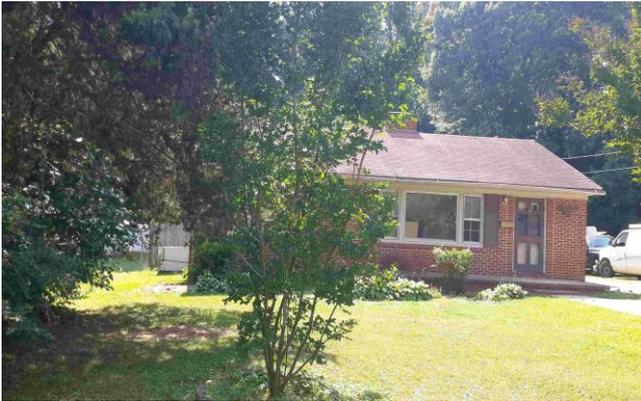
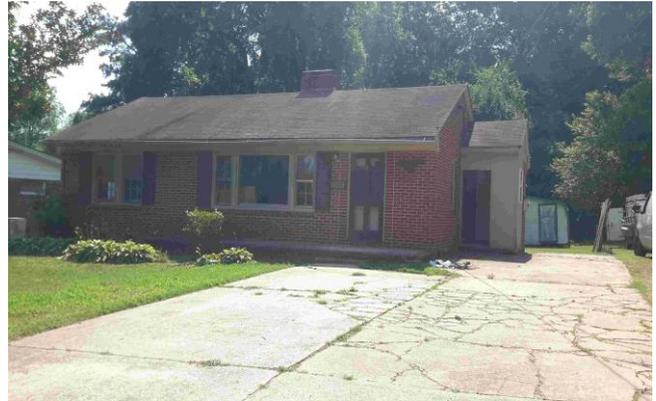
Property Locator / Repetitive Loss#: 3711-99-0686.000
Inspection Date: 6/11/2015 **Inspector:** Yuqi
No. of Stories: 1 **Basement:**
Occupied: Yes **Neighborhood:** Single Family Residential
Fill: 0-1 Feet **Elevated:** 2-3 Feet
Observations: Has secondary structure shield, has gutters, has HVAC
Flooding: Unknown
Flooding Notes:
Land Use: Single-family residential
Land Use Notes:
Adequate Vents Present: Yes
Spoke with: Owner Unavailable
Structure Type: Masonry
Structure Type Notes:
Condition of Structure: Good (optional minor repairs)
Foundation Type: Crawlspace floor at or above grade on at least 1 side
Foundation Type Notes:
Condition of Foundation: Good (optional minor repairs)

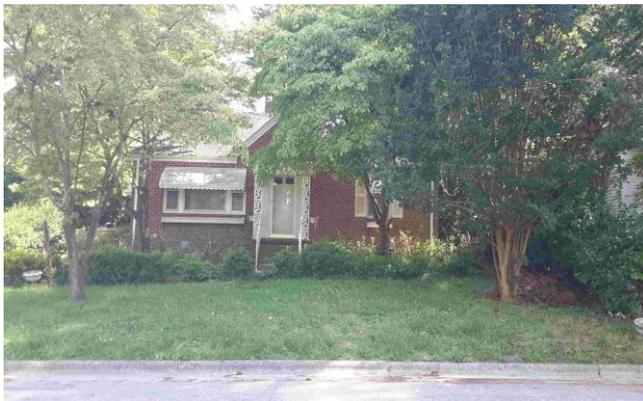
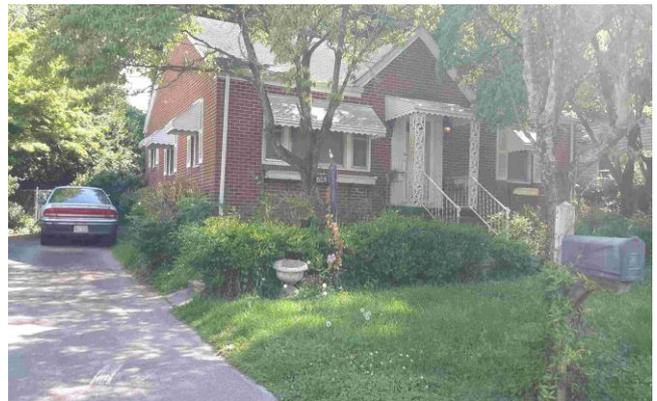
Property Locator / Repetitive Loss#: 3711-99-1493.000
Inspection Date: 6/11/2015 **Inspector:** Yuqi
No. of Stories: 1 **Basement:** Unknown
Occupied: Yes **Neighborhood:** Single Family Residential
Fill: 2-3 Feet **Elevated:** 4-6 Feet
Observations: Has gutters, unobserved HVAC, unobserved secondary structure
Flooding: Unknown
Flooding Notes:
Land Use: Single-family residential
Land Use Notes:
Adequate Vents Present: Yes
Spoke with: Owner Unavailable
Structure Type: Masonry
Structure Type Notes:
Condition of Structure: Good (optional minor repairs)
Foundation Type: Crawlspace floor at or above grade on at least 1 side
Foundation Type Notes:
Condition of Foundation: Good (optional minor repairs)

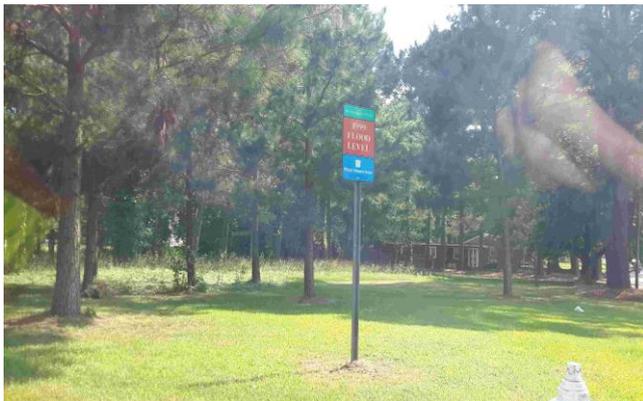
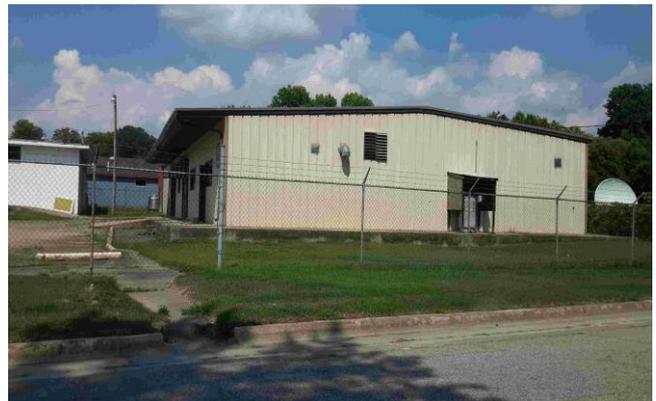
Property Locator / Repetitive Loss#: 3712-90-5465.000
Inspection Date: 6/11/2015 **Inspector:** Yuqi
No. of Stories: 1 **Basement:**
Occupied: Yes **Neighborhood:** Industrial
Fill: 0-1 Feet **Elevated:** 2-3 Feet
Observations: Has gutters, flood sign on the other side of street.
Flooding: Unknown
Flooding Notes:
Land Use: Industrial
Land Use Notes:
Adequate Vents Present: No
Spoke with: Owner Unavailable
Structure Type: Steel
Structure Type Notes:
Condition of Structure: Good (optional minor repairs)
Foundation Type: Slab-on-grade
Foundation Type Notes:
Condition of Foundation: Good (optional minor repairs)

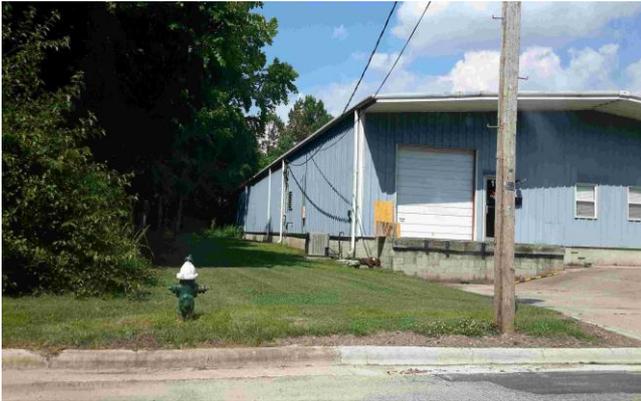
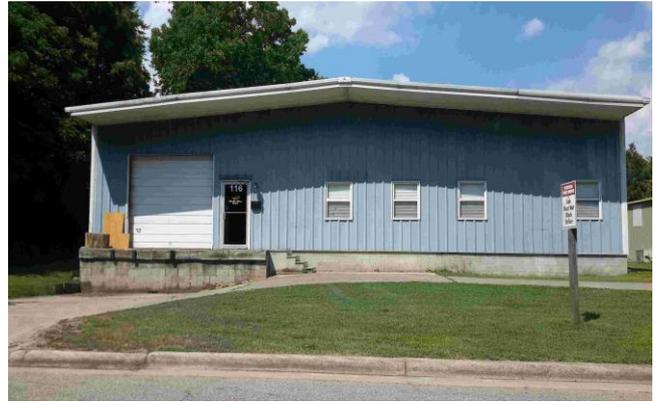
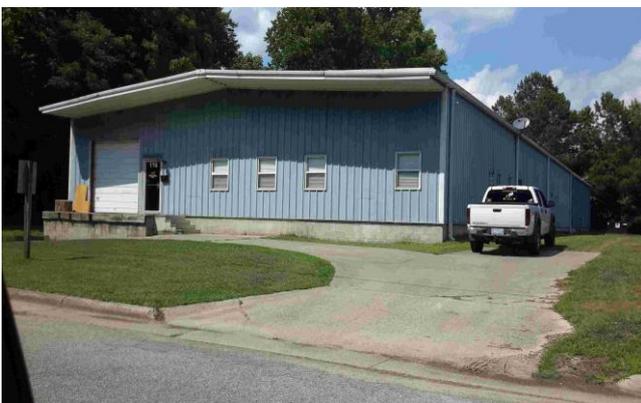
Property Locator / Repetitive Loss#: 3721-09-0918.000
Inspection Date: 6/11/2015 **Inspector:** Yuqi
No. of Stories: 1 **Basement:**
Occupied: Yes **Neighborhood:** Industrial
Fill: 2-3 Feet **Elevated:** 2-3 Feet
Observations: Has gutters, has HVAC
Flooding: Unknown
Flooding Notes:
Land Use: Industrial
Land Use Notes:
Adequate Vents Present: No
Spoke with: Owner Unavailable
Structure Type: Steel
Structure Type Notes:
Condition of Structure: Fair (needs minor repairs)
Foundation Type: Slab-on-grade
Foundation Type Notes:
Condition of Foundation: Good (optional minor repairs)

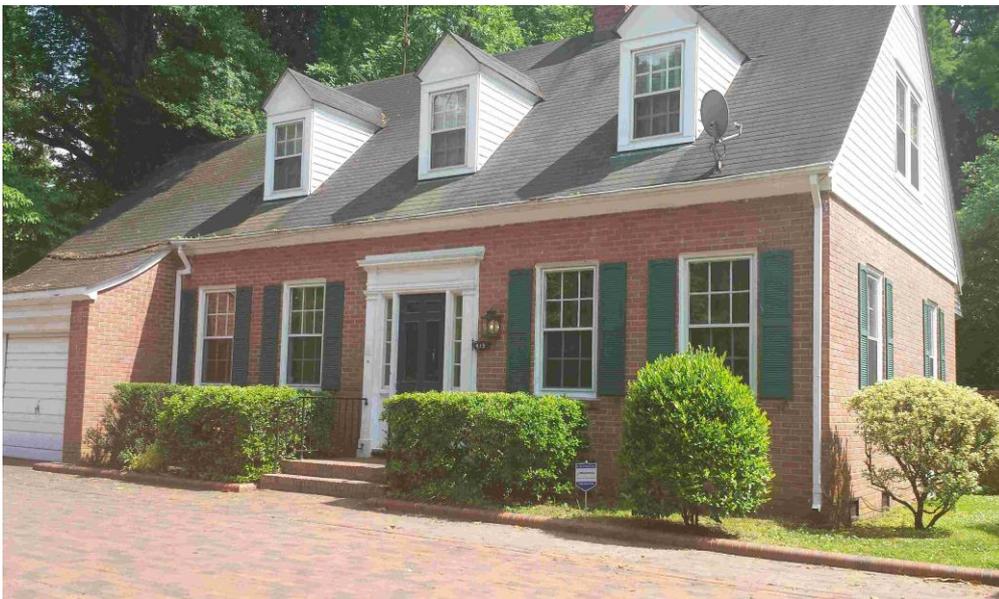
Property Locator / Repetitive Loss#: 3712-93-0326.000
Inspection Date: 6/11/2015 **Inspector:** Alex Magruder
No. of Stories: 2 **Basement:** No
Occupied: Yes **Neighborhood:** Single Family Residential
Fill: 2-3 Feet **Elevated:** 0-1 Feet
Observations: Partial guttering. Hvac unit unknown.
Flooding: Unknown
Flooding Notes:
Land Use: Single-family residential
Land Use Notes:
Adequate Vents Present: No
Spoke with: Owner Unavailable
Structure Type: Masonry
Structure Type Notes:
Condition of Structure: Good (optional minor repairs)
Foundation Type: Crawlspace floor at or above grade on at least 1 side
Foundation Type Notes:
Condition of Foundation: Good (optional minor repairs)

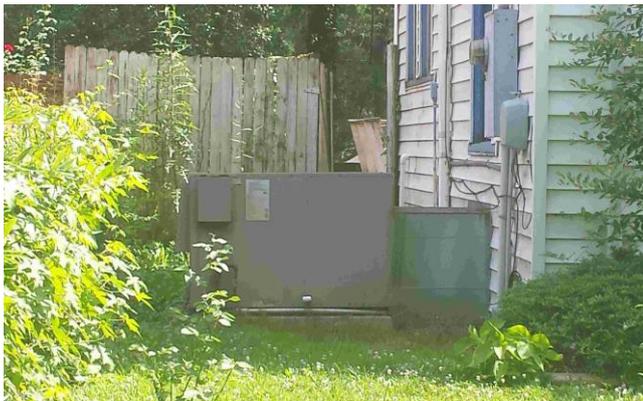
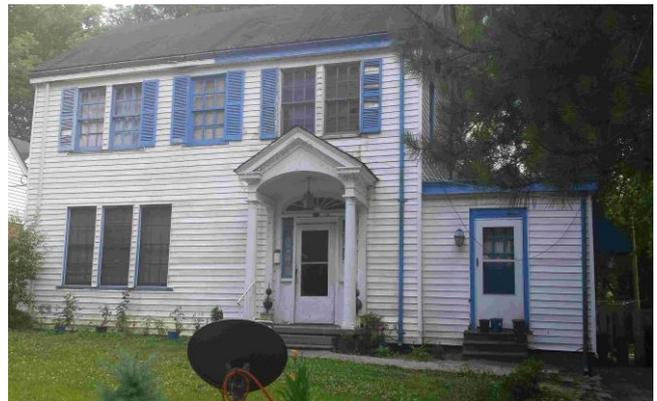
Property Locator / Repetitive Loss#: 3712-83-9358.000
Inspection Date: 6/11/2015 **Inspector:** Alex Magruder
No. of Stories: 2 **Basement:** No
Occupied: **Neighborhood:** Single Family Residential
Fill: 2-3 Feet **Elevated:** 0-1 Feet
Observations: No guttering. Hvac unit on ground.
Flooding: Unknown
Flooding Notes:
Land Use: Single-family residential
Land Use Notes:
Adequate Vents Present: Yes
Spoke with: Owner Unavailable
Structure Type: Wood Frame
Structure Type Notes:
Condition of Structure: Good (optional minor repairs)
Foundation Type: Crawlspace floor at or above grade on at least 1 side
Foundation Type Notes:
Condition of Foundation: Good (optional minor repairs)

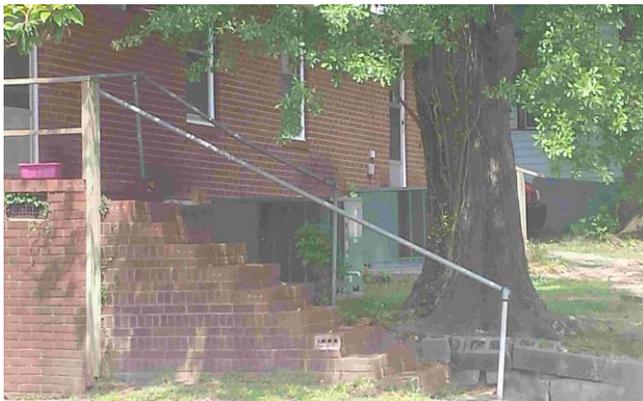
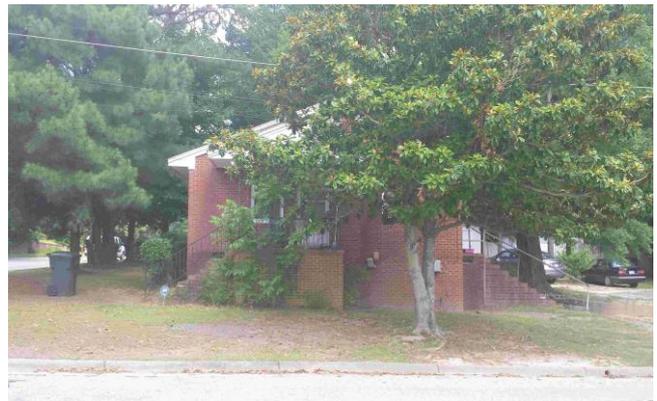
Property Locator / Repetitive Loss#: 3712-83-8389.000
Inspection Date: 6/11/2015 **Inspector:** Alex Magruder
No. of Stories: 1 **Basement:** No
Occupied: Yes **Neighborhood:** Single Family Residential
Fill: 0-1 Feet **Elevated:** 3-4 Feet
Observations: No guttering. Hvac unit on ground.
Flooding: Unknown
Flooding Notes:
Land Use: Single-family residential
Land Use Notes:
Adequate Vents Present: Yes
Spoke with: Owner Unavailable
Structure Type: Masonry
Structure Type Notes:
Condition of Structure: Good (optional minor repairs)
Foundation Type: Crawlspace floor at or above grade on at least 1 side
Foundation Type Notes:
Condition of Foundation: Good (optional minor repairs)

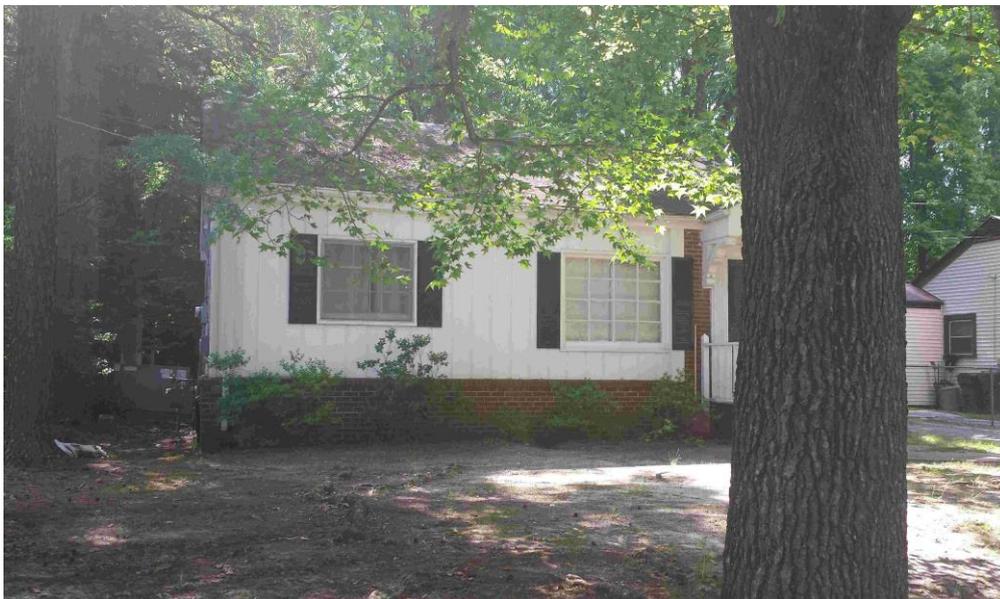
Property Locator / Repetitive Loss#: 3711-99-0788.000

Condition of Structure: Good (optional minor repairs)

Condition of Foundation: Good (optional minor repairs)

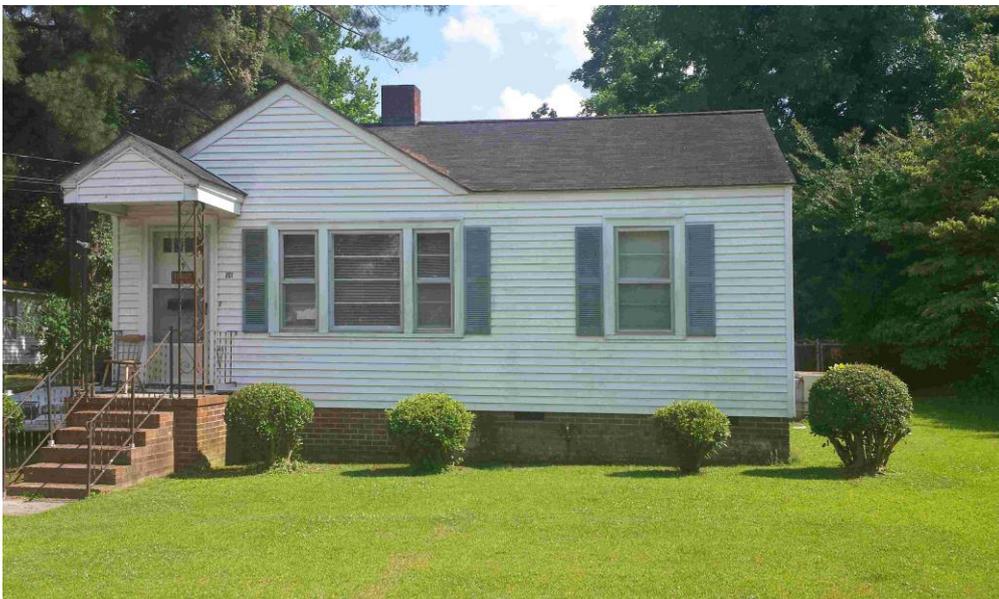
Property Locator / Repetitive Loss#: 3711-99-2464.000
Inspection Date: 6/11/2015 **Inspector:** Alex Magruder
No. of Stories: 1 **Basement:** No
Occupied: Yes **Neighborhood:** Single Family Residential
Fill: 0-1 Feet **Elevated:** 3-4 Feet
Observations: No guttering. Hvac unit on ground.
Flooding: Unknown
Flooding Notes:
Land Use: Single-family residential
Land Use Notes:
Adequate Vents Present: Yes
Spoke with: Owner Unavailable
Structure Type: Wood Frame
Structure Type Notes:
Condition of Structure: Good (optional minor repairs)
Foundation Type: Crawlspace floor at or above grade on at least 1 side
Foundation Type Notes:
Condition of Foundation: Good (optional minor repairs)

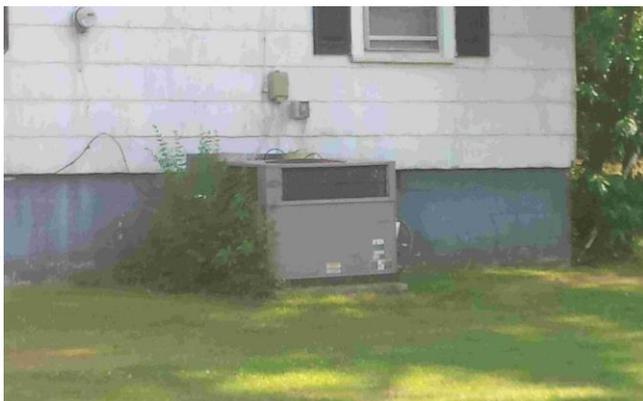
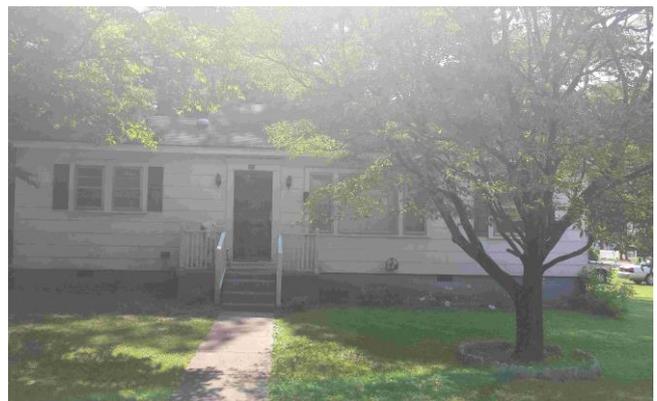
Property Locator / Repetitive Loss#: 3711-99-3444.000
Inspection Date: 6/11/2015 **Inspector:** Alex Magruder
No. of Stories: 1 **Basement:** No
Occupied: Yes **Neighborhood:** Single Family Residential
Fill: 0-1 Feet **Elevated:** 2-3 Feet
Observations: No guttering. Hvac unit on ground.
Flooding: Unknown
Flooding Notes:
Land Use: Single-family residential
Land Use Notes:
Adequate Vents Present: Yes
Spoke with: Owner Unavailable
Structure Type: Wood Frame
Structure Type Notes:
Condition of Structure: Good (optional minor repairs)
Foundation Type: Crawlspace floor at or above grade on at least 1 side
Foundation Type Notes:
Condition of Foundation: Good (optional minor repairs)

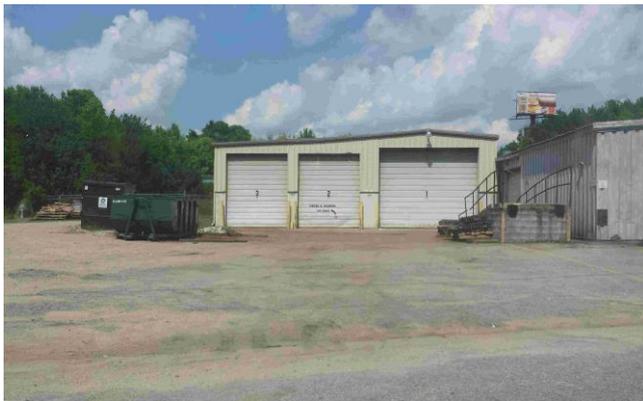
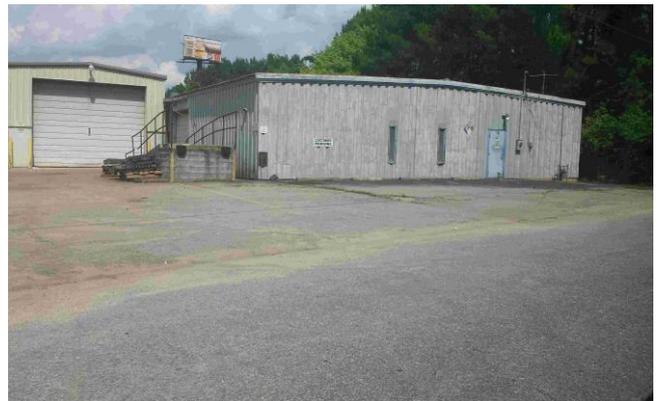
Property Locator / Repetitive Loss#:	<u>3721-09-1793.000</u>	Inspector:	<u>Alex Magruder</u>
Inspection Date:	<u>6/11/2015</u>	Basement:	<u>No</u>
No. of Stories:	<u>1</u>	Neighborhood:	<u>Industrial</u>
Occupied:	<u>Yes</u>	Elevated:	<u>At Grade</u>
Fill:	<u>0-1 Feet</u>		
Observations:			
Flooding:	<u>Unknown</u>		
Flooding Notes:			
Land Use:	<u>Industrial</u>		
Land Use Notes:			
Adequate Vents Present:	<u>No</u>		
Spoke with:	<u>Owner Unavailable</u>		
Structure Type:	<u>Steel</u>		
Structure Type Notes:			
Condition of Structure:	<u>Fair (needs minor repairs)</u>		
Foundation Type:	<u>Slab-on-grade</u>		
Foundation Type Notes:			
Condition of Foundation:	<u>Unable To Determine</u>

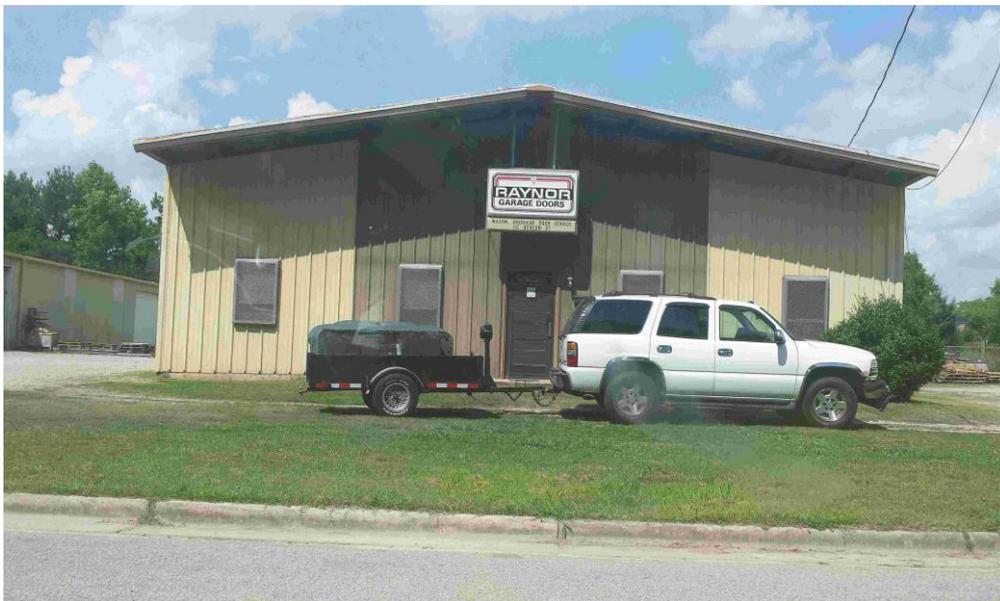
Property Locator / Repetitive Loss#: 3721-09-1874.000

Condition of Structure: Fair (needs minor repairs)

Condition of Foundation: Unable To Determine

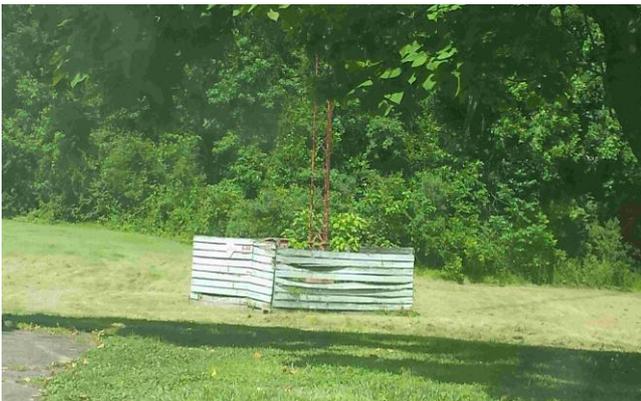
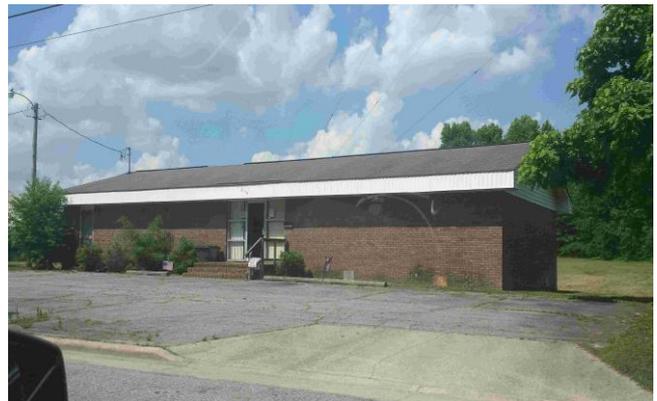
Property Locator / Repetitive Loss#: 3712-90-7249.000

Condition of Structure: Good (optional minor repairs)

Condition of Foundation: Good (optional minor repairs)

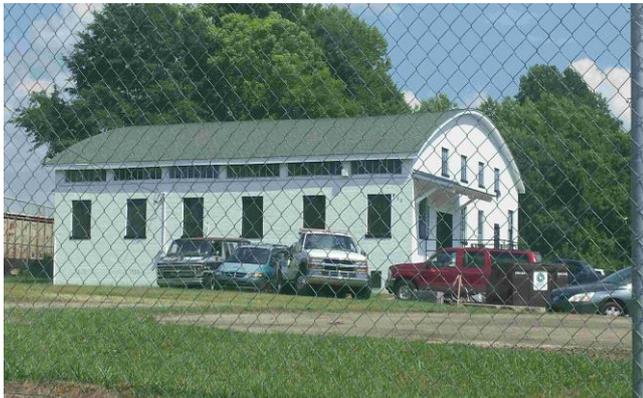
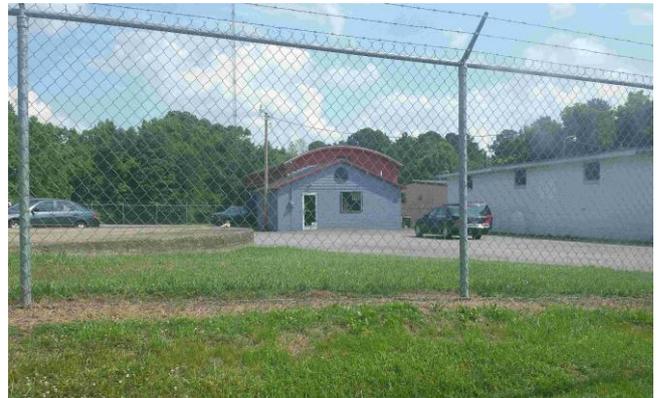
Property Locator / Repetitive Loss#: 3712-90-7524.000
Inspection Date: 6/11/2015 **Inspector:** Alex Magruder
No. of Stories: 1 **Basement:** No
Occupied: Yes **Neighborhood:** Industrial
Fill: Unable To Determine **Elevated:** At Grade
Observations: Multiple buildings.
Flooding: Unknown
Flooding Notes:
Land Use: Commercial
Land Use Notes:
Adequate Vents Present:
Spoke with: Owner Unavailable
Structure Type: Masonry
Structure Type Notes:
Condition of Structure: Good (optional minor repairs)
Foundation Type: Slab-on-grade
Foundation Type Notes:
Condition of Foundation: Unable To Determine
