REPETITIVE LOSS AREA ANALYSIS

City of Wilson, North Carolina
Planning & Development Services

Prepared by:
Amec Foster Wheeler
Environment & Infrastructure, Inc.

October 2015

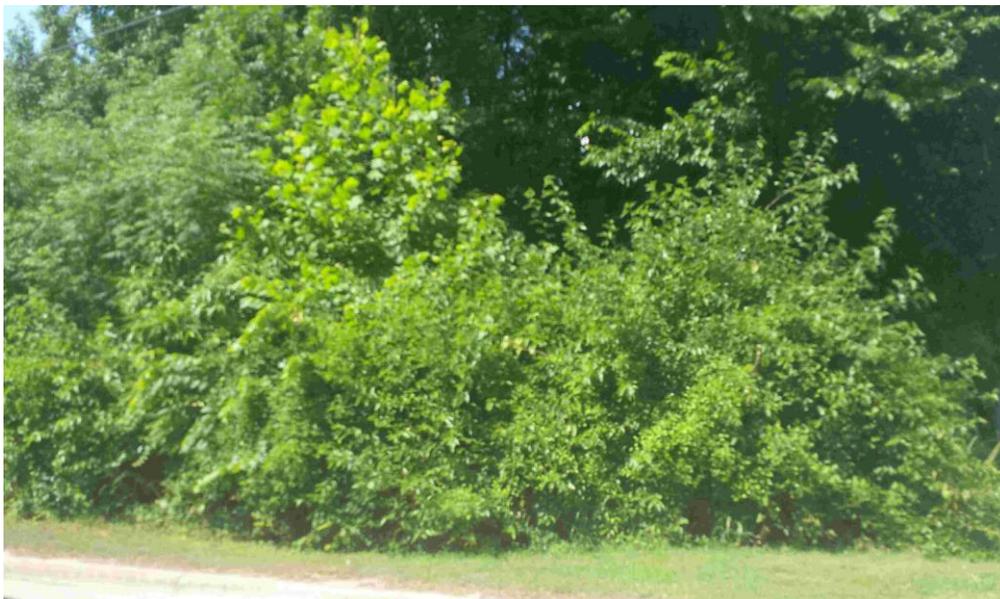
Property Locator / Repetitive Loss#: 3722-00-0049.000
Inspection Date: 6/11/2015 **Inspector:** Alex Magruder
No. of Stories: **Basement:**
Occupied: **Neighborhood:**
Fill: **Elevated:**
Observations: Empty lot.
Flooding:
Flooding Notes:
Land Use:
Land Use Notes:
Adequate Vents Present:
Spoke with:
Structure Type:
Structure Type Notes:
Condition of Structure:
Foundation Type:
Foundation Type Notes:
Condition of Foundation:

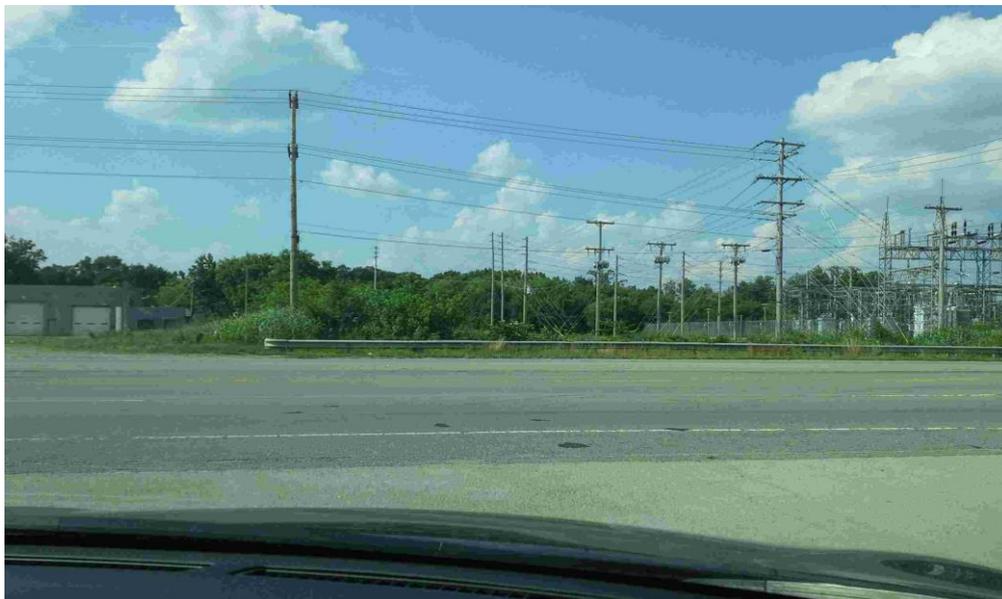
Property Locator / Repetitive Loss#: 3721-13-9959.000
Inspection Date: 6/11/2015 **Inspector:** Scott Gentry
No. of Stories: 0 **Basement:** No
Occupied: **Neighborhood:**
Fill: **Elevated:**
Observations: Parcel is the vacant area adjacent to industrial parcel.
Flooding:
Flooding Notes:
Land Use:
Land Use Notes:
Adequate Vents Present:
Spoke with: Owner Unavailable
Structure Type:
Structure Type Notes:
Condition of Structure:
Foundation Type:
Foundation Type Notes:
Condition of Foundation:

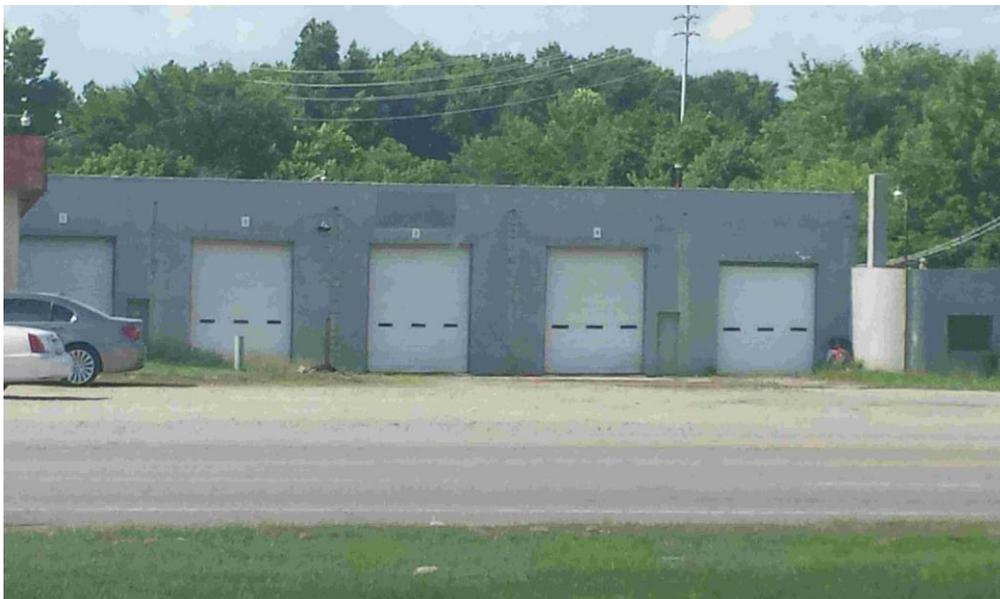
Property Locator / Repetitive Loss#: 3721-13-8709.000
Inspection Date: 6/11/2015 **Inspector:** Alex Magruder
No. of Stories: 1 **Basement:** No
Occupied: Yes **Neighborhood:** Commercial
Fill: None **Elevated:** At Grade
Observations:
Flooding: No
Flooding Notes:
Land Use: Commercial
Land Use Notes:
Adequate Vents Present: No
Spoke with: Owner Unavailable
Structure Type: Concrete
Structure Type Notes:
Condition of Structure: Fair (needs minor repairs)
Foundation Type: Slab-on-grade
Foundation Type Notes:
Condition of Foundation: Unable To Determine
